The EAA Abandoned Well Program Presentation to EAA Board of Directors

August 8, 2017
San Antonio, TX

Advocating for enhanced groundwater protection by:

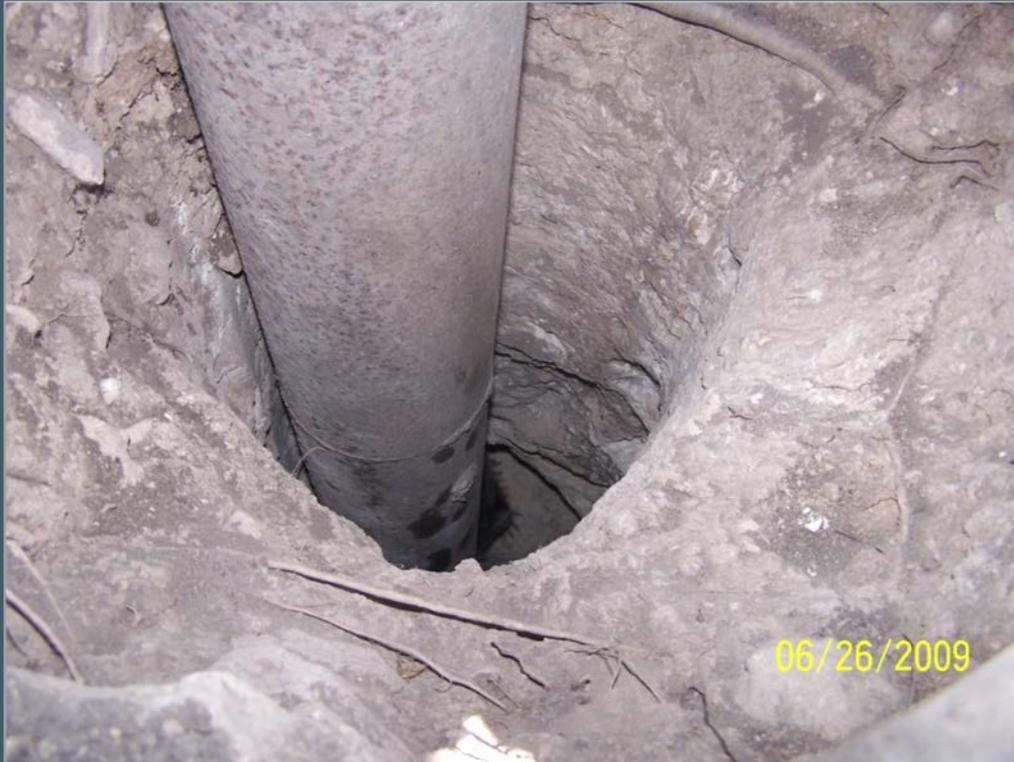
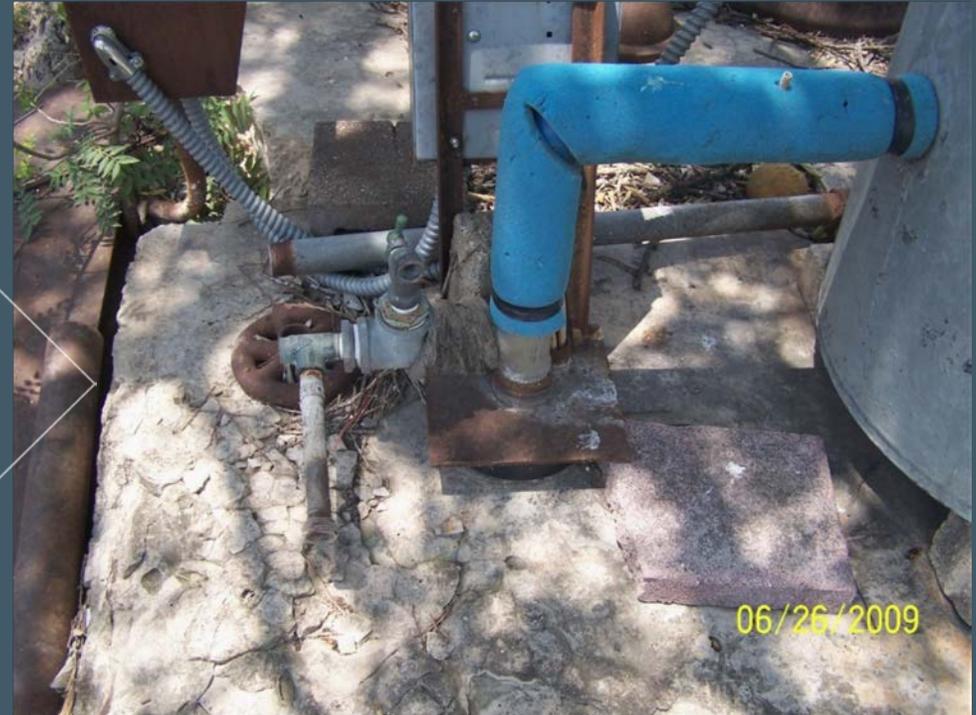
Grout Deterioration Over Time

View from below surface pad

Surface view

- Cement deteriorates over time
- Leaks occur when cement shrinks, develops cracks or channels

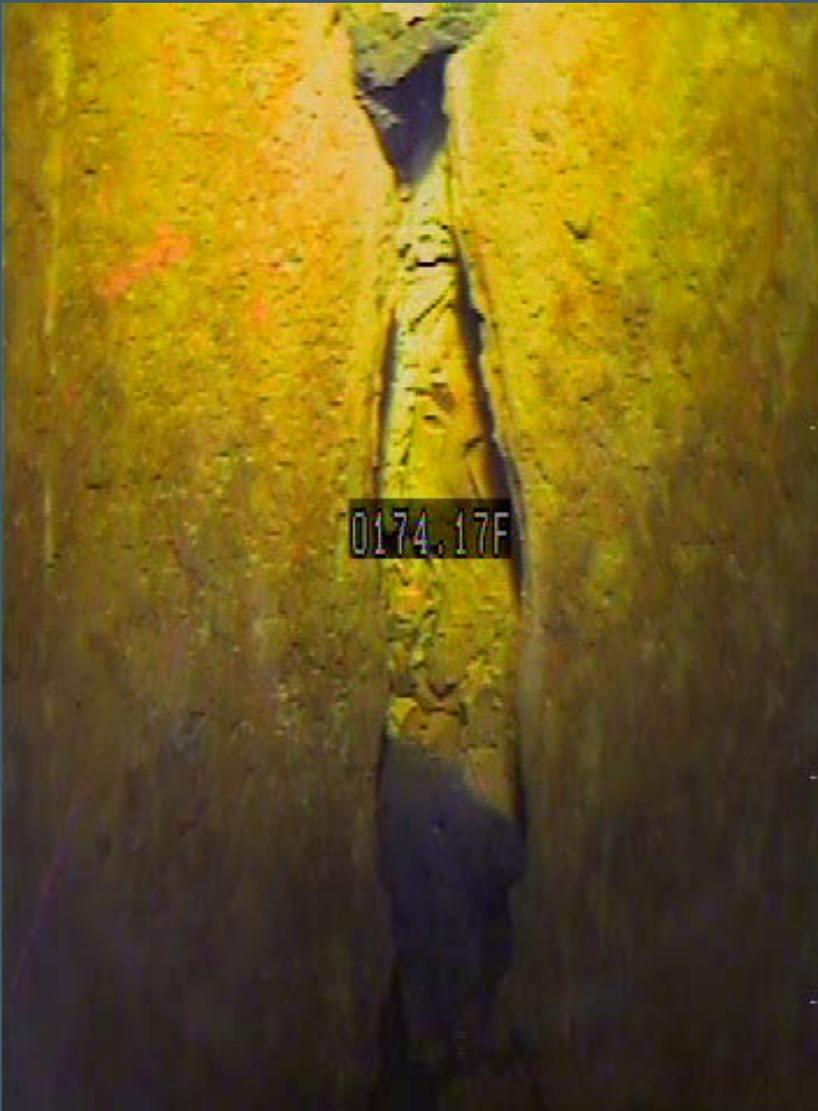
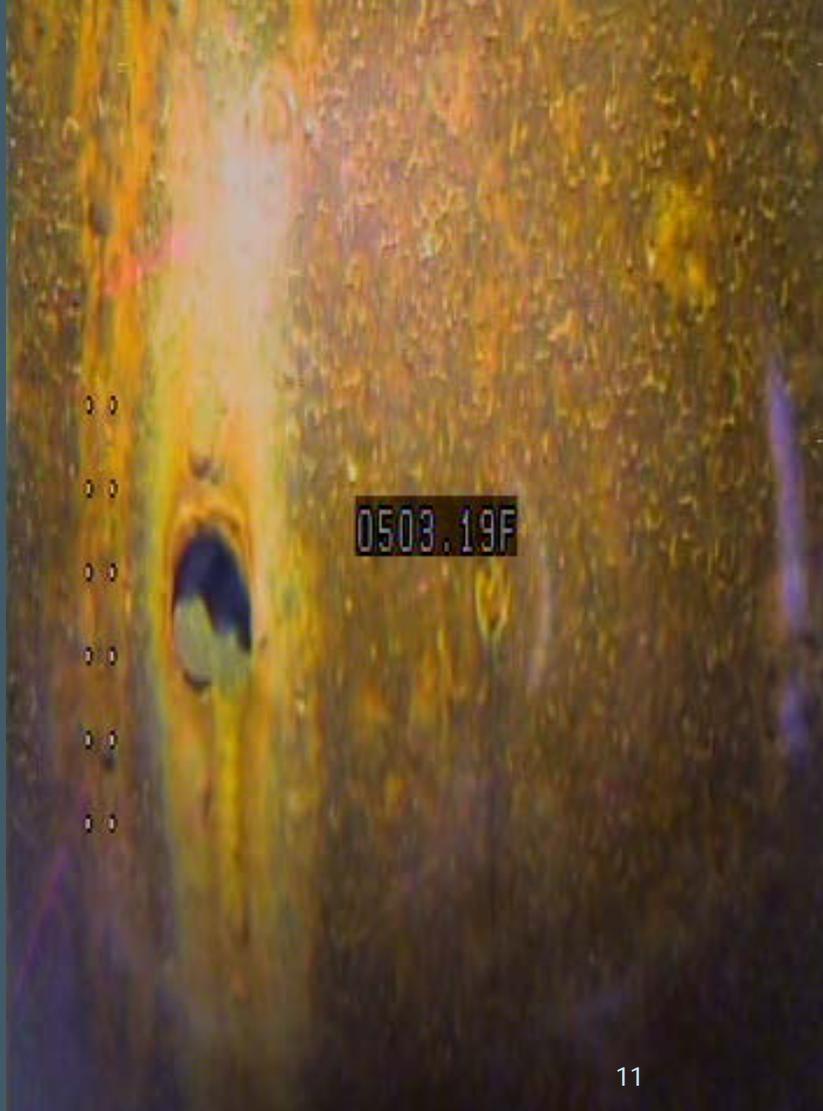
Deteriorated Casing: Split casing and holes in casing

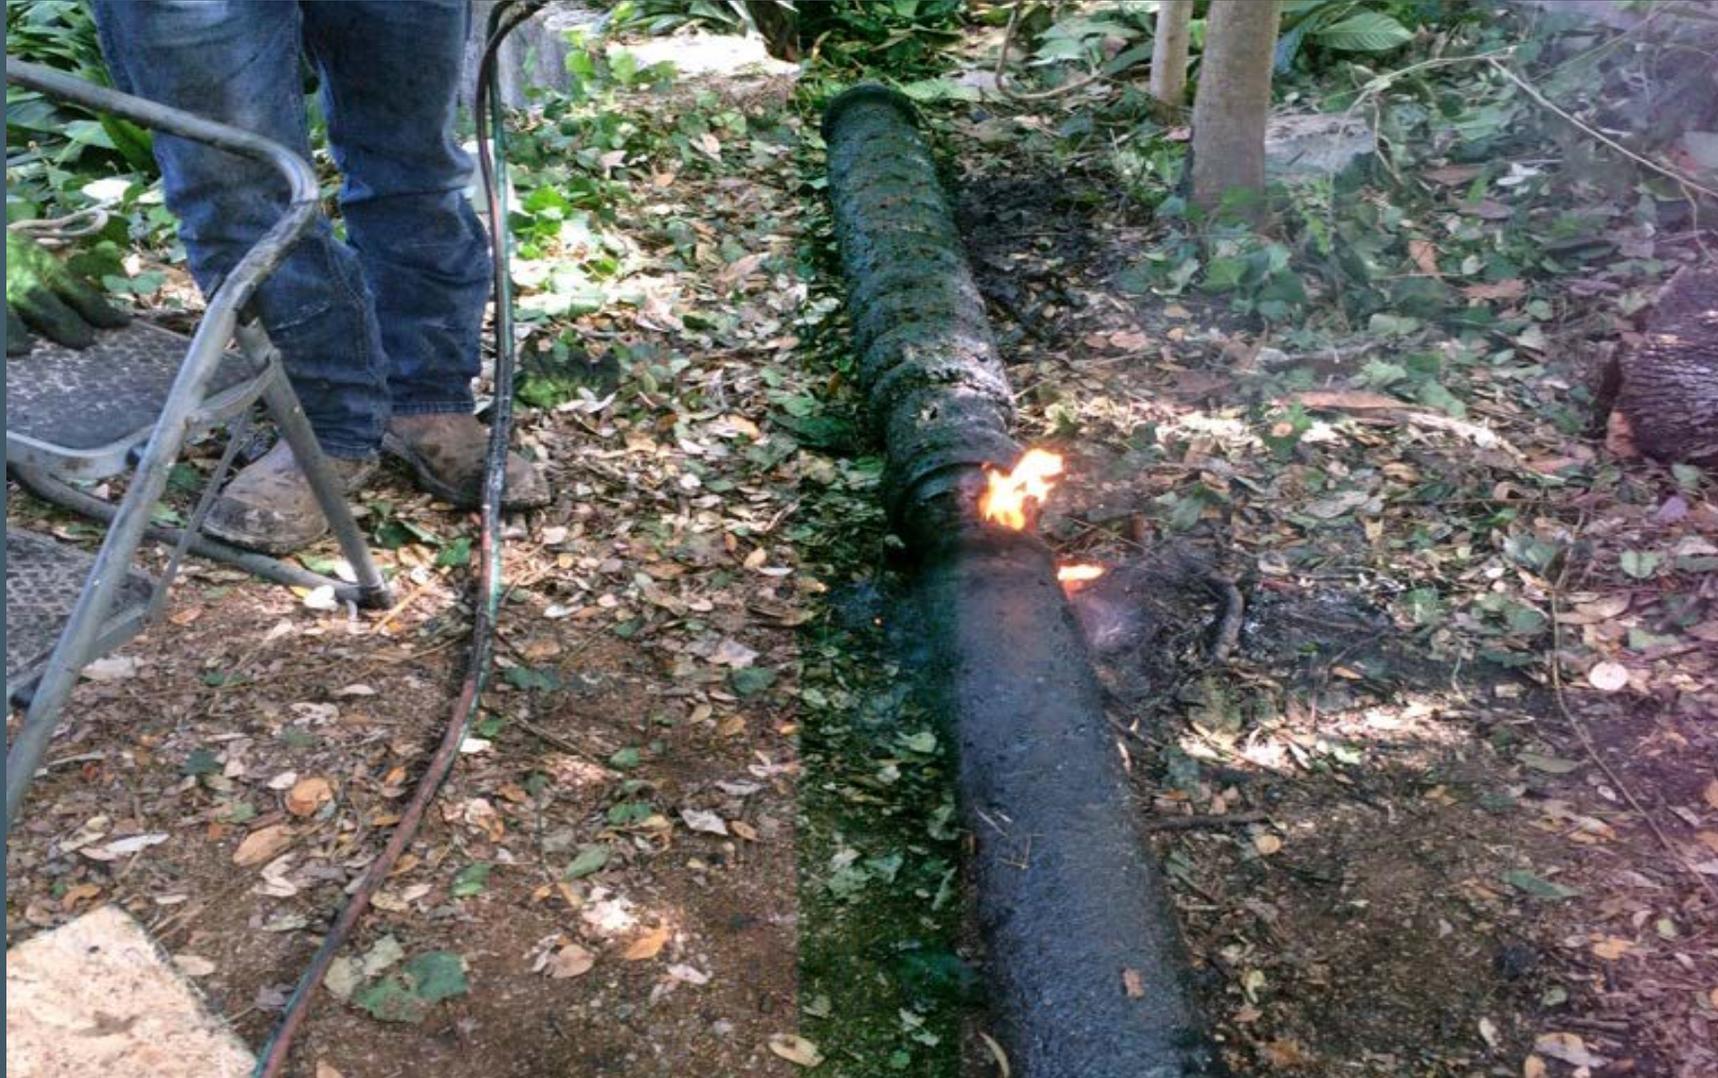
Deteriorated Wells: Water Quality Issue

Suspected oil source

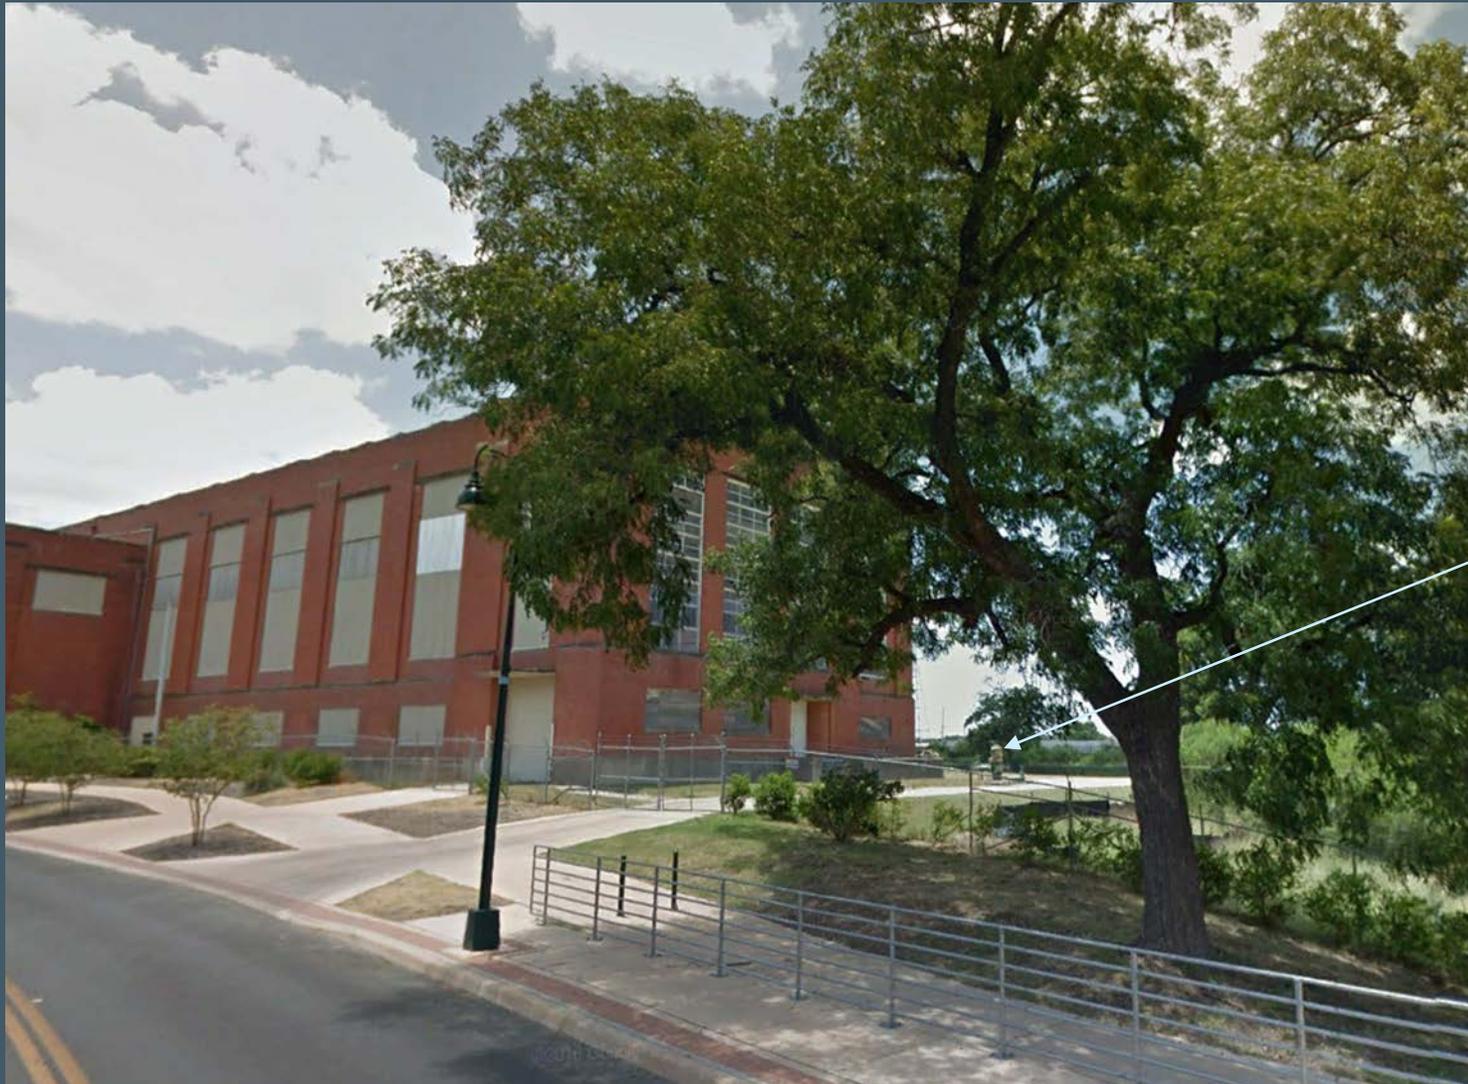
Only well
visible at
ground surface.

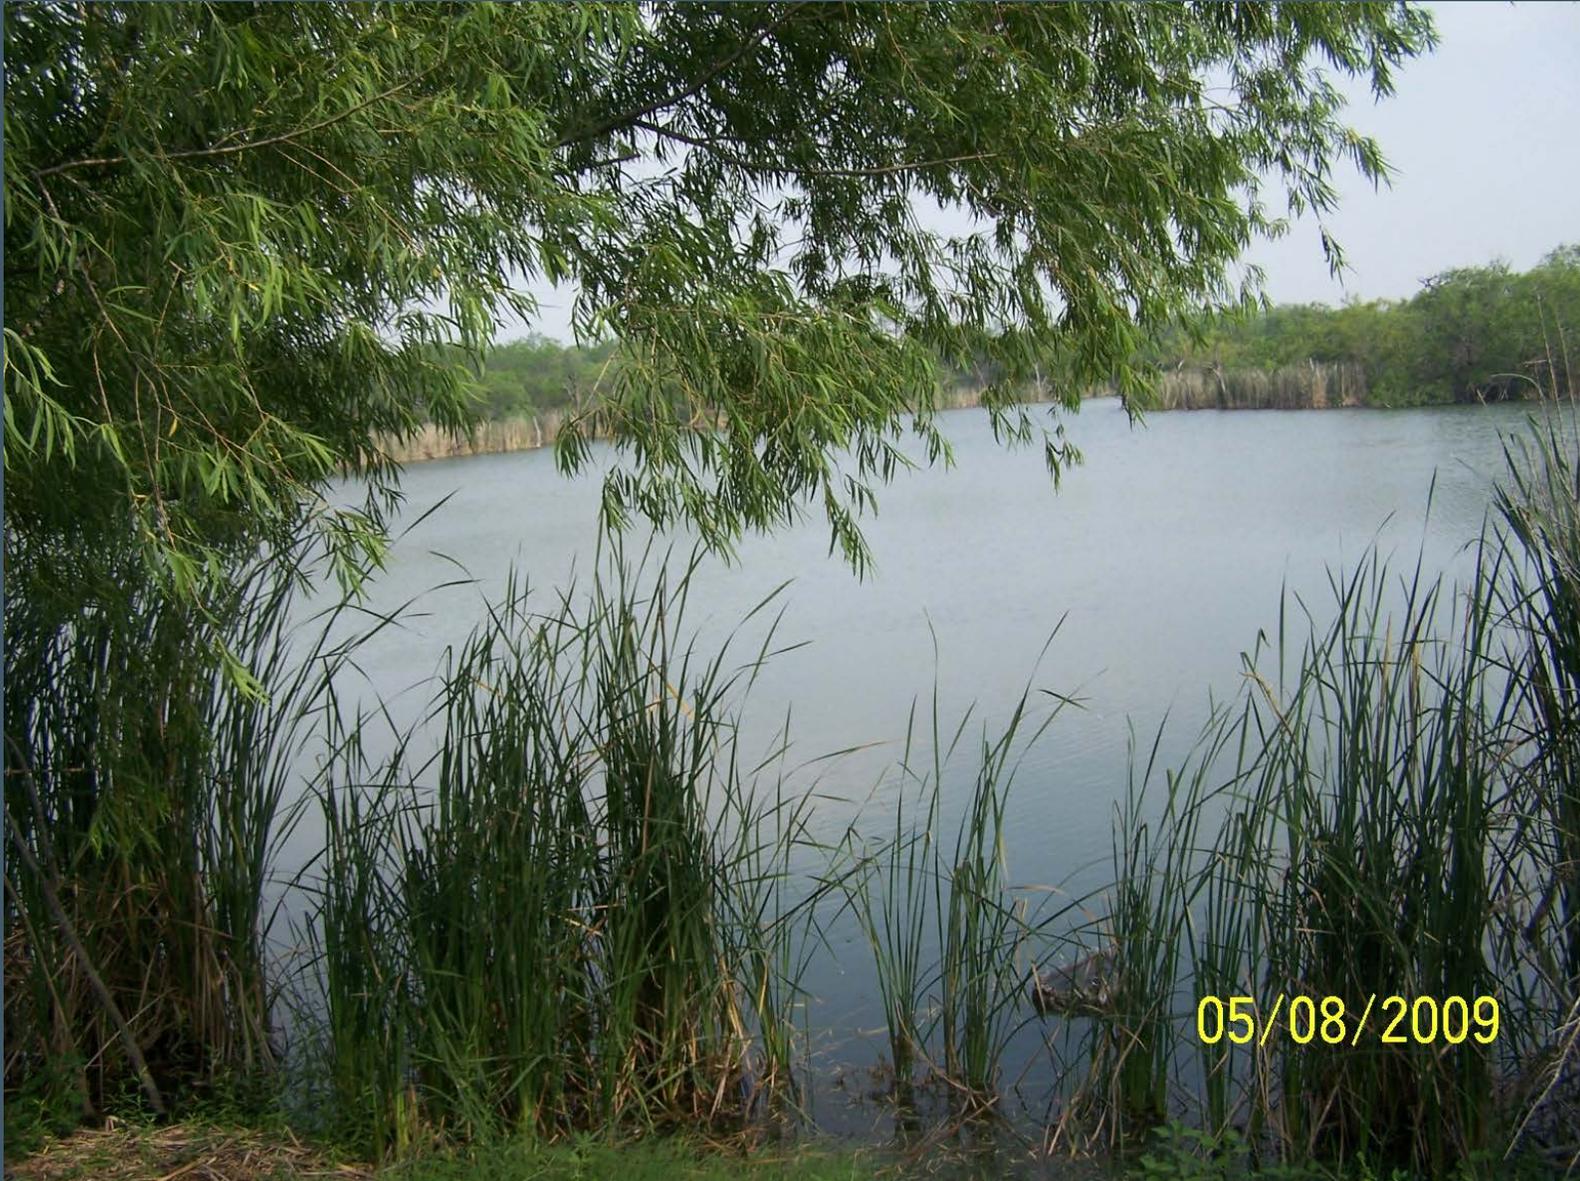
Significant ecosystem has developed over many years from an abandoned flowing artesian well. Suggestion to plug well met significant resistance from community entities.

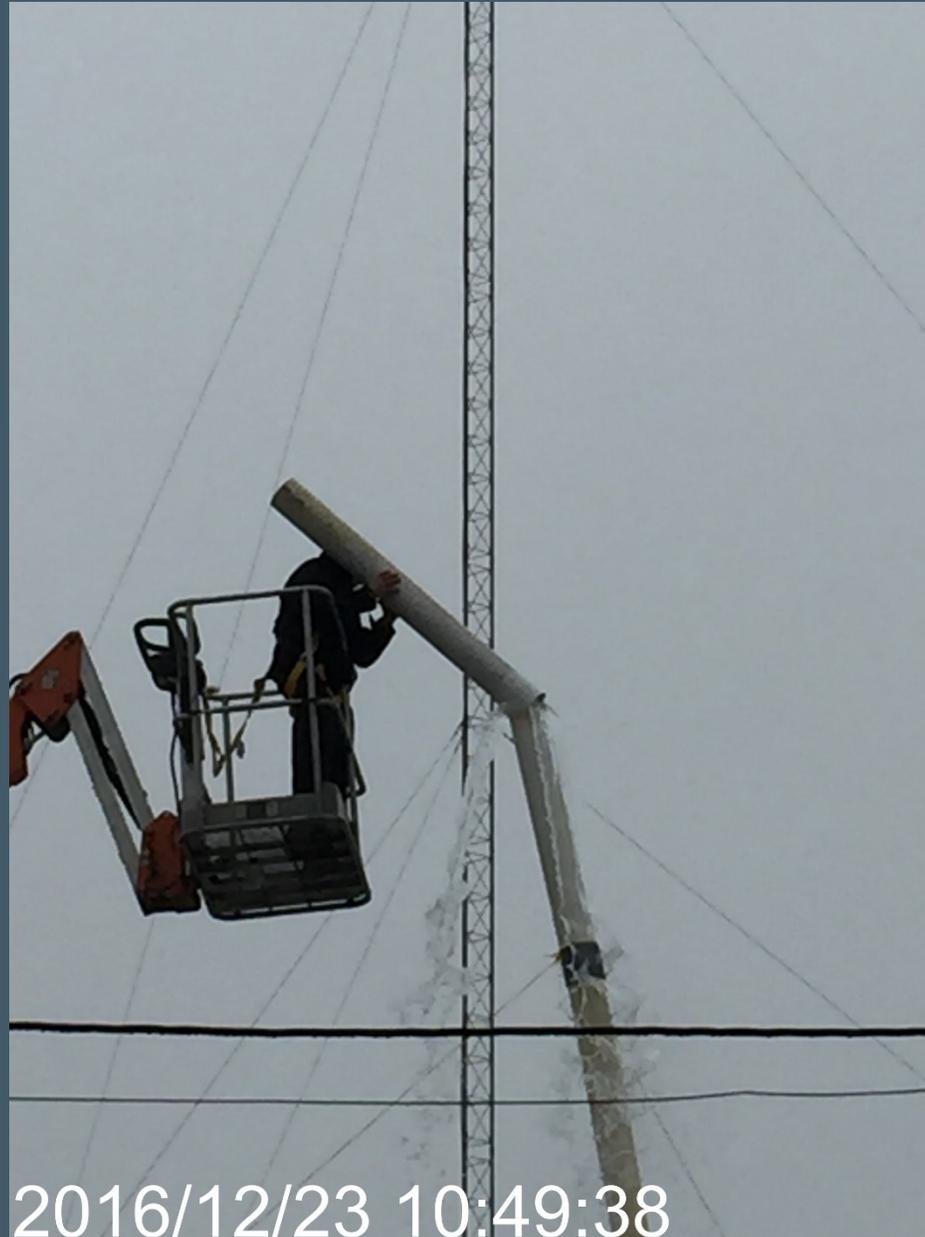
Recent high aquifer levels to start flowing above standpipe height, requiring additional PVC section.

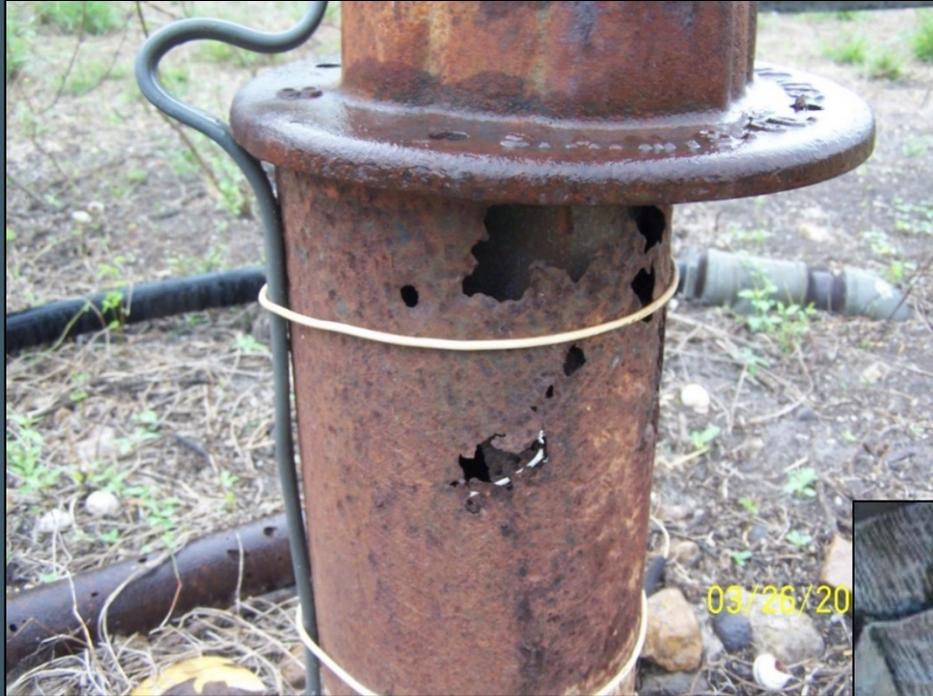
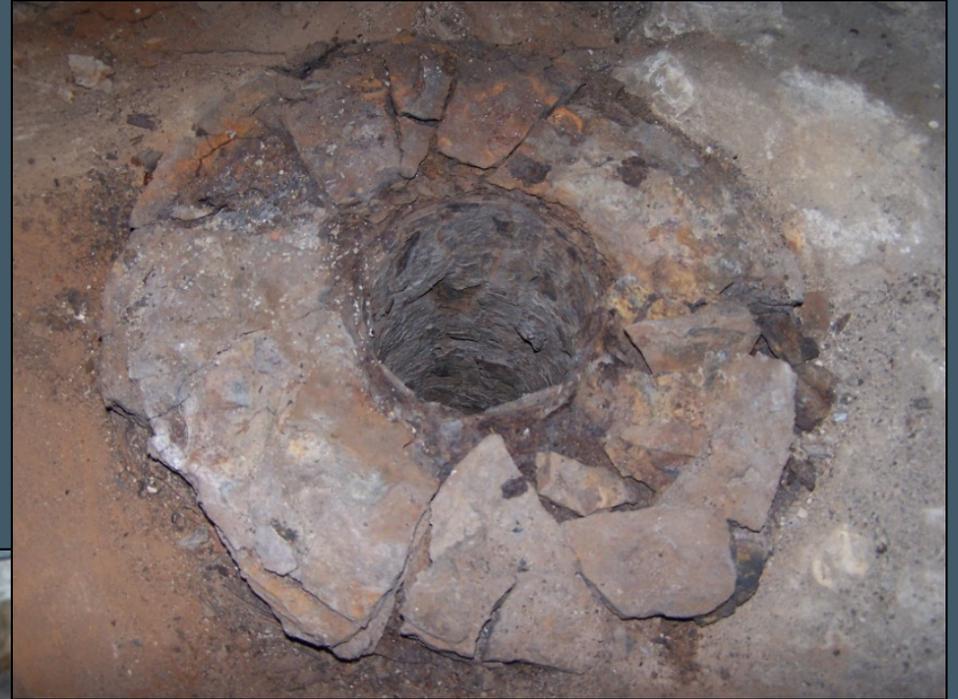
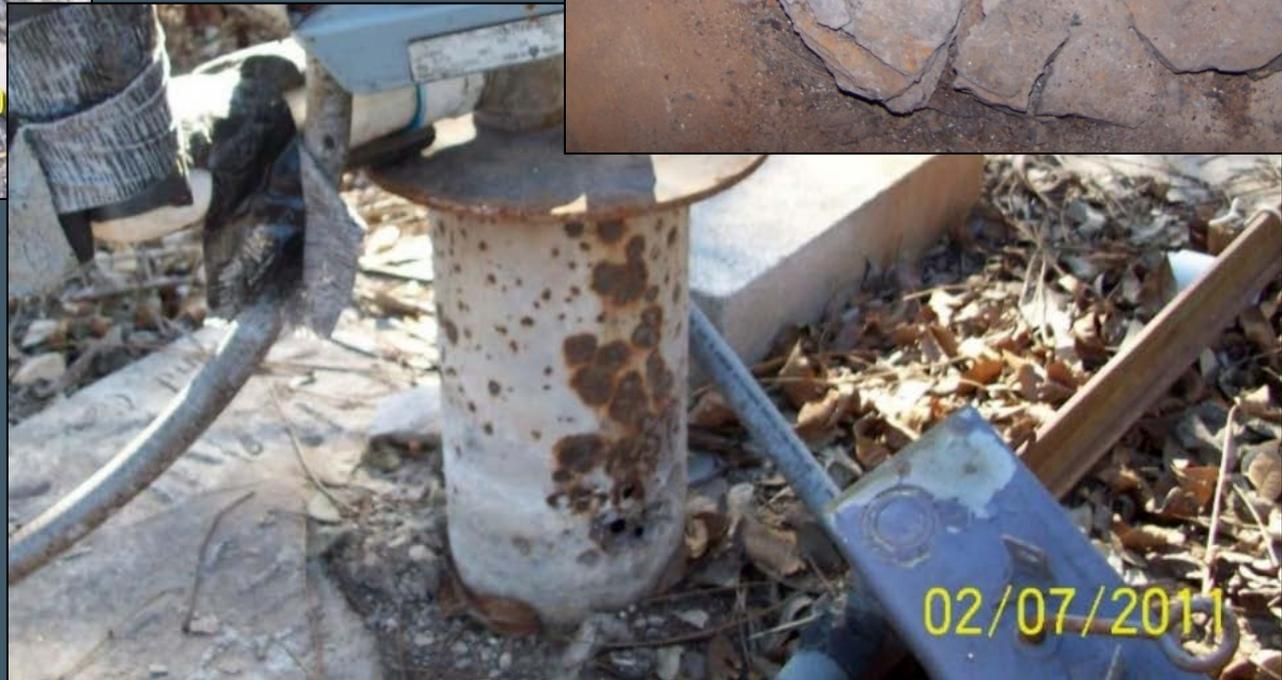
Abandoned Well Condition: Deteriorated Casing
