FLOODING ALONG THE BALCONES ESCARPMENT, CENTRAL TEXAS

S. Christopher Caran
Bureau of Economic Geology
The University of Texas at Austin
Austin, TX 78713

Victor R. Baker
Department of Geosciences
University of Arizona
Tucson, AZ 85721

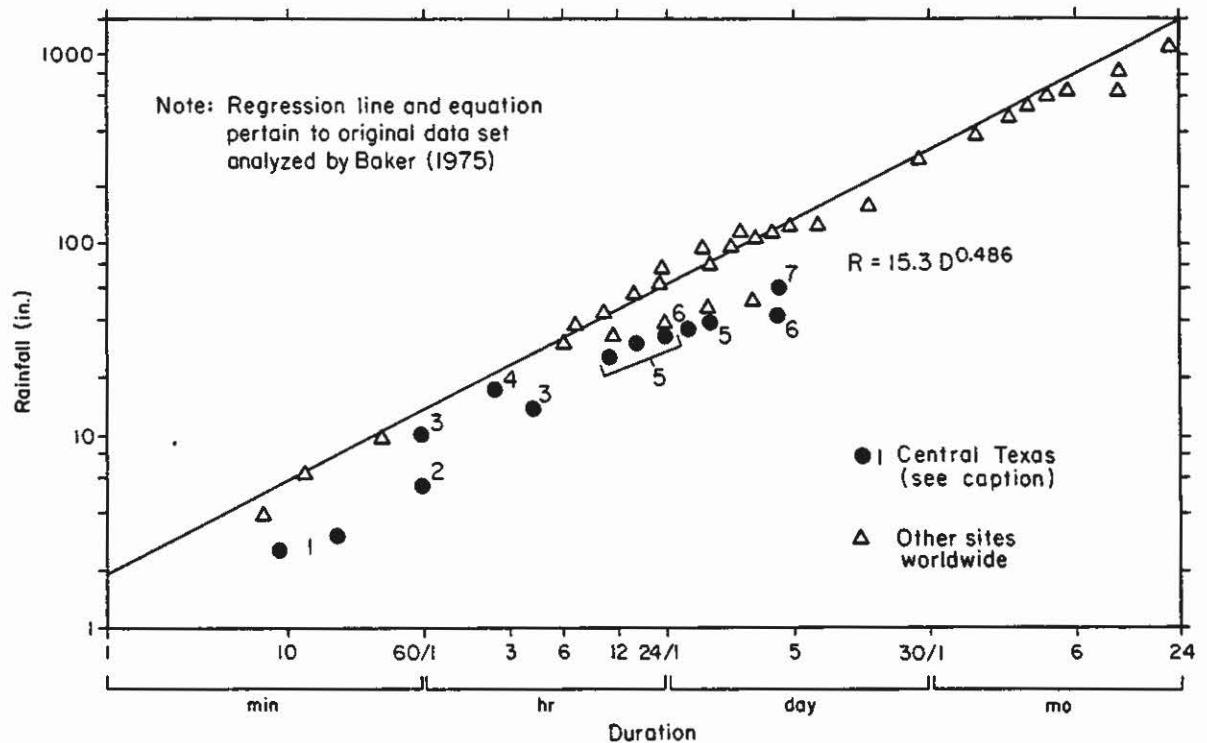
Figure 2. Magnitude-duration relationships of the most intense rainstorms in Central Texas and the rest of the world. Sites in Central Texas: (1) Trough Creek, 1973; (2) Austin, 1981; (3) New Braunfels, 1973; (4) D'Hanis, 1935; (5) Thrall, 1921; (6) Voss Ranch, 1978; (7) Manatt Ranch, 1978. Adapted from Baker (1975, fig. 2). Additional data sources: Hansen (1979); Massey and others (1982, table 2); Moore and others (1982, figs. 2.2, 2.4); and sources cited by Baker (1975, fig. 2).

approaching the trend of worldwide precipitation maxima (fig. 2).

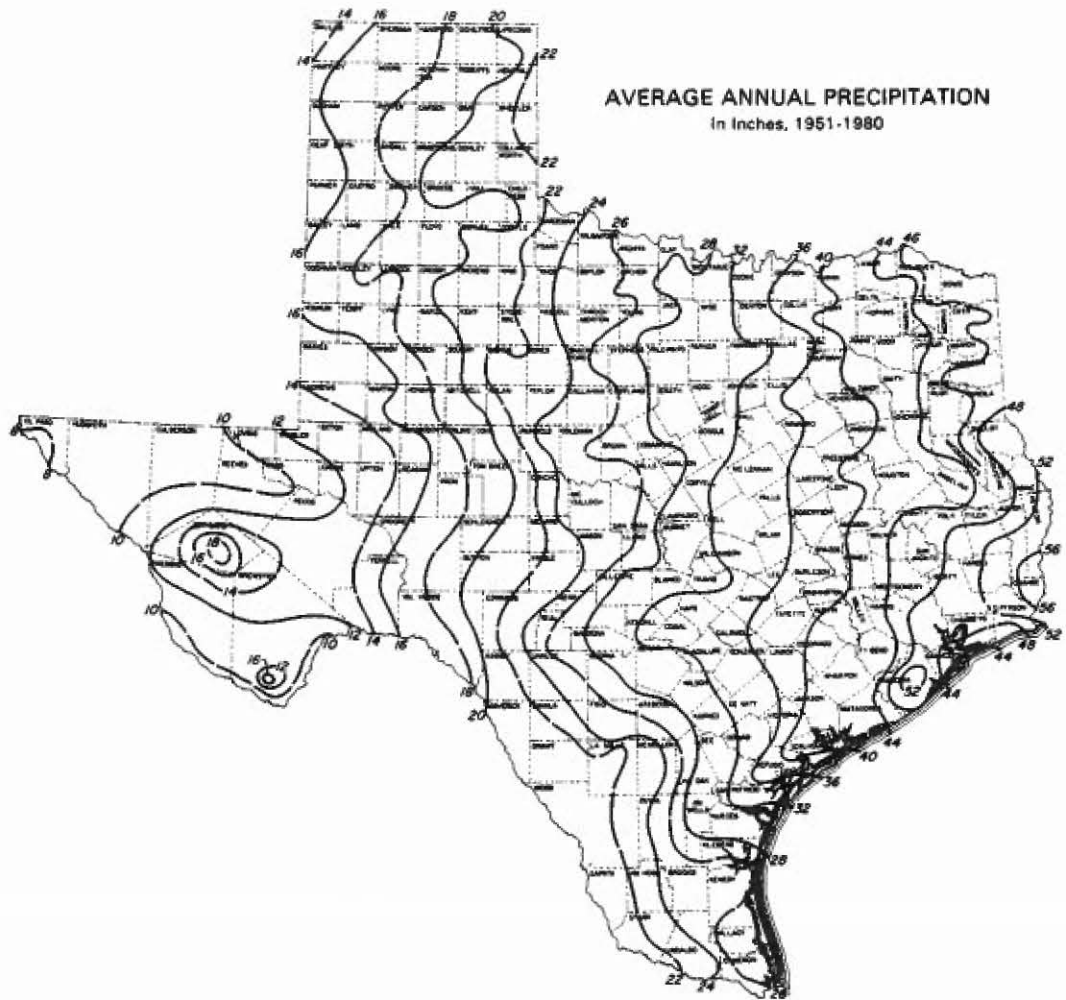
Figure 4. Mean annual precipitation in Texas. Note westward deflection of isohyet contours in Balcones Escarpment area, indicating increased rainfall relative to adjacent areas. From Larkin and Bowmar (1983, p. 18).

The easterly wave that produced the Thrall storm of 1921 was augmented by topographic conditions in the region. Relief across most of the Balcones Escarpment ranges from 100 to 500 ft (fig. 1 caption). Warm, moisture-laden air from the Gulf of Mexico is pushed northward across the gently sloping Coastal Plains by dominant southerly winds. As these winds encounter the escarpment they rise abruptly to higher altitude. If the Gulf air is nearly saturated at lower elevations, rainstorms may occur along the escarpment because of orographic cooling of the air mass. The climate of Central Texas is semiarid; drought years offset wet periods, thereby reducing mean annual precipitation. But cumulative rainfall increases sharply at the escarpment compared to adjacent regions (fig. 4), and rains may be extremely intense for periods of

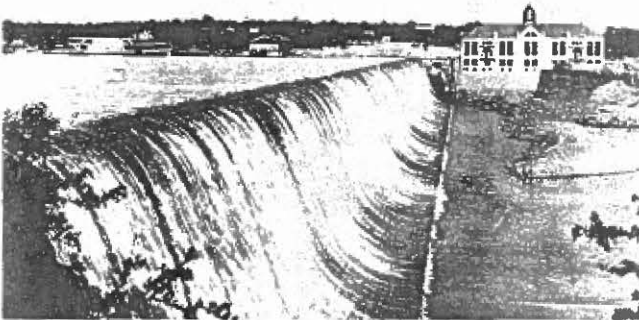
Figure 10. Historic photographs of Austin Dam (now call Tom Miller Dam). Photos courtesy of Austin History Center. In all photos drainage is from north to south. (A) Photo number Chal 8484. Dam soon after construct (photo taken about 1895). View is toward east. Note paddlewheel steamboat Ben Hur at left. (B) Photo num Chal 1613. Remnants of dam soon after flood of August 7, 1900 (photo taken about 1900). View is toward northwest. Section in center has been displaced downstream. Note wreck of Ben Hur at right. (C) Photo number Chal 65. Dam during flood of June 15, 1935. View is toward west.

Floods have posed serious hazards throughout the history of Central Texas. In an effort to control flooding and harness the Colorado River for water supplies, recreation, and hydroelectric-power generation, the city of Austin and, later, the Lower Colorado River Authority constructed and maintained a dam in western Austin. The present structure, known as Tom Miller Dam, impounds Lake Austin. An earlier dam at this site was the world's largest masonry structure when it was completed in 1893 (Lower Colorado River Authority, undated). The reservoir formed by this early dam was called Lake McDonald (fig.

10A). Design problems and controversy surrounding the advisability of the site raised some concern although the dam appeared stable (Taylor, 1930, p. 25). But on April 7, 1900, a major flood in the Colorado watershed caused the dam to fail, draining Lake McDonald. Sections of the dam were displaced downstream yet remained upright (fig. 10B). Other sections were washed away entirely. The dam was reconstructed, only to fail a second time in 1915 (Lower Colorado River Authority, undated). Further construction was delayed. Another flood in 1935 did additional damage (fig. 10C). Finally, in 1938, the existing structure was completed and has operated with few interruptions since that time.
