BIO-WEST, Inc.
1812 Central Commerce Court
Round Rock, Texas 78664

MEMORANDUM

SUBJECT: **ITEM M NET DISTURBANCE AND INCIDENTAL TAKE
ASSESSMENT FOR 2015 EARIP ITP ANNUAL REPORT**

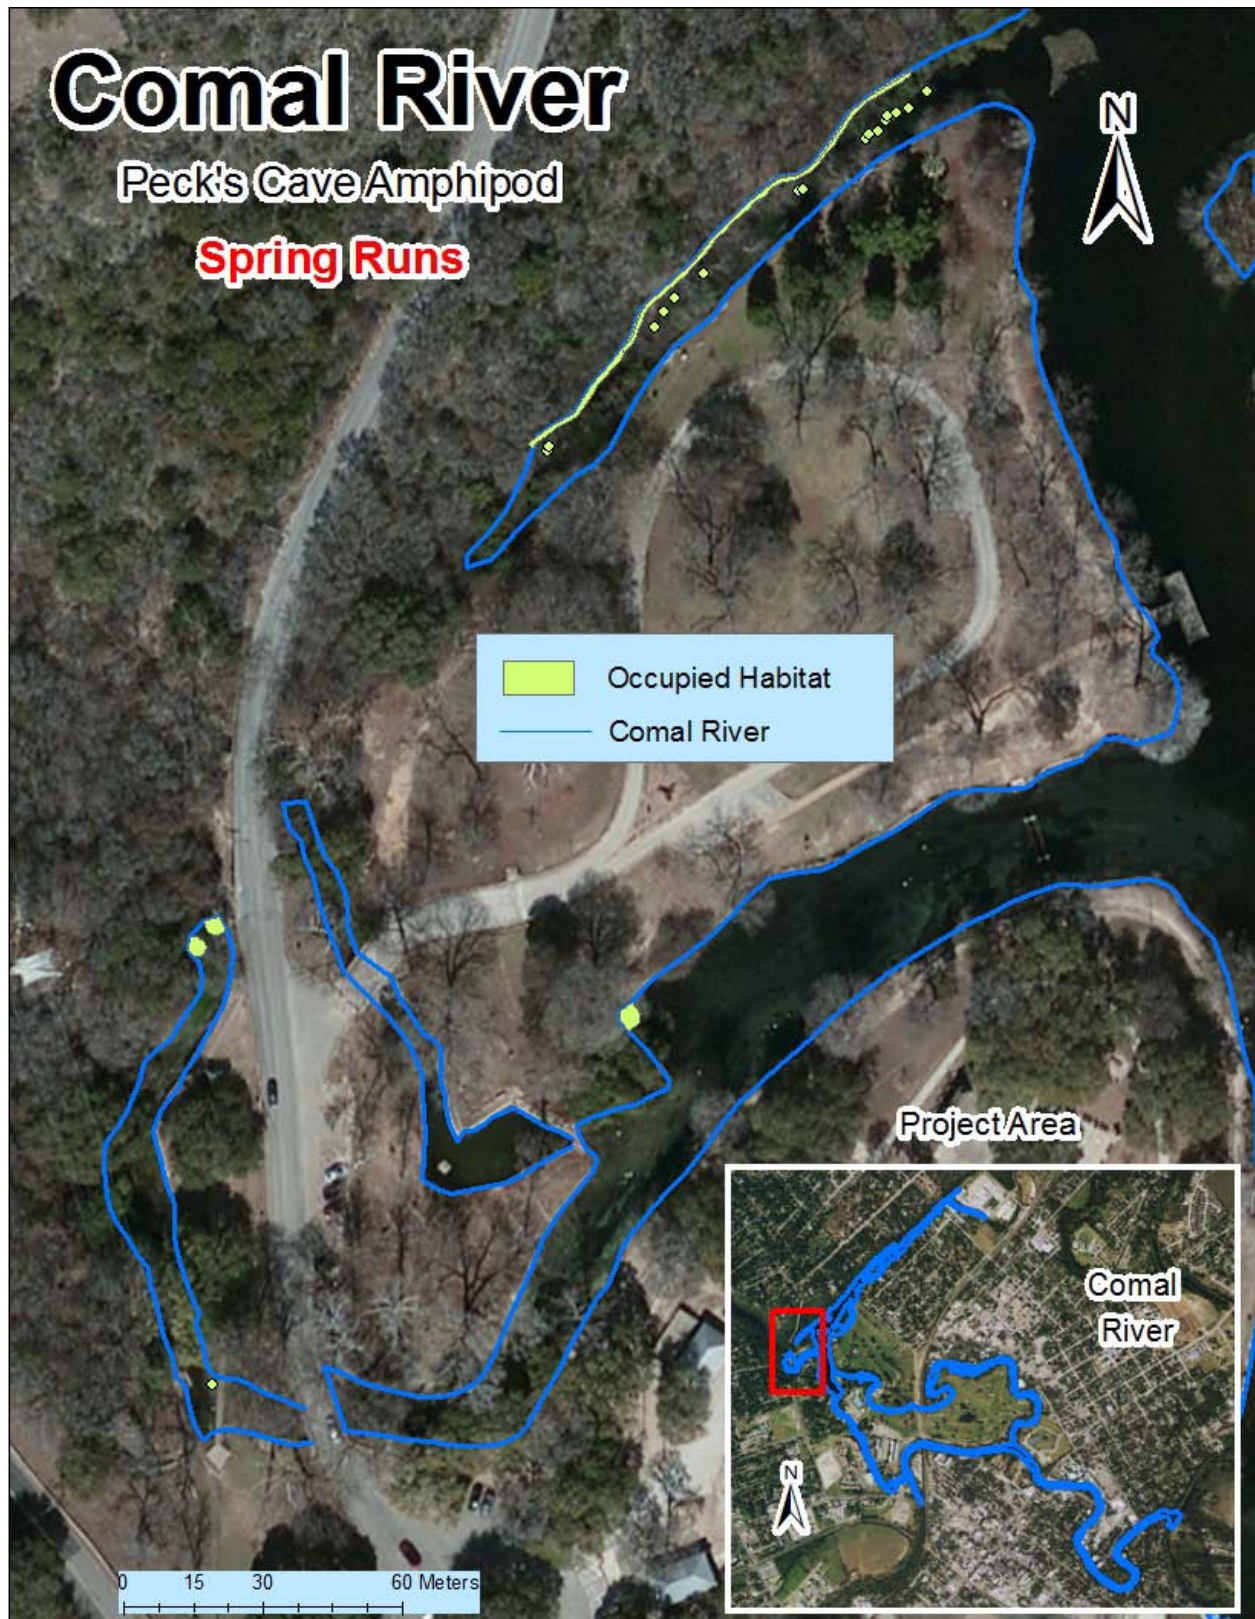
Figure 3: Peck's Cave Amphipod Occupied Surface Habitat – Upper Spring Run (top) and Spring Island and Western Shoreline areas (bottom) - (Comal System).

Figure 3 (continued): Peck's Cave Amphipod Occupied Surface Habitat – Spring Runs (Comal System).

As described in the HCP, both the Peck's cave amphipod and Comal Springs dryopid beetle are subterranean species. Peck's cave amphipods are frequently found at the surface primarily in areas that Comal Springs riffle beetles are collected, whereas the Comal Springs dryopid beetle is less commonly found. As it is presumed that these subterranean invertebrates are not suited for survival in surface conditions, the decision was made to quantify 0.5 m² around the orifices that these species have been collected in the Comal system. As for the riffle beetle, sampling for these species over the years has been conducted by quadrats, drift netting, and cotton lures. Dr. Bowles and Mr. Gibson's data were again reviewed in detail as was the EAA biological monitoring database. For these two species, it is presumed that the majority of their occupied habitat is located subsurface. However, it is not possible to quantify the subsurface occupied habitat for these species at this time. Rather, the orifices where they have been collected are documented for further evaluation of potential impacts to these areas later in this memorandum. Figures 3 and 4 show occupied habitat for the Peck's Cave amphipod and Comal Springs dryopid beetle, respectively, throughout the Comal System with the quantification of surface habitat area presented in Table 1.

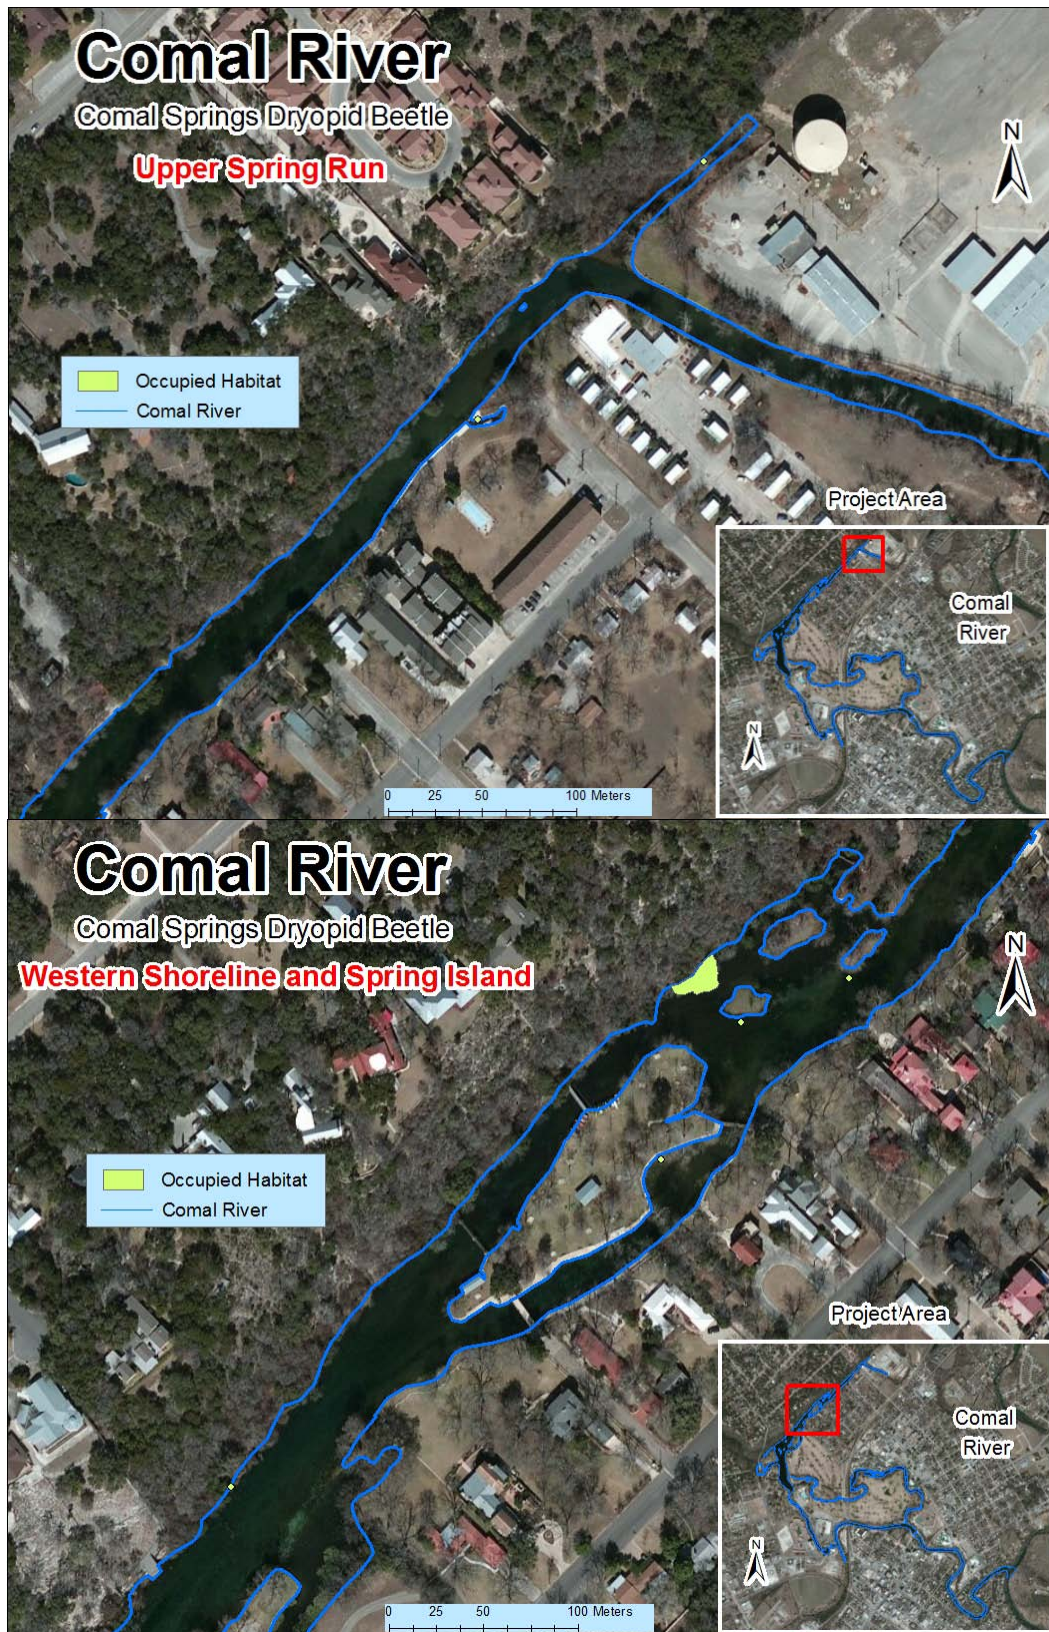
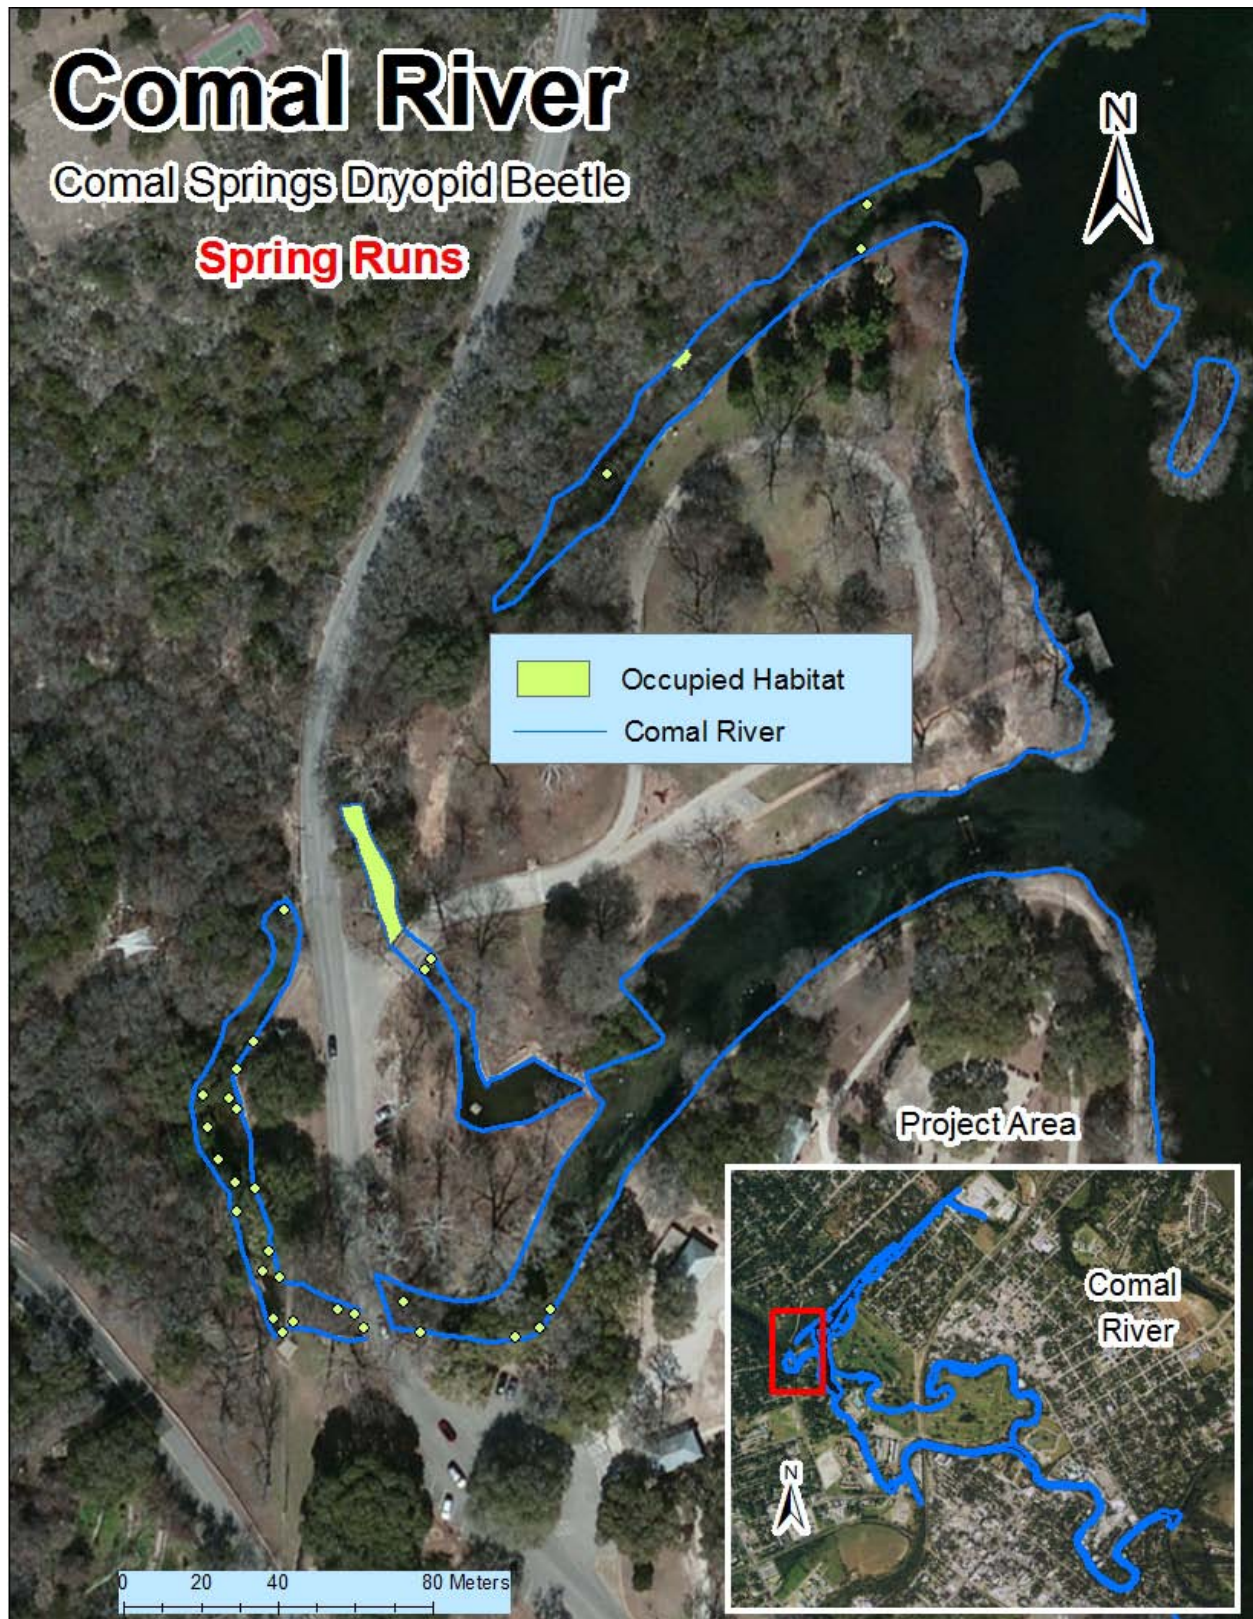
Figure 4: Comal Springs Dryopid Beetle Occupied Surface Habitat – Upper Spring Run (top) and Spring Island and Western Shoreline areas (bottom) - (Comal System).

Figure 4 (continued): Comal Springs Dryopid Beetle Occupied Surface Habitat – Spring Runs (Comal System).

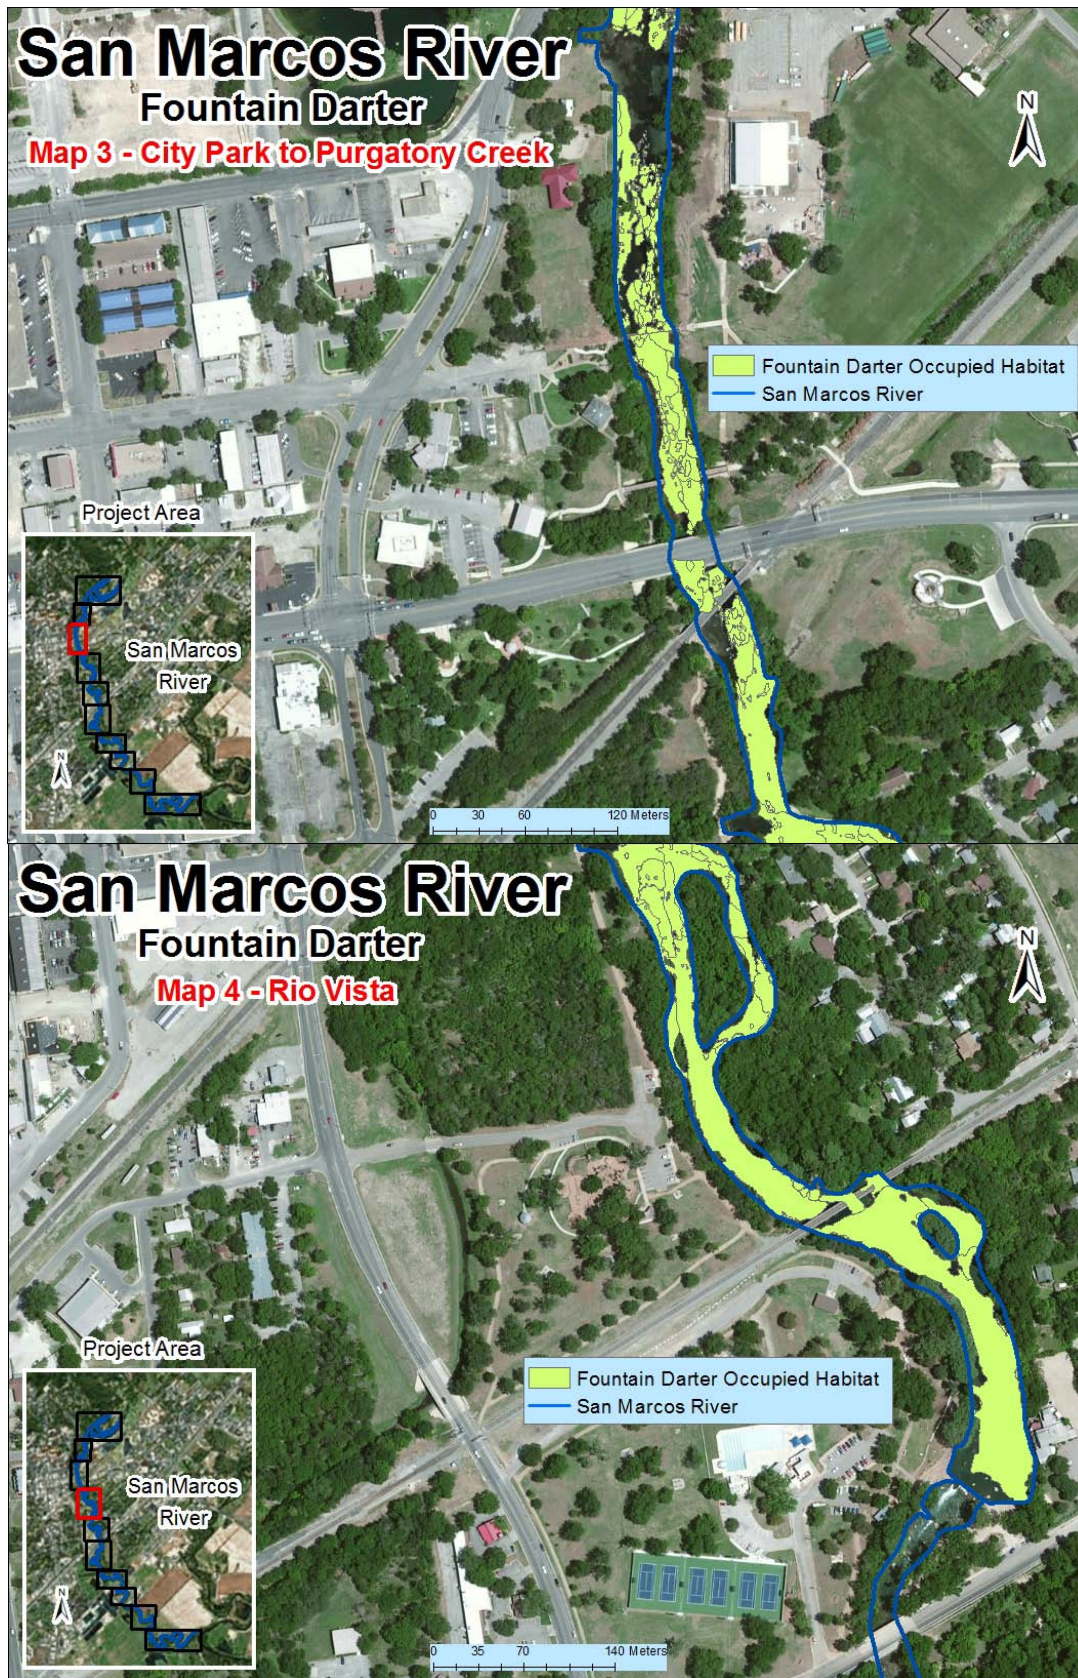
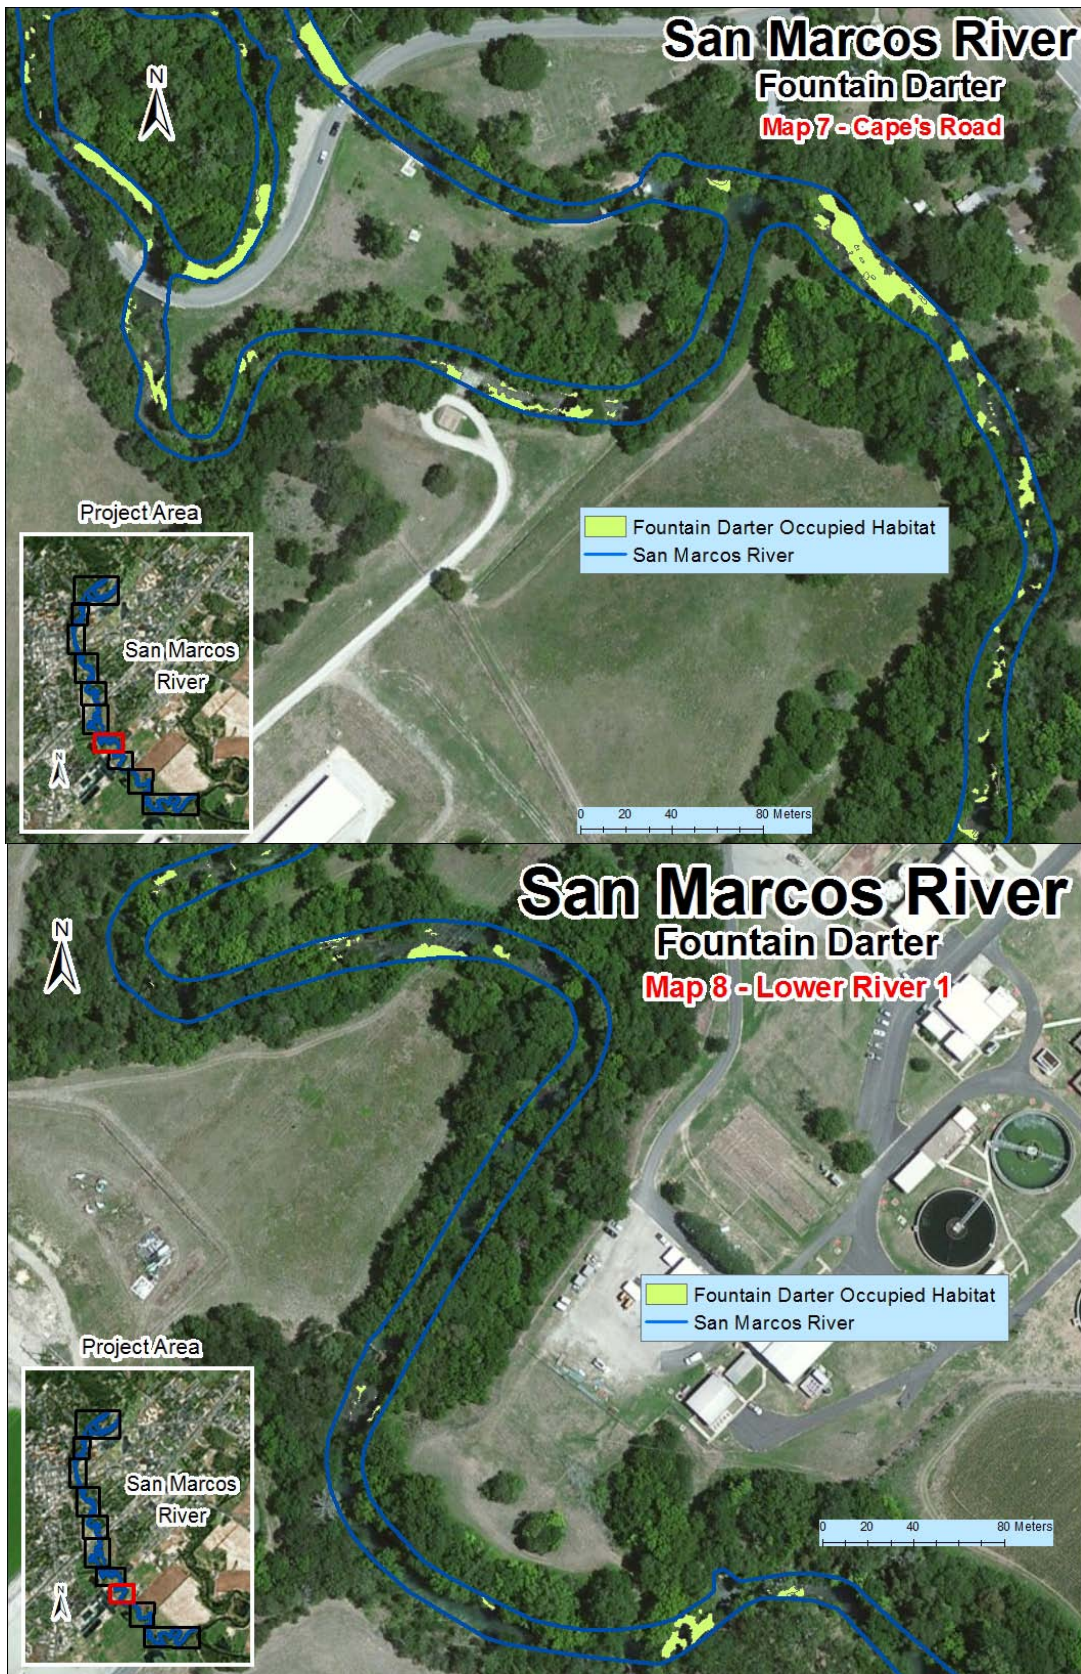
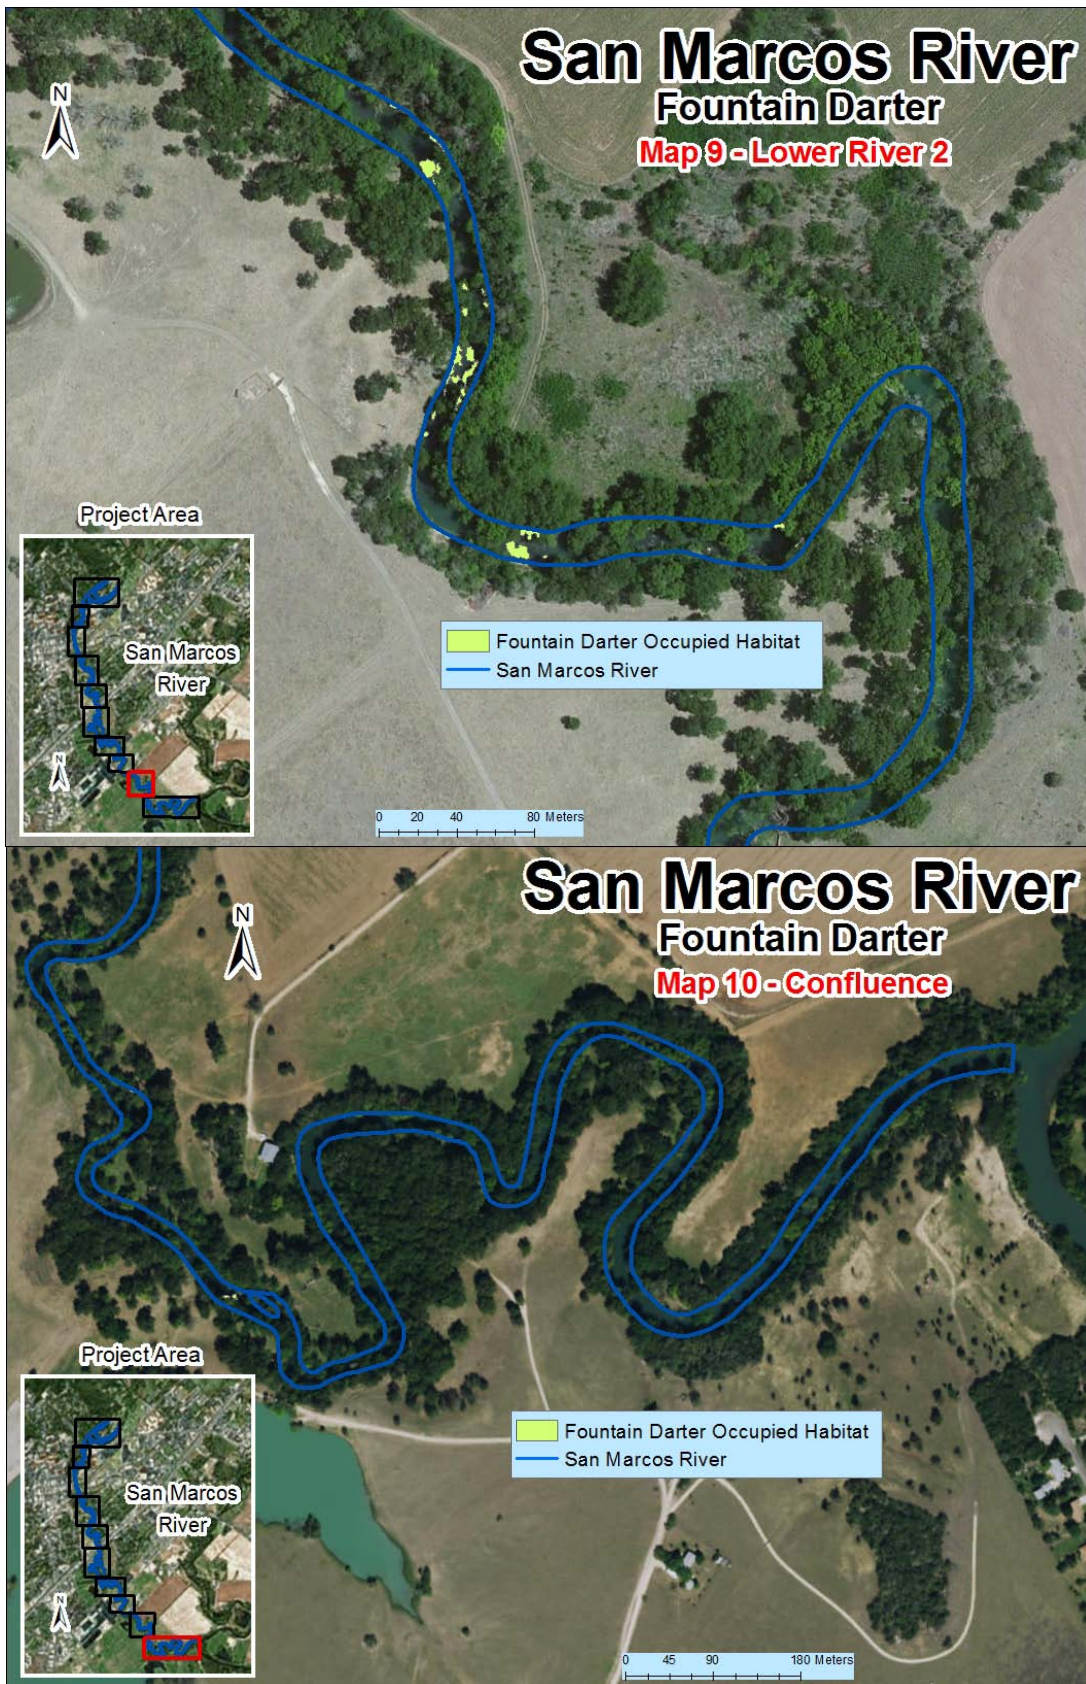
Figure 5: Fountain Darter 2015 Occupied Habitat – San Marcos System

Figure 5 (continued): Fountain Darter 2015 Occupied Habitat – San Marcos System

Figure 5 (concluded): Fountain Darter 2015 Occupied Habitat – San Marcos System

Similar to the Comal system, although fountain darters have been physically collected and visually documented on bare substrate in the San Marcos River, this is not a common occurrence in the river. As such, bare substrate was not counted as occupied habitat for the fountain darter in the San Marcos River. In contrast, bare substrate and algae areas in Spring Lake were included for this assessment as fountain darters have frequently been observed inhabiting these areas within Spring Lake. Finally, although fountain darters have been collected further upstream in the slough arm of Spring Lake, those collections are considered seasonal at this time and thus were not included in the overall area calculated. Figure 5 shows the occupied habitat for the fountain darter throughout the San Marcos system with the quantification of area presented in Table 1.

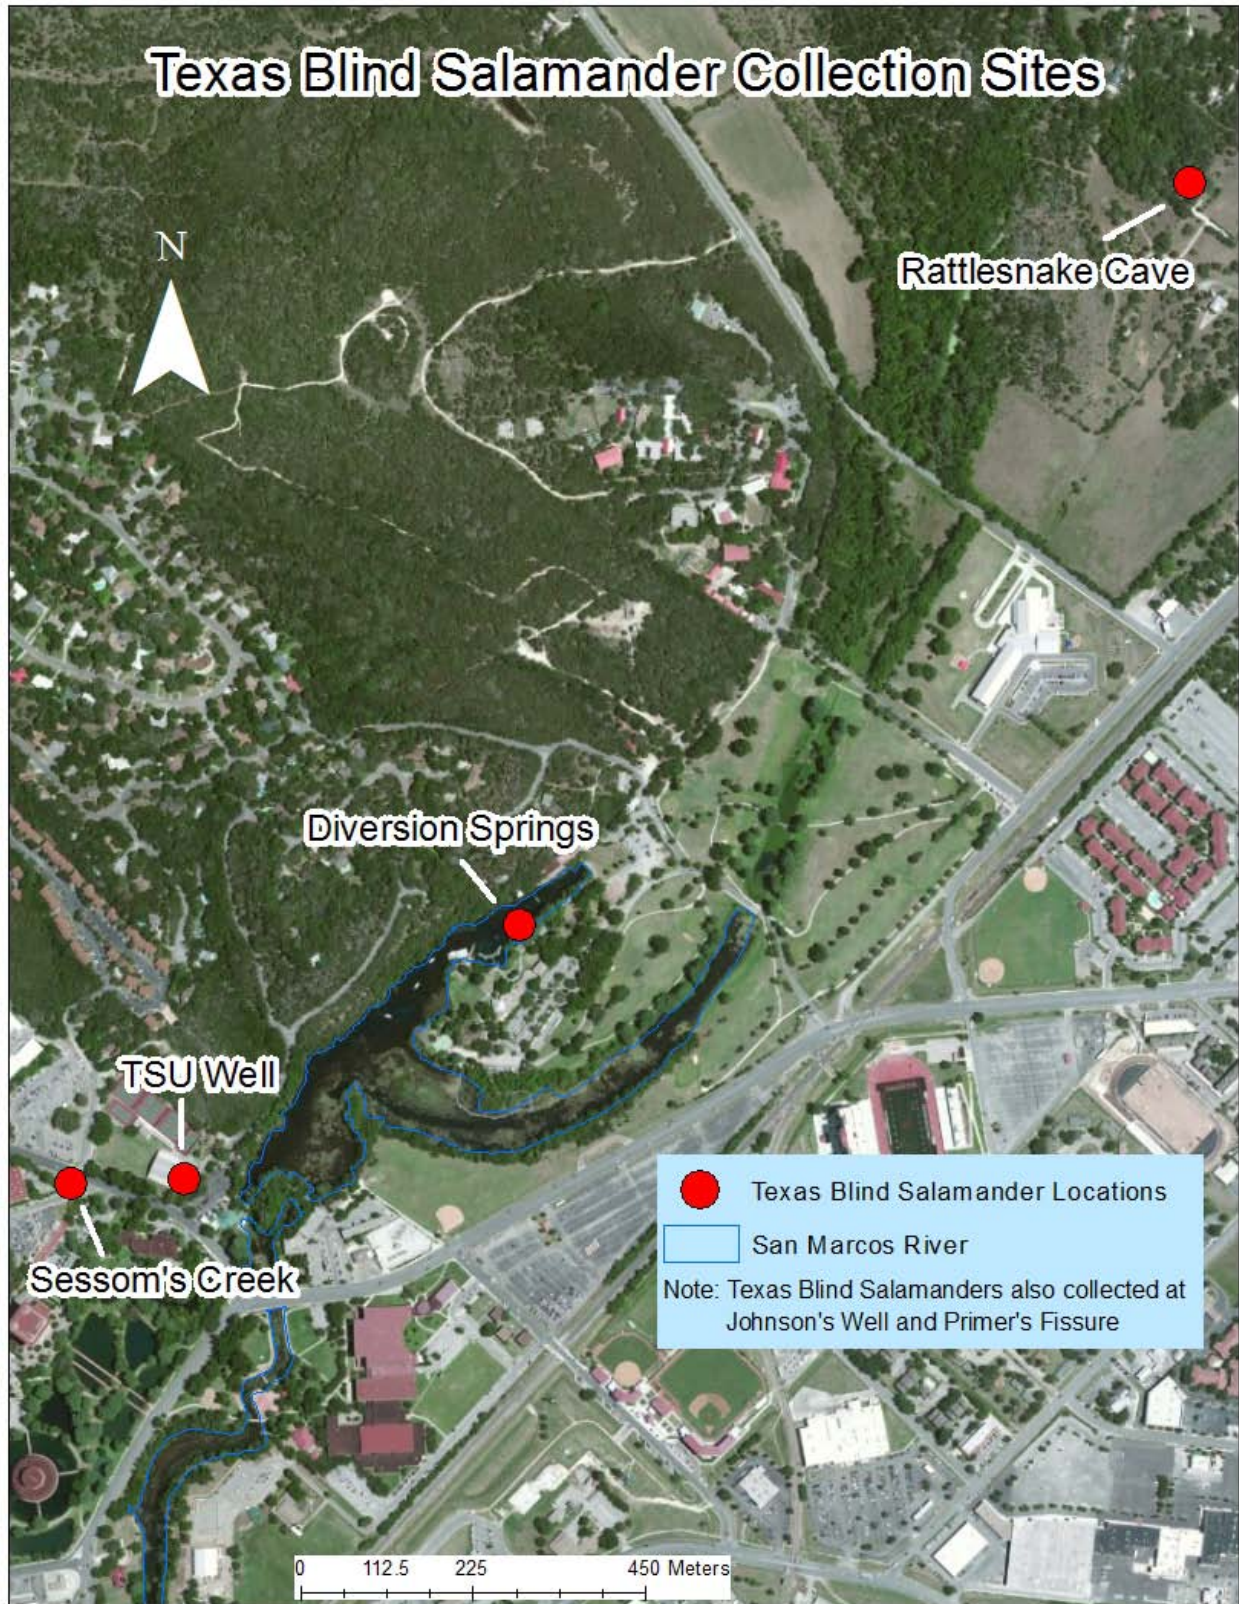
Figure 7: Texas Blind Salamander Routine Collection Locations – San Marcos System

As documented in the HCP, the Texas blind salamander is an aquifer/cave dwelling species. Unlike the subterranean Comal invertebrates which can be found in and around orifices in surface habitat at times, blind salamanders are collected as they are expelled from the aquifer. As such, there is no surface habitat designated for the Texas blind salamander as footnoted in Table 1. Known collection areas are depicted in Figure 7 for later use in the net disturbance assessment.

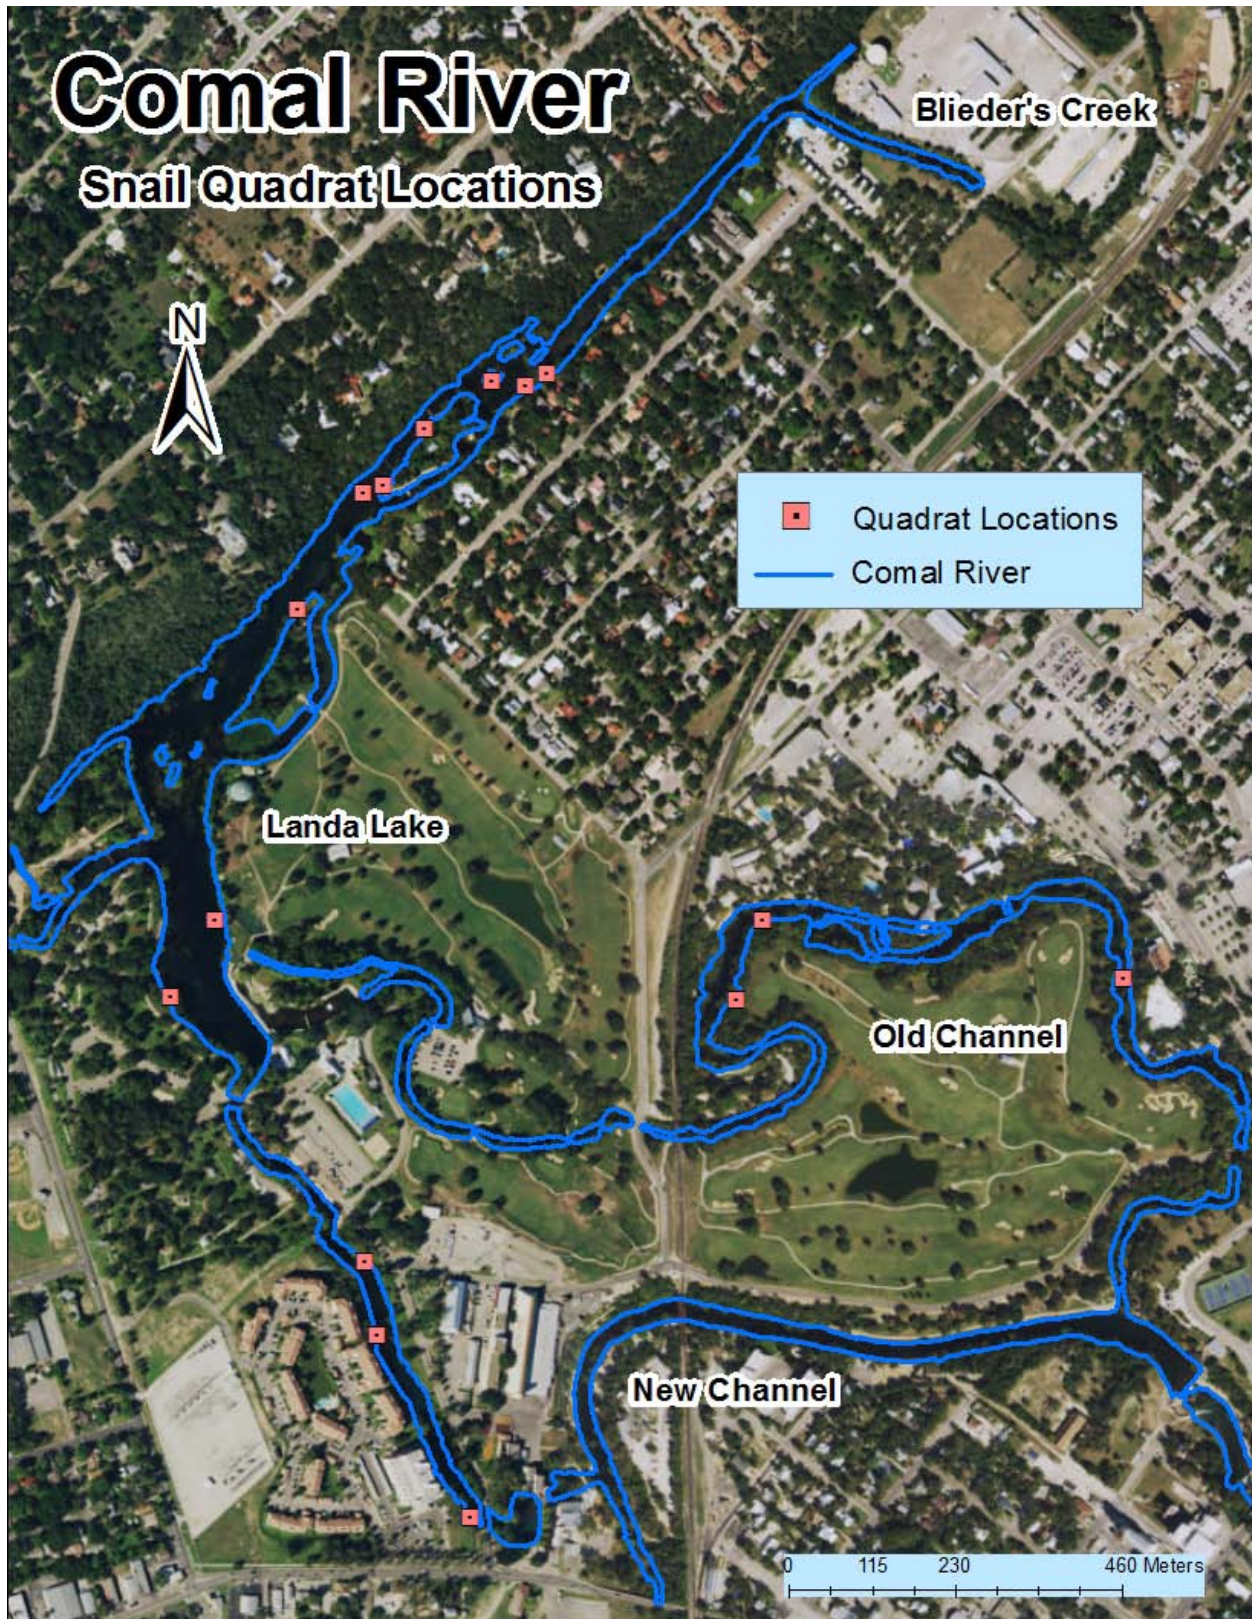
Figure 11: Gill Parasite project – Snail Quadrat Locations

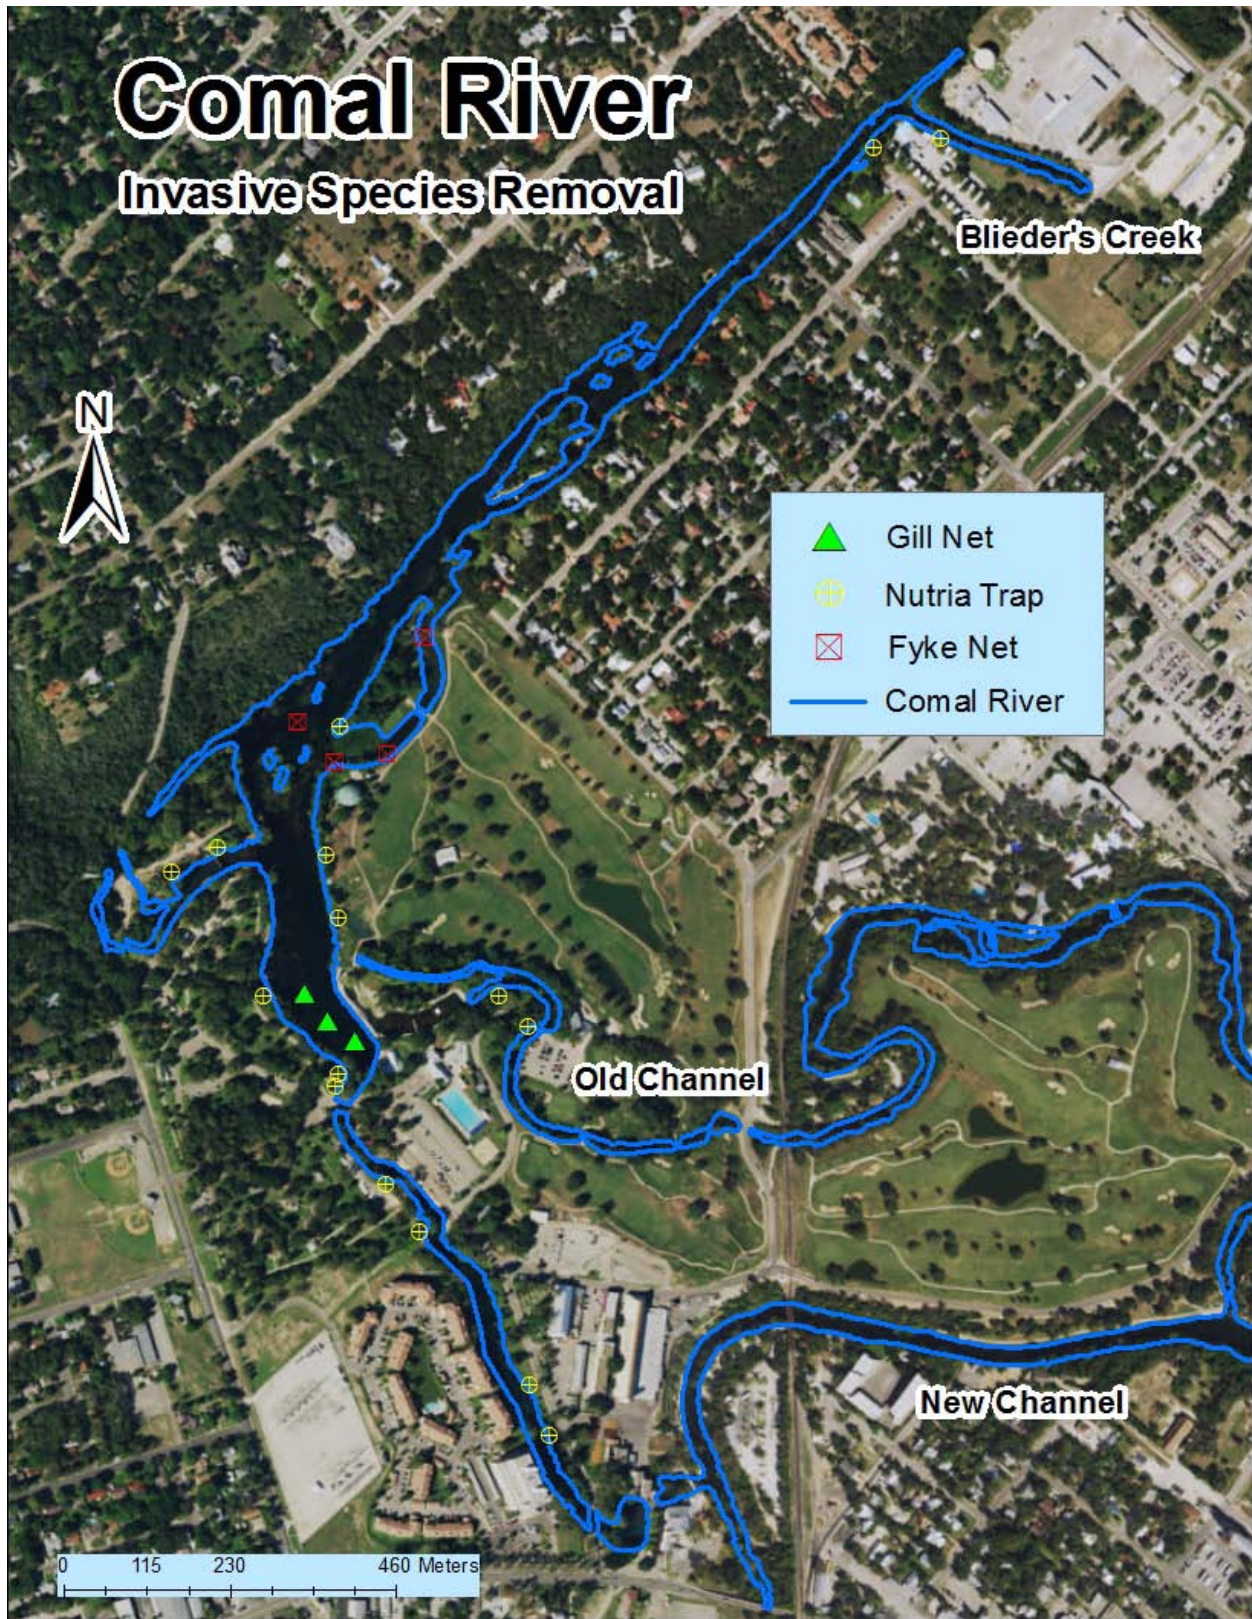
Figure 13: Non-native Animal Species Removal Project – Comal System.

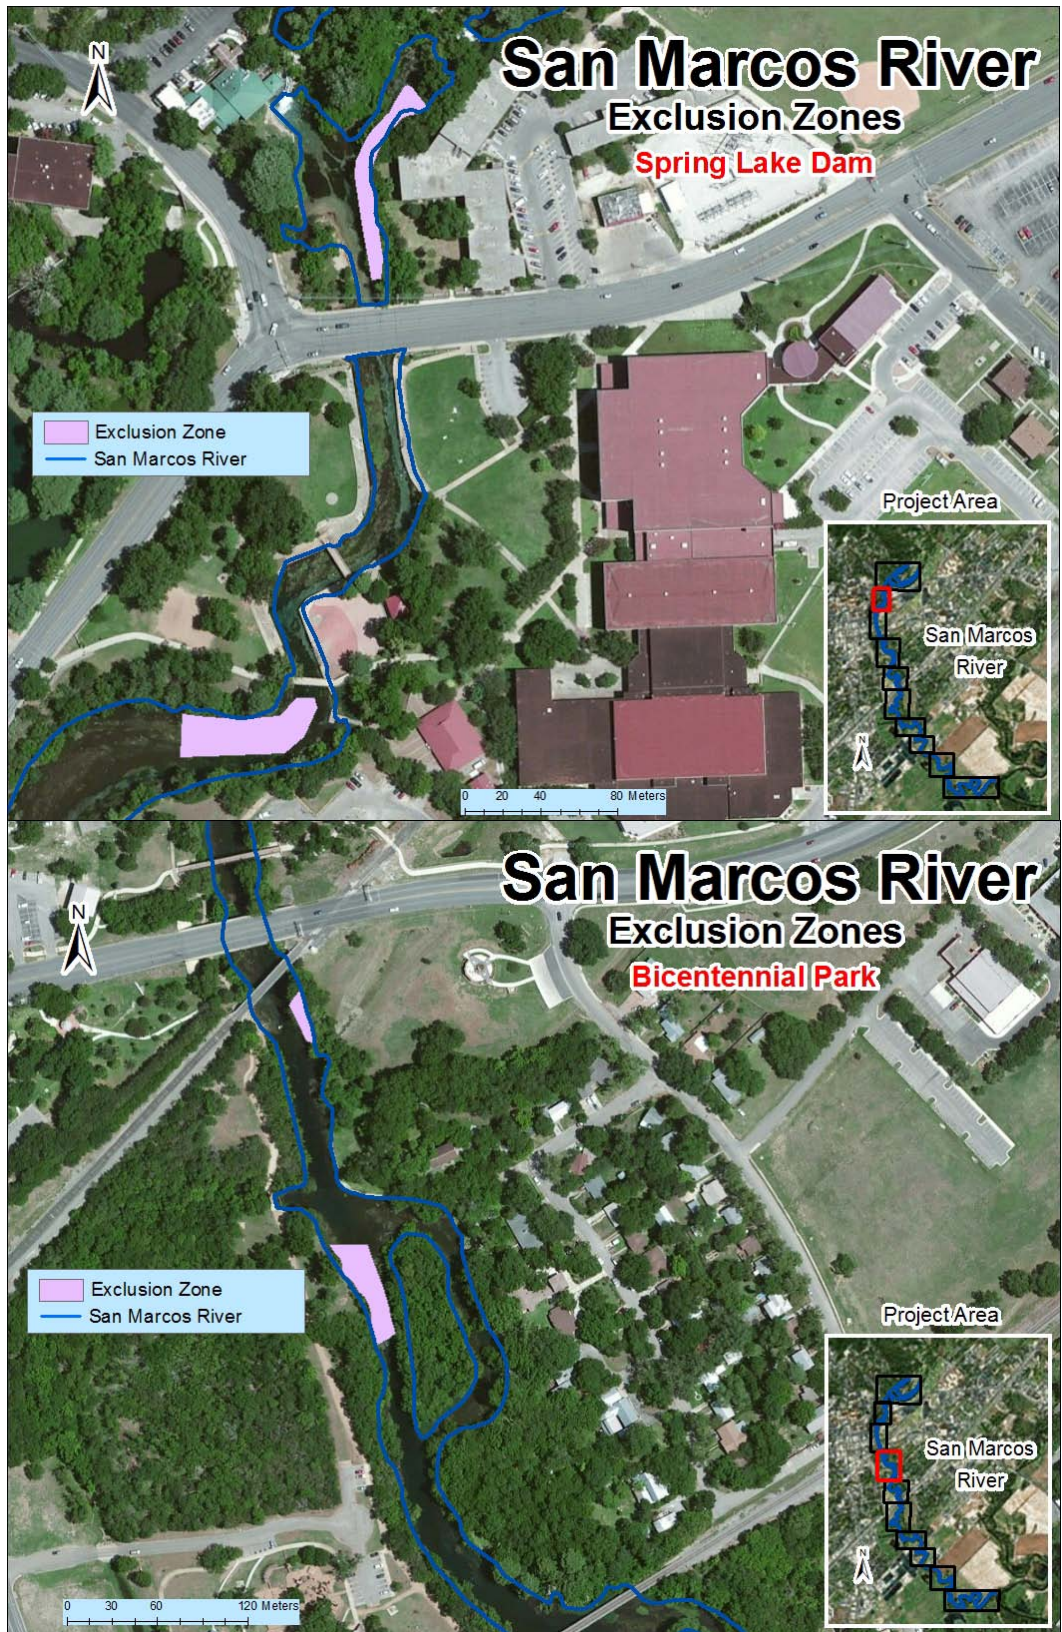
Figure 15: 2015 Exclusion Zones within State Scientific Area for Recreation control – San Marcos River.

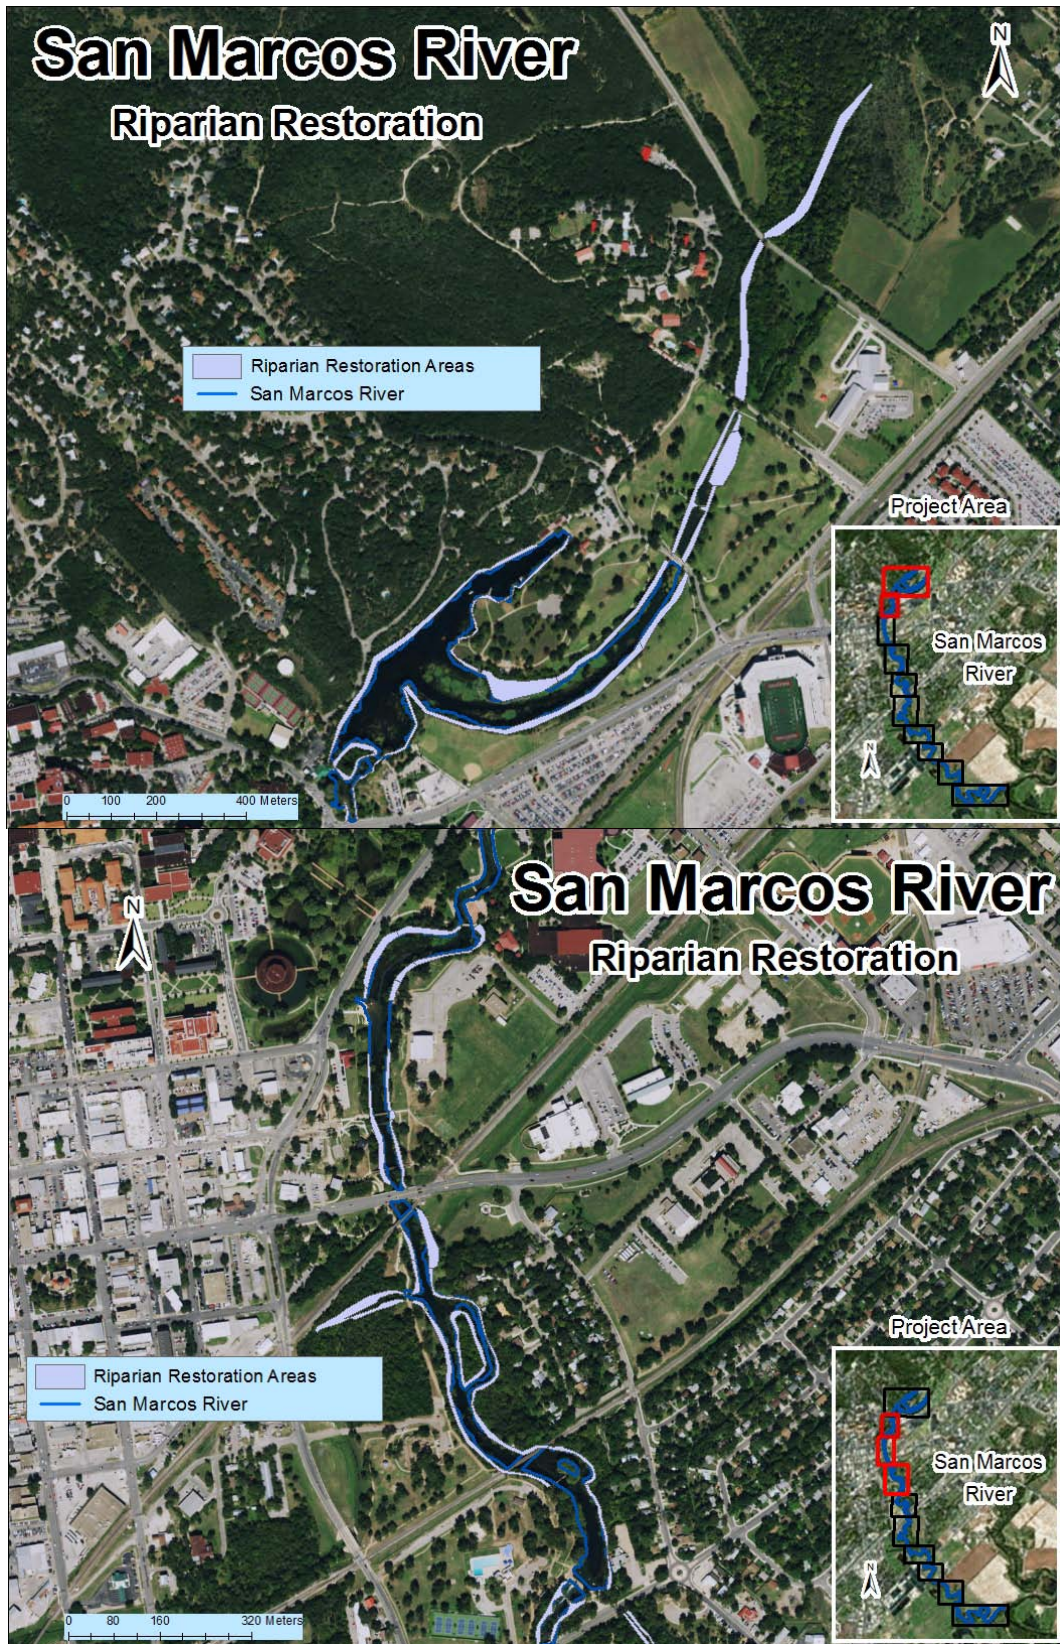
Figure 17: 2015 Riparian Restoration areas – San Marcos River.

Figure 17 (continued): 2015 Riparian Restoration areas – San Marcos River.

The **Riparian restoration** project along the San Marcos River in 2015 involved the largest project footprint (103,096 m²) of any HCP restoration project in either spring system to date. The restored areas are depicted on Figure 17 and quantified in Table 2. As in years past, the riparian restoration project took place on the banks and water's edge and did not overlap with any occupied habitat for the covered species.
