BIO-WEST, Inc.
1812 Central Commerce Court
Round Rock, Texas 78664

MEMORANDUM

SUBJECT: **ITEM M NET DISTURBANCE AND INCIDENTAL TAKE
ASSESSMENT FOR 2015 EARIP ITP ANNUAL REPORT**

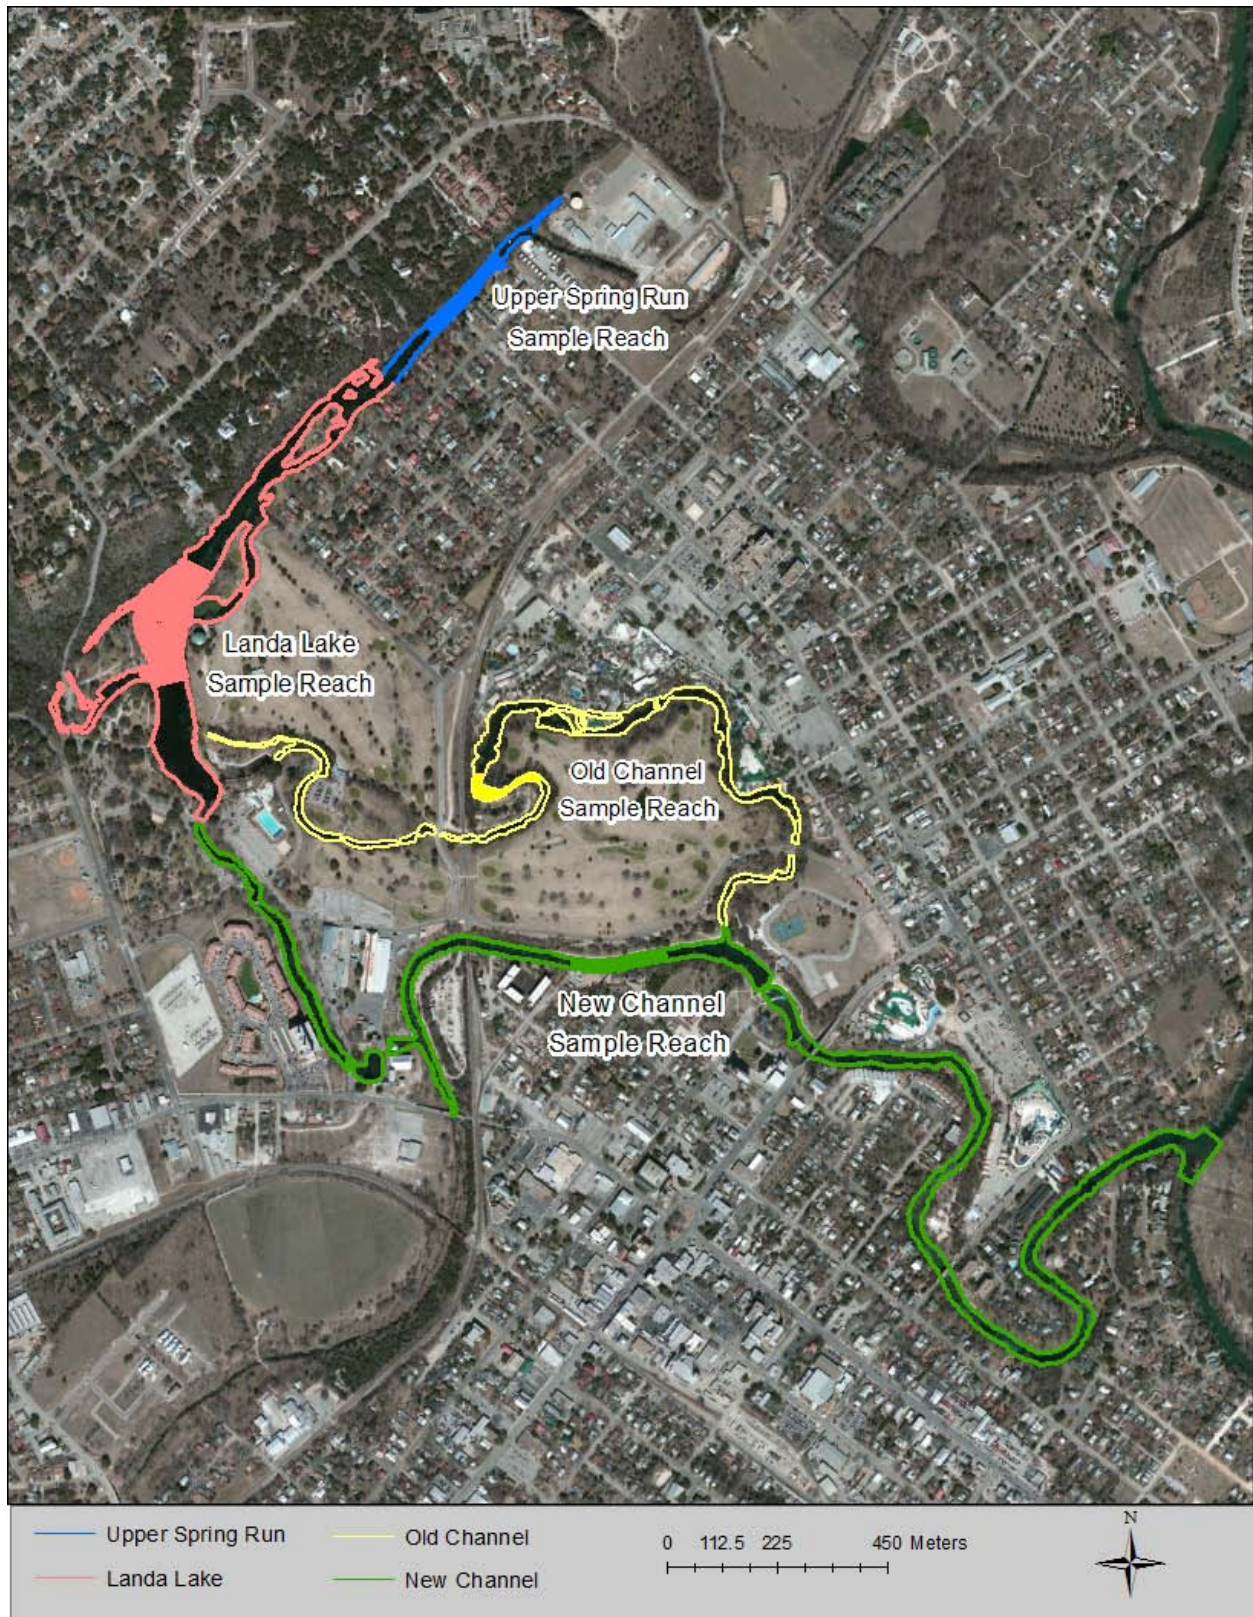
Figure 18. Sample Reaches (4) for the Comal System and Corresponding River Section.

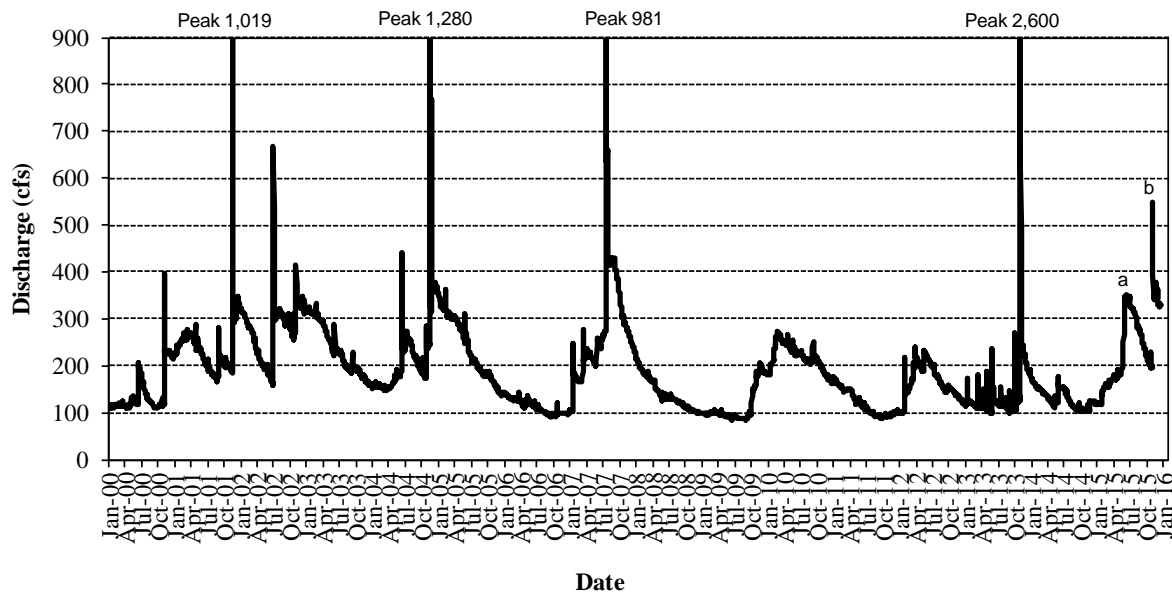
Figure 21: San Marcos River hydrograph presented as daily discharge over the biological monitoring period. ^a Memorial Day weekend flood 2015, USGS estimate not available. ^b Late-October flood 2015, USGS estimate not available.

While average monthly discharge in the San Marcos systems began the year below the historic average, both minor and major precipitation events quickly increased discharge resulting in above average total system discharge for the majority of 2015. A severe flooding event occurred on the San Marcos system over the Memorial Day weekend timeframe when record precipitation fell over the San Marcos and Blanco watersheds. Most of the severe flooding affected the Blanco River, but its historic discharge caused the San Marcos River to back up from I-35 all the way to Spring Lake dam. The positive note was that the nature of this flooding (backwater inundation effect) resulted in very minor damage to the aquatic vegetation (i.e. habitat) in the San Marcos river upstream of I-35. This is an important consideration as all three study reaches used in the take calculation for the San Marcos system are above this landmark. As such, the late May flooding on the San Marcos River did not affect take calculations per established methodologies for this report. Another more devastating flooding event occurred in the San Marcos River at the end of October 2015. Unlike the Memorial Day weekend flood, this flood in the San Marcos system occurred when precipitation dumped and swelled the Sink and Purgatory creek drainages. With Sink Creek flowing into Spring Lake, and Purgatory Creek coming in upstream of Rio Vista Park, flooding affects on habitat were magnified throughout the system. However, as the comprehensive fall biological monitoring was conducted prior to this flooding event, and those aquatic vegetation maps are used for the spring to fall aquatic vegetation change calculations, this flooding event did not affect take calculations per established methodologies for this report either.

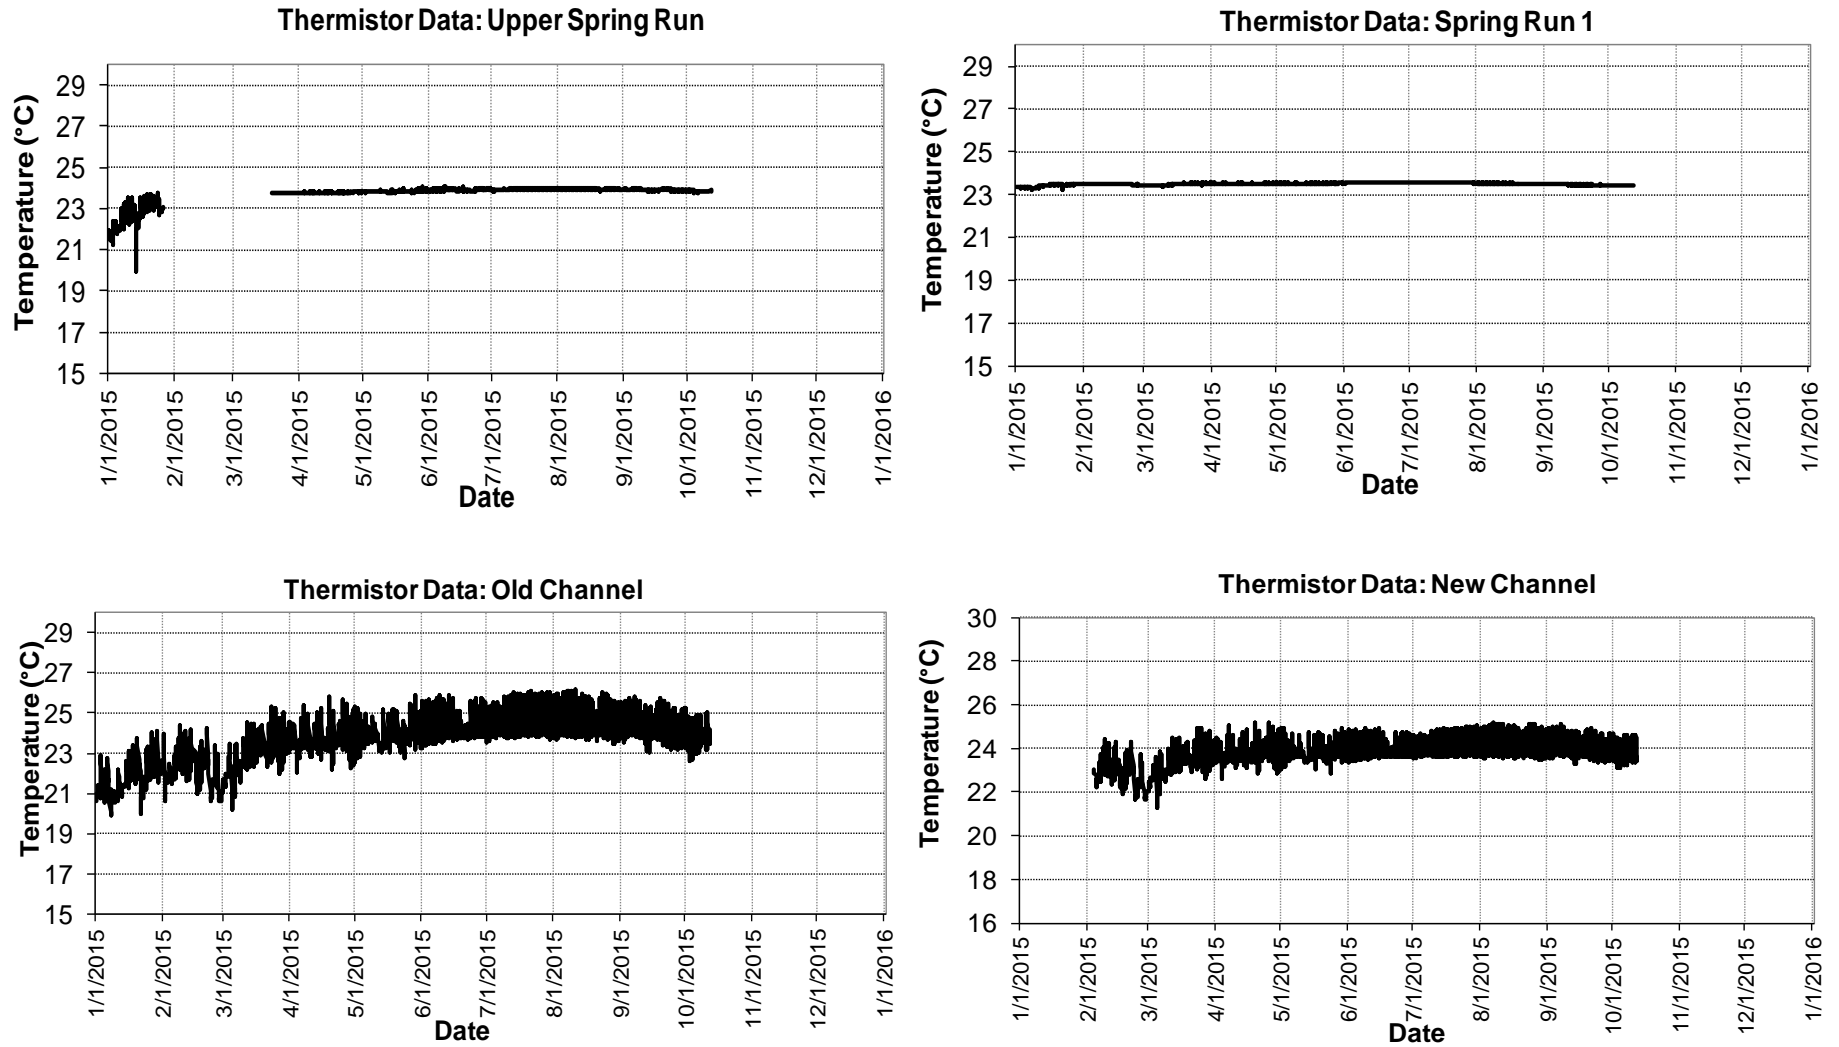
Figure 22: Thermistor data collected during 2015 at four select sites extending upstream to downstream in the Comal System.

Similar to the original 2013 assessment, no standard water quality parameters were outside of a suitable range for the covered species thus they were not considered for causes of incidental take in 2015. Figures 22 and 23 show water temperature ranges observed in each system over the course of 2015.

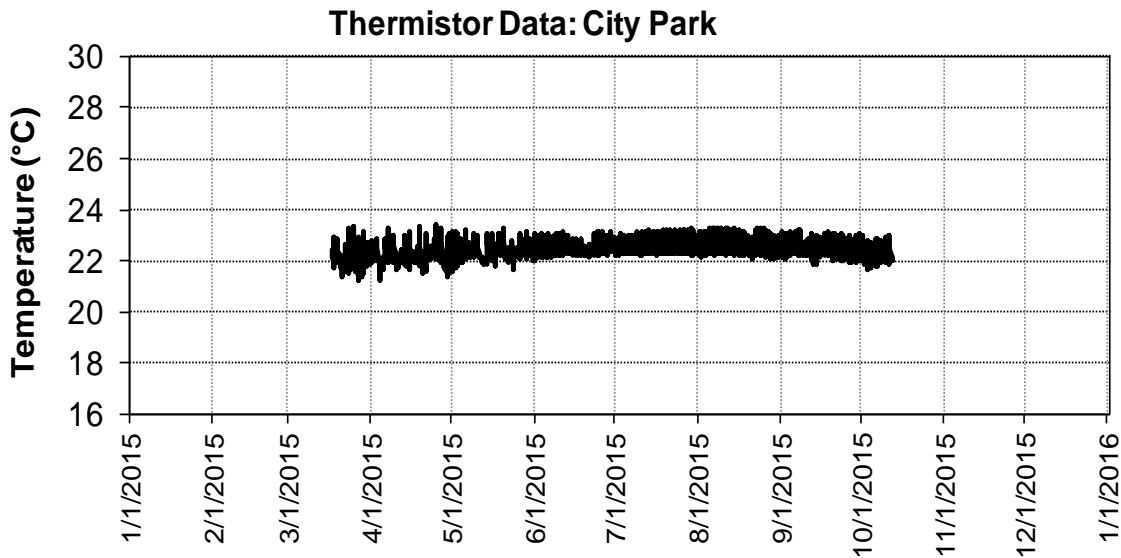
Figure 23: Thermistor data collected during 2015 at City Park reach of the San Marcos River.
