**Aquatic Plant Boom Assessment in Spring Lake
Meadows Center for Water and Environment
Texas State University**

April 12, 2019 – November 15, 2019

Prepared for:

Edwards Aquifer Habitat Conservation Plan

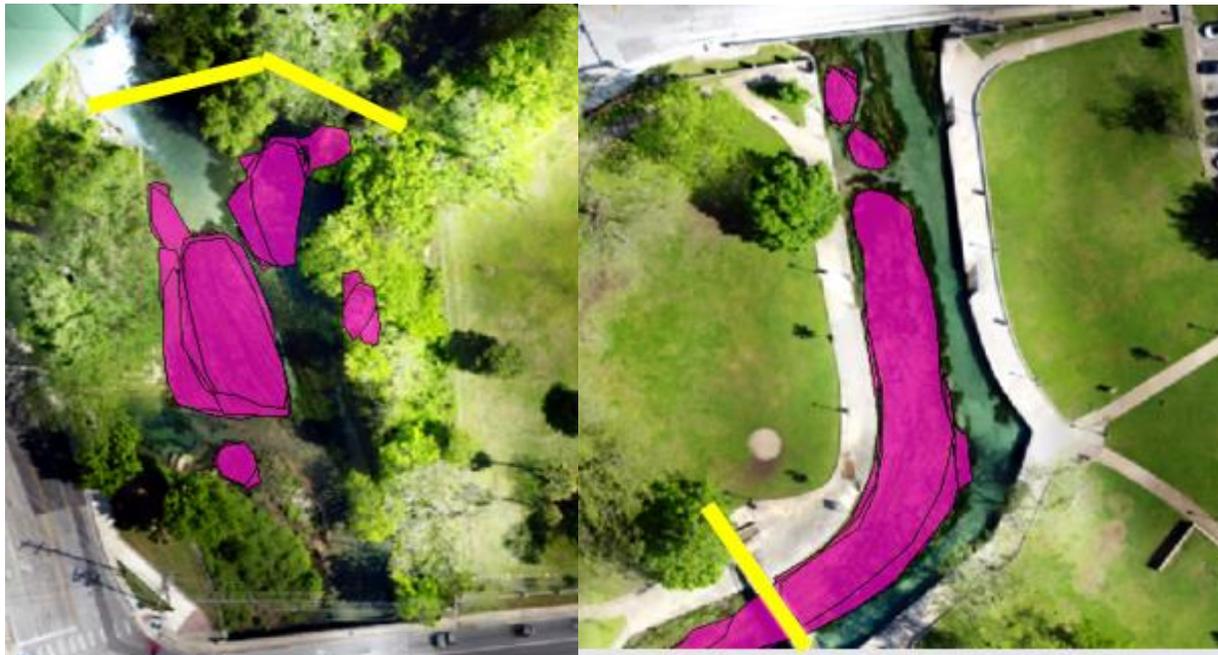
Figure 4. Areas in pink show the normal location for vegetation mat accumulation that were removed to quantify buildup on a weekly basis. Yellow lines mark the boundaries of the collection area. Spring Lake Dam Reach on left. Sewell Park Reach on the right.

Two weeks prior to boom deployment, a downstream monitoring site was selected and monitored to quantify the amount of vegetation mat accumulation. Vegetation mat removal occurred once a week on Fridays, weather and flow permitting. The monitoring area was located below Spring Lake Dam downstream to the 1st walking bridge in Sewell Park (see Figure 4). The HCP crew removed the vegetation mats by hand, using small duck boats to collect the vegetation, and transferred it to a trailer or the back of a pickup. Both the pickup bed and trailer capacities were calculated and the percent volume for each removal session was recorded and reported as cubic meters of vegetation removed.

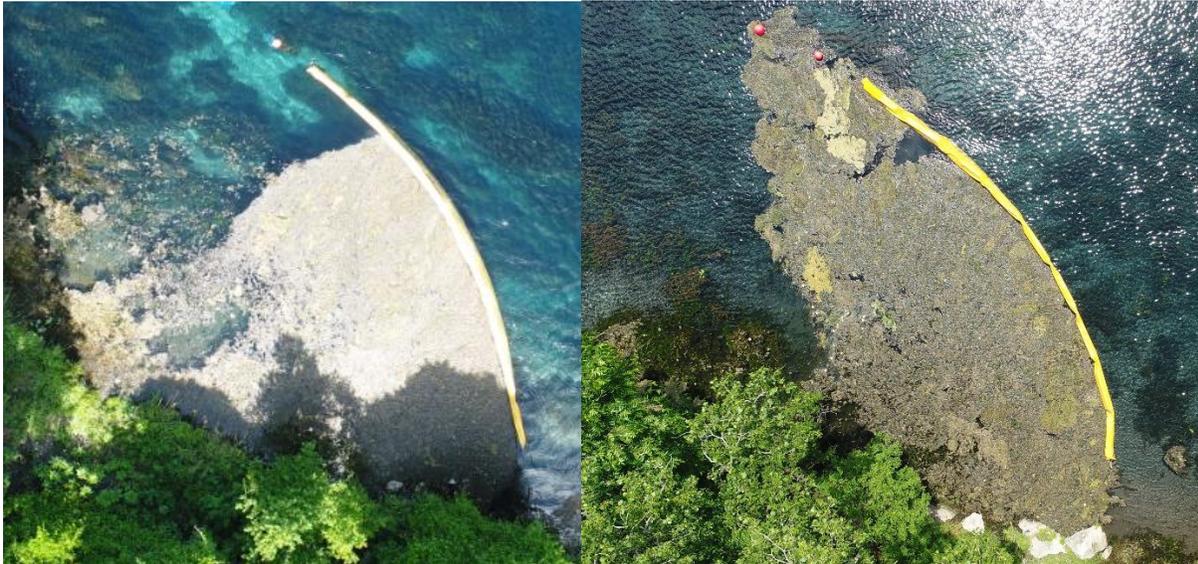
Figure 5. Aerial imagery shows boom 2 at full capacity before vegetation started to flow underneath the skirt (Left). Imagery of boom 3 shows that it was able to hold more at full capacity, with vegetation extending out past the opening (Right).

Both temporary booms started capturing vegetation almost immediately upon installation. Once both booms were in place, it was clear that boom 3 was collecting more vegetation and at a faster rate compared to boom 2. Both aerial imagery and dive inspections supported this, as seen in Figure 5. Since boom 3 had a more appropriate skirt length for the depth, it was able to collect more vegetation and could keep more of the vegetation in place during harvester removal. Boom 2 had a gap of almost ten feet between the skirt and the lakebed which allowed for vegetation to easily flow underneath the skirt, especially as the shallow area filled with vegetation and diverted the flow path toward the deeper section of the boom (see Appendix A2).

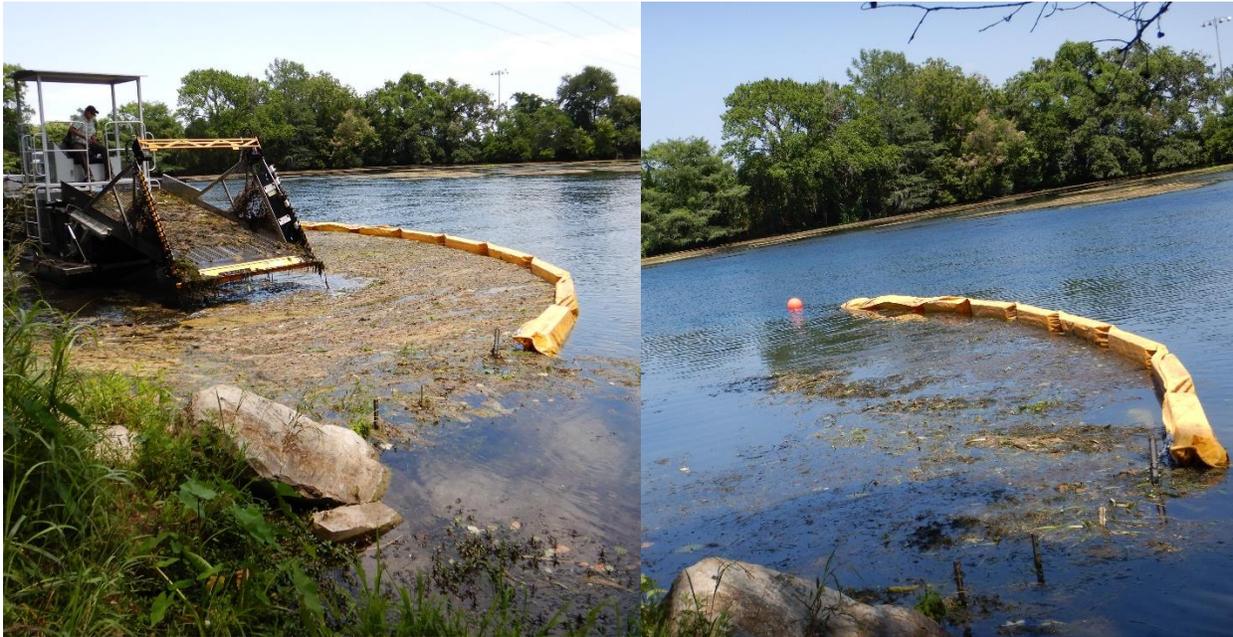
Appendix A1. The harvester emptying out temporary boom 3 after additional anchor weights were installed and subsequent leftover vegetation due to shallow water inhibiting the harvester's access.

After boom installation, accumulated vegetation on the booms was removed as part of normal lake operations, which was typically 2-3 times per week (see Appendix A1). The amount of vegetation collected by harvester operations at the booms was quantified by level of removed vegetation within the harvester collection bin and reported as cubic meters of vegetation removed.

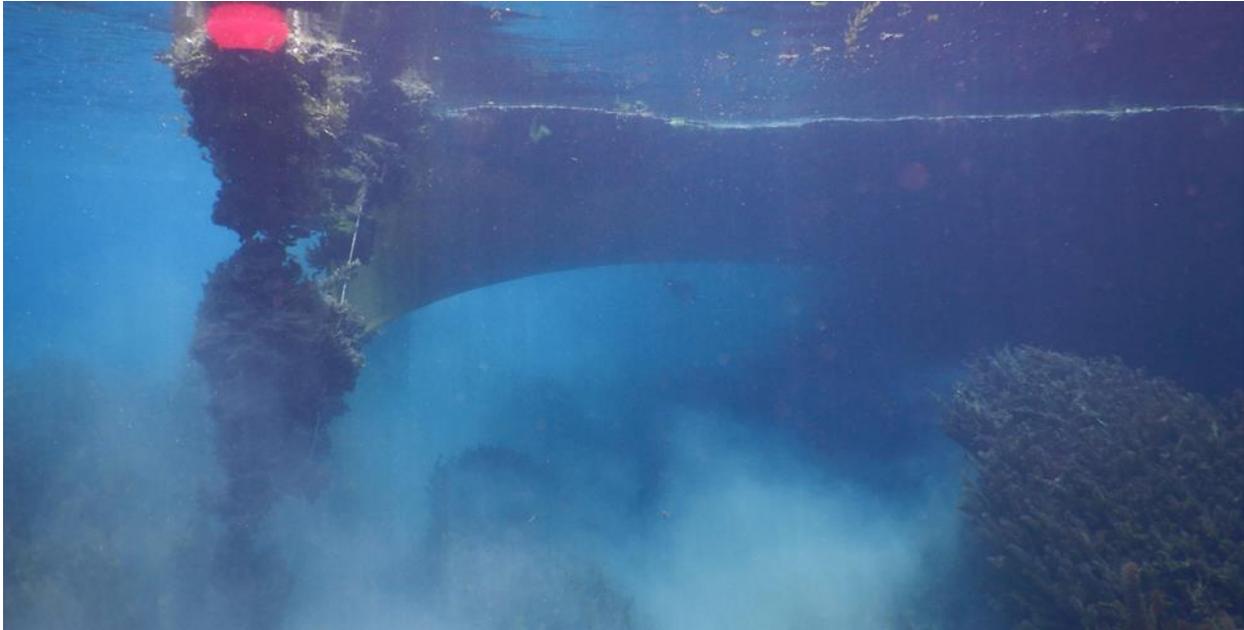
Appendix A2. Shows the gap between the skirt and the lakebed that allowed for vegetation to flow underneath the boom and escape collection.

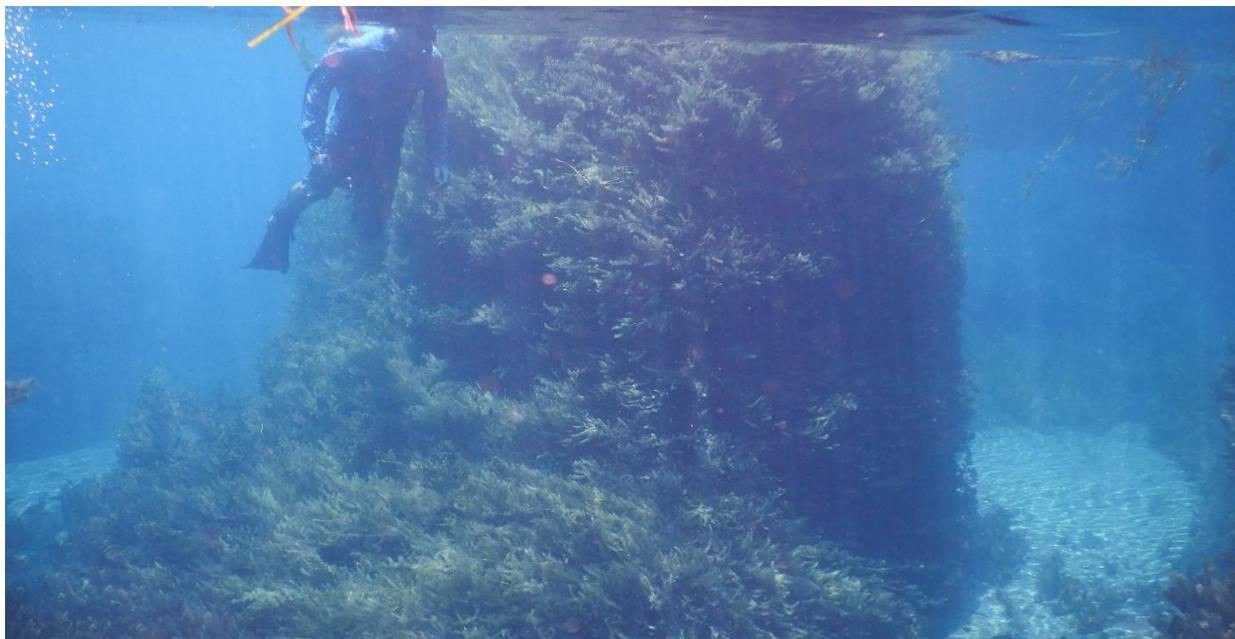
Appendix A4. Vegetation buildup on the anchor cables and outside end of boom 2.

Both booms experienced the buildup of vegetation on the outside boom end (lake side) and on the anchor cables (see Appendix A4). This caused the booms to shift multiple times before the additional weight was added. The accumulated vegetation at boom 3 was sufficient

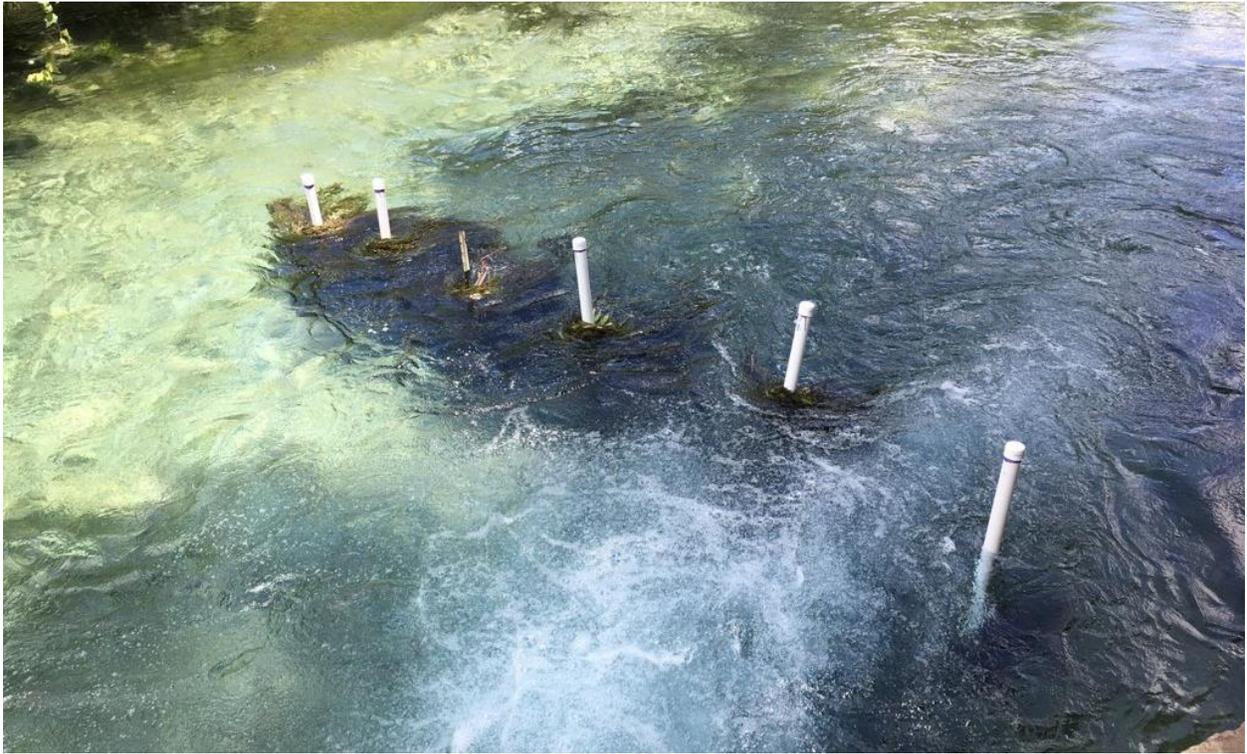
Appendix A5. Setup for initial vegetation collection in Spring Lake Dam Reach below the western spillway.

A separate test was conducted in the upper most section of the river, immediately downstream of Spring Lake Dam at the upper section of the test reach, in an attempt to quantify vegetation mat dynamics concurrent while the harvester was removing the collected vegetation from the temporary booms. A series of T-posts were setup perpendicular to the flow, about 60 feet below the western spillway (main flow path from the lake), in two to three-foot intervals (see Appendix A5) The intent was to capture vegetation before it dispersed downstream into the lower river reaches. The T-posts were effective in capturing a large portion of downstream drifting hornwort and milfoil, and is associated with the observation that these species do not fragment into smaller pieces when going over the spillway. The initial setup utilized six T-posts with PVC covers, but observations indicated that they did not extend out into the river far enough and needed to be placed closer together to capture more vegetation. The second setup used T-posts set at less than two-foot intervals and extended out further into the river. A second row of T-posts was offset downstream to add additional collection points. Although the T-posts were deployed for two hours, it was observed that entrapment of vegetation was at maximum capacity after only an hour with subsequent vegetation transiting downstream around the accumulated mats on the posts. All the captured vegetation was removed from the T-posts and quantified by volume. Approximately four cubic meters were collected during the test period and quantified the extent of downstream vegetation dislodged from the booms within Spring Lake during harvester boom operations. These data suggest that upwards of 30 cubic meters/week of aquatic vegetation exits Spring Lake into the river during summer months.

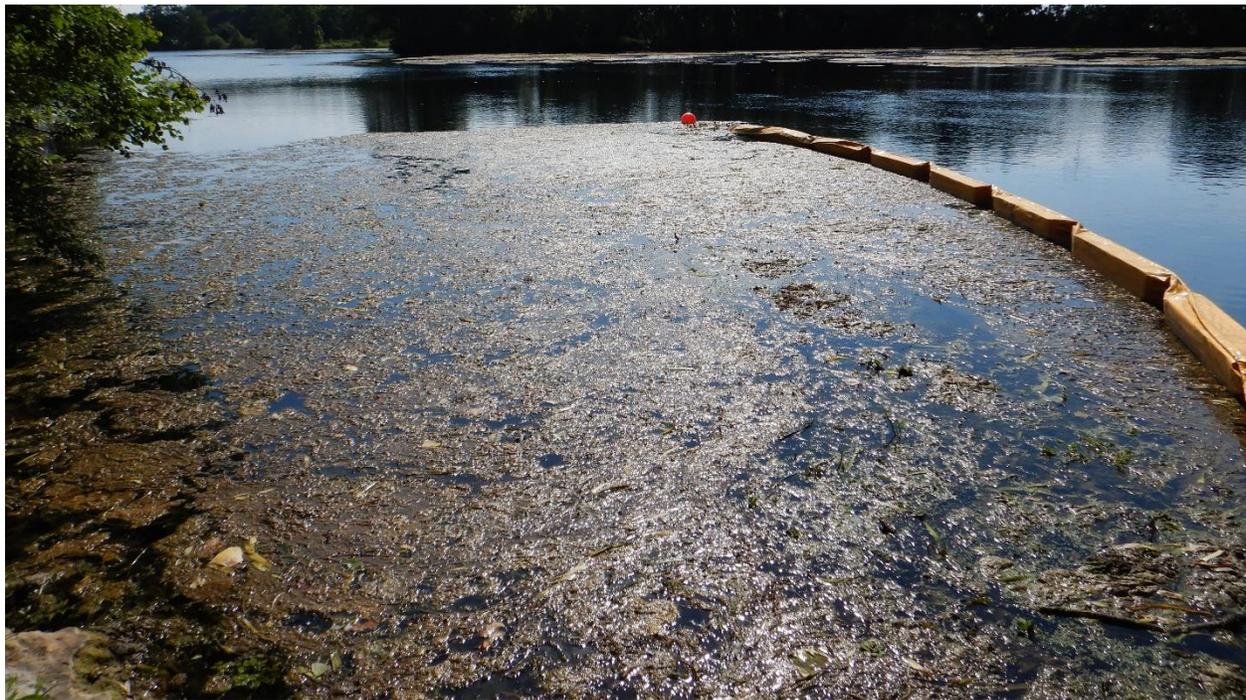
Appendix A10. Temporary boom 3 setup near full capacity showing what it looks like before harvester collection.

It is also noted that having the booms installed in Spring Lake with the associated buildup of vegetation mat on the booms and the physical footprint of the booms themselves, is not esthetically pleasing to the glass-bottom-boat tours (see Appendix A10). The booms also result in the presence of denuded areas directly in front of the booms that represent modified natural habitat conditions (see Appendix A11 & A12). Finally, as noted, the added time required for inspections and maintenance of the booms and associated increased costs in harvester operations do not appear to offset measurable gains in the reduction of time and effort for vegetation mat removal in downstream reaches.

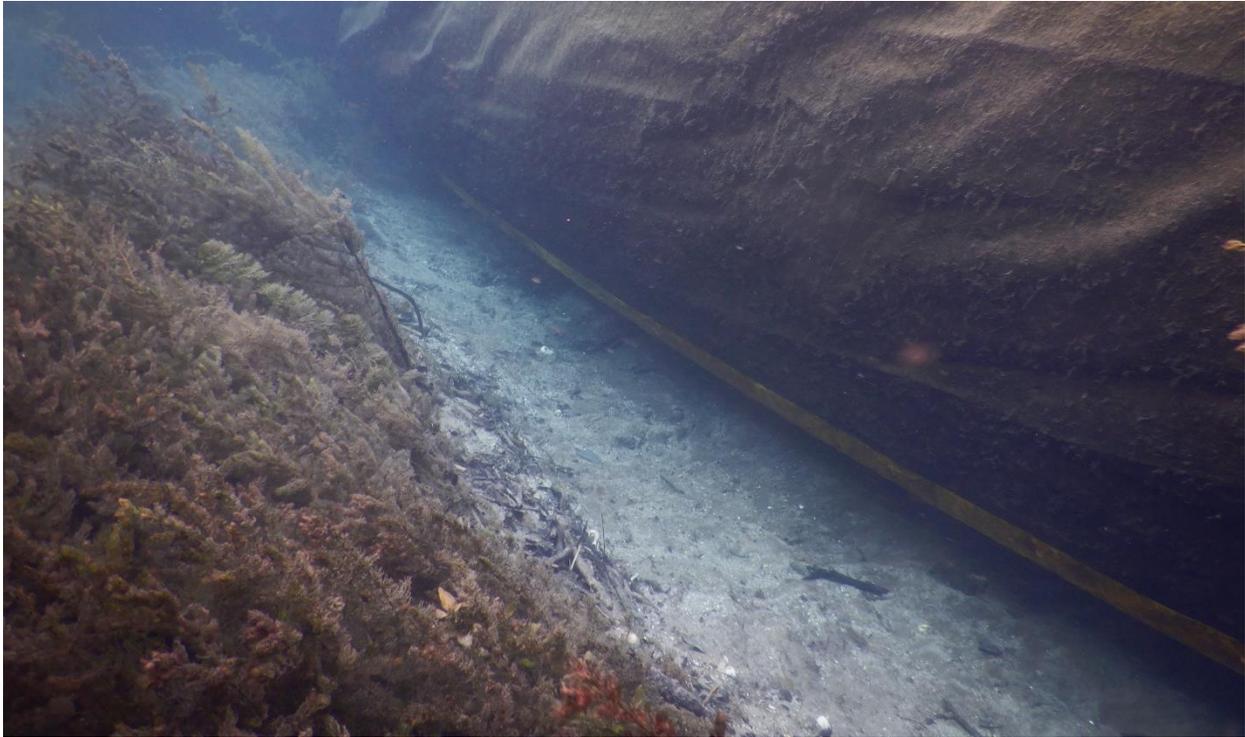
Appendix A11. Custom boom 3 before removal showing the buildup of sediment behind the boom due to harvester activity pushing excess water under the boom during removal efforts.

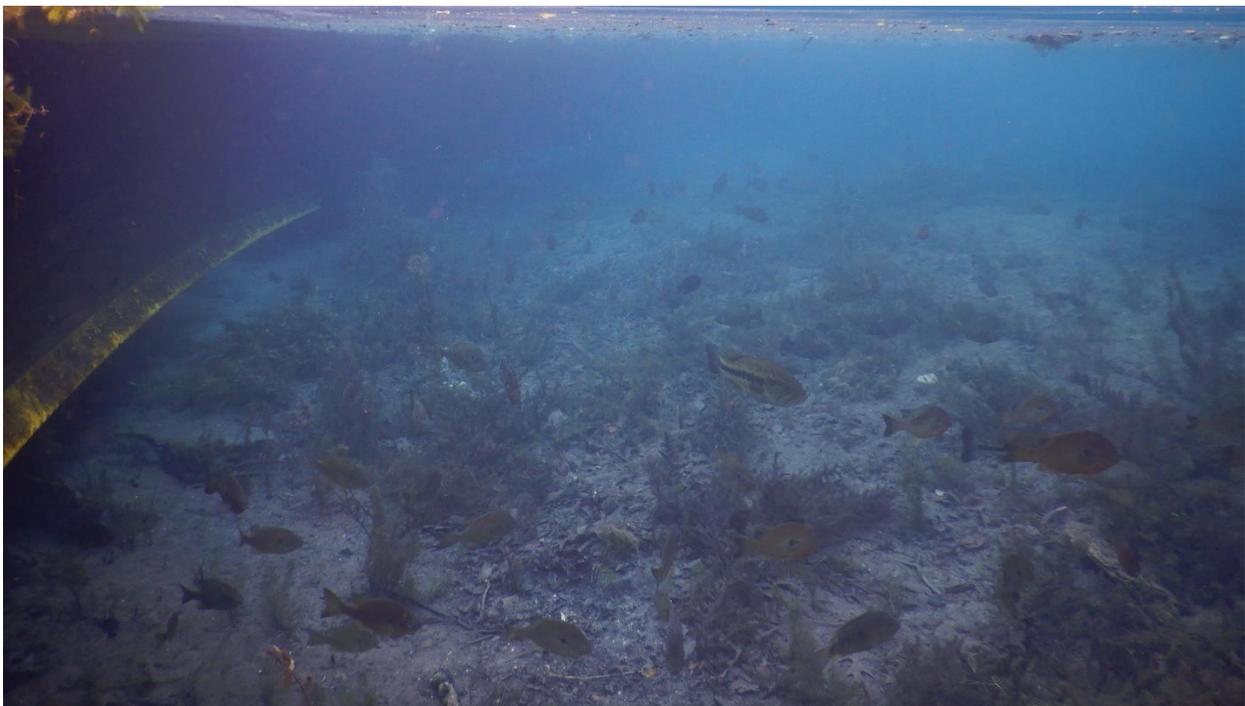
Appendix A12. Area in front of custom boom 3 before removal showing the denuded area due to floating vegetation accumulation that's typical overhead and harvester activity from removal efforts.
