MEMORANDUM

TO: Nathan Pence
FROM: Ed Oborny (BIO-WEST)
DATE: **September 12, 2014**
SUBJECT: EA HCP Biological Monitoring – **Week 22**

BIOLOGICAL MONITORING UPDATES

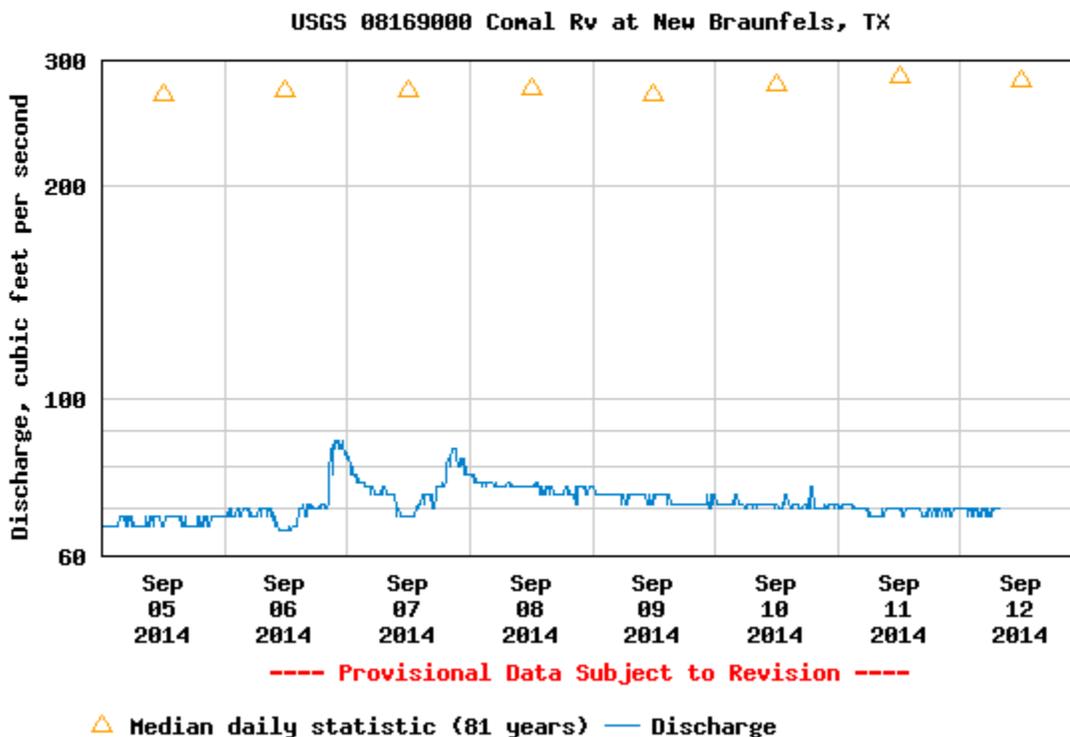
Figure 1: Screen shot of USGS webpage for the *COMAL* gage (08169000) showing total system discharge over the past week.

At the time of this memorandum, the total system discharge at Comal Springs was 70 cfs, slightly higher than last week's value following a small bump in the hydrograph with some scattered showers last weekend (Figure 1). This week marks the twenty-second consecutive week below 150 cfs, and therefore, the required weekly habitat evaluation was conducted on September 11th. Weekly habitat evaluations and memorandums will continue to occur until total system discharge at Comal Springs/River increases and consistently stays above 150 cfs. HCP species specific trigger (< 80 cfs) activities continue to be performed on their respective schedules. The next full system Critical Period monitoring effort will be triggered when total system discharge consistently declines below 50 cfs.

The slight increase in total system discharge this week (Figure 1) resulted in a slight increase at both Spring Run 3 and the Old Channel (Table 1). Upwellings and some surface discharge are still evident in Spring Run 1 and the Upper Spring Run reach but too minimal to measure with a traditional cross-sectional method. Surface habitat conditions at Spring Run 1 (Figure 2) and Spring Run 2 are extremely limited or non-existent throughout extended stretches of each run. Spring Run 3 looks similar to last week with drying of surface habitat at the headwaters and the channel constricting in several locations downstream. Although Spring Run 3 continues to support the most discharge of any of the major spring runs at this time, it too is impacted with a considerable reduction in surface habitat, which is starting to become evident in both the salamander and riffle beetle sample results discussed below.

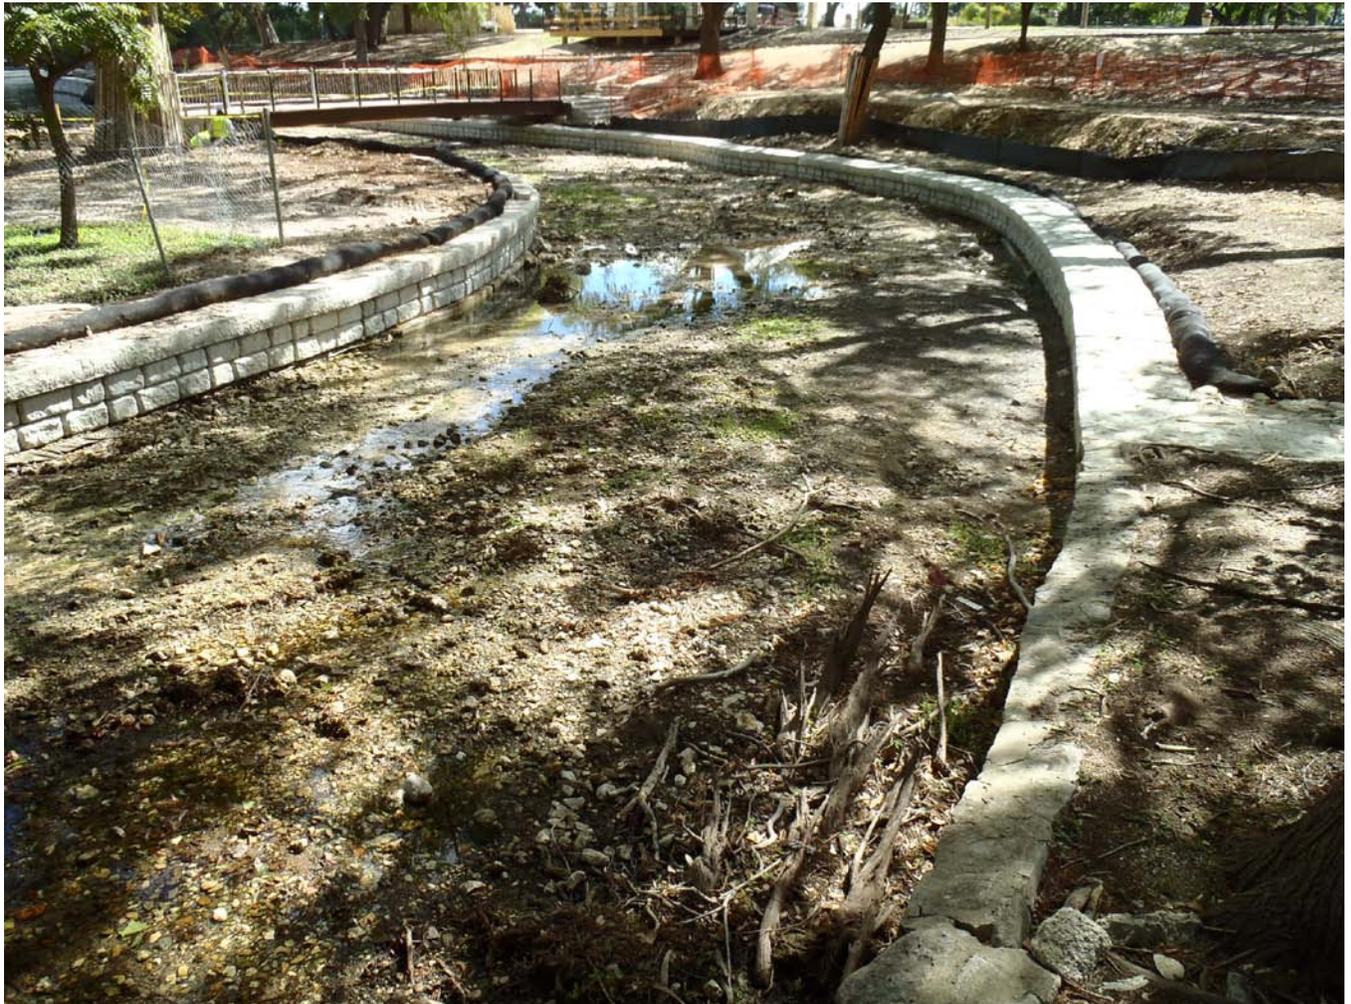
Figure 2: Extremely limited surface water habitat in Spring Run 1 downstream of Landa Drive.

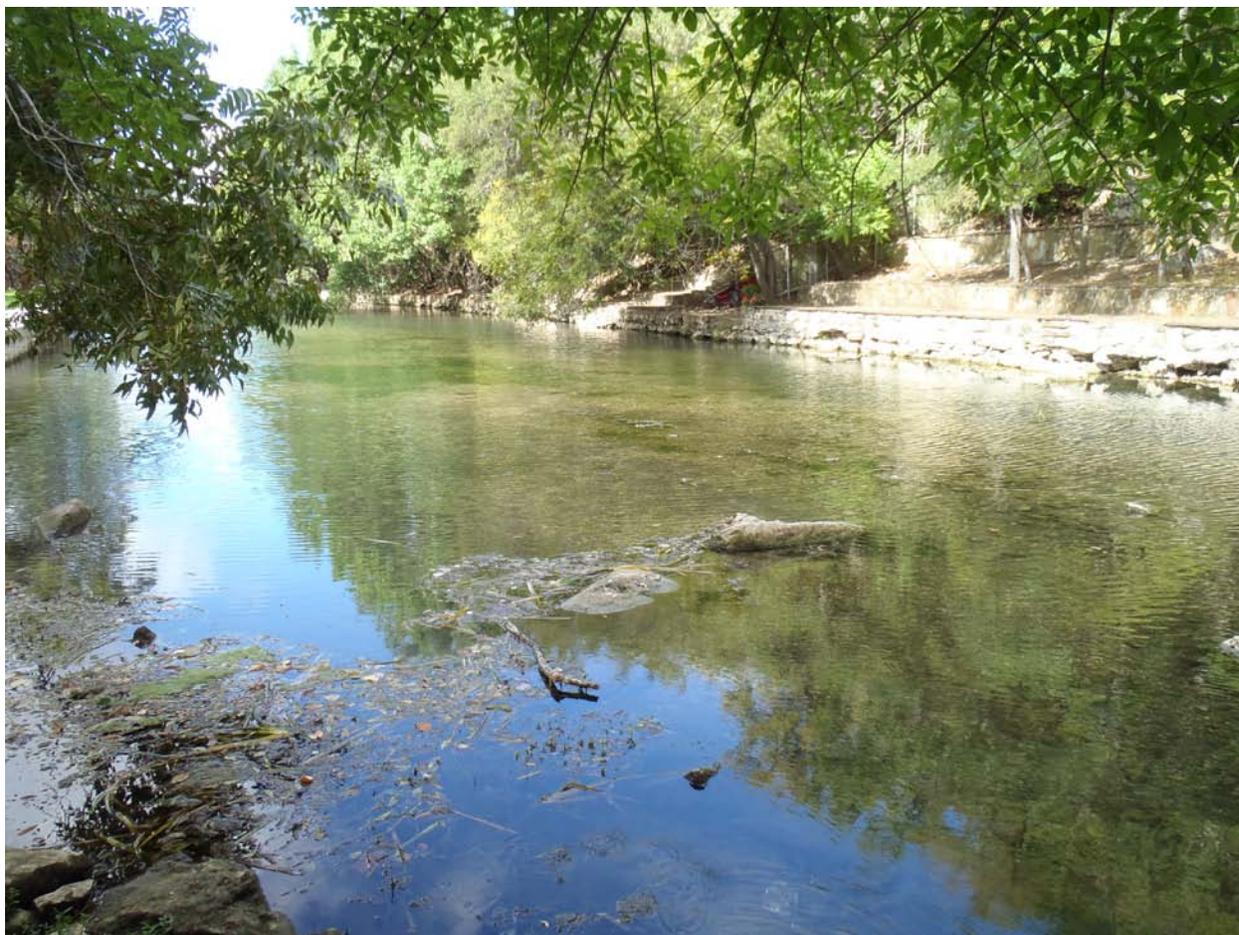
Fountain darter habitat continues to be in very poor condition in the Upper Spring Run but actually experienced a slight improvement this past week (Figure 3). Despite minimal habitat and very poor apparent overall conditions, movement study night snorkeling this week confirmed that darters are still present in this area. The surface water level in the Spring Island area this week is similar to that observed last week with exposed surface habitat along large portions of the eastern and northern side of the island (Figure 4).

Figure 3: Conditions slightly improved in places this week in the Upper Spring Run reach.

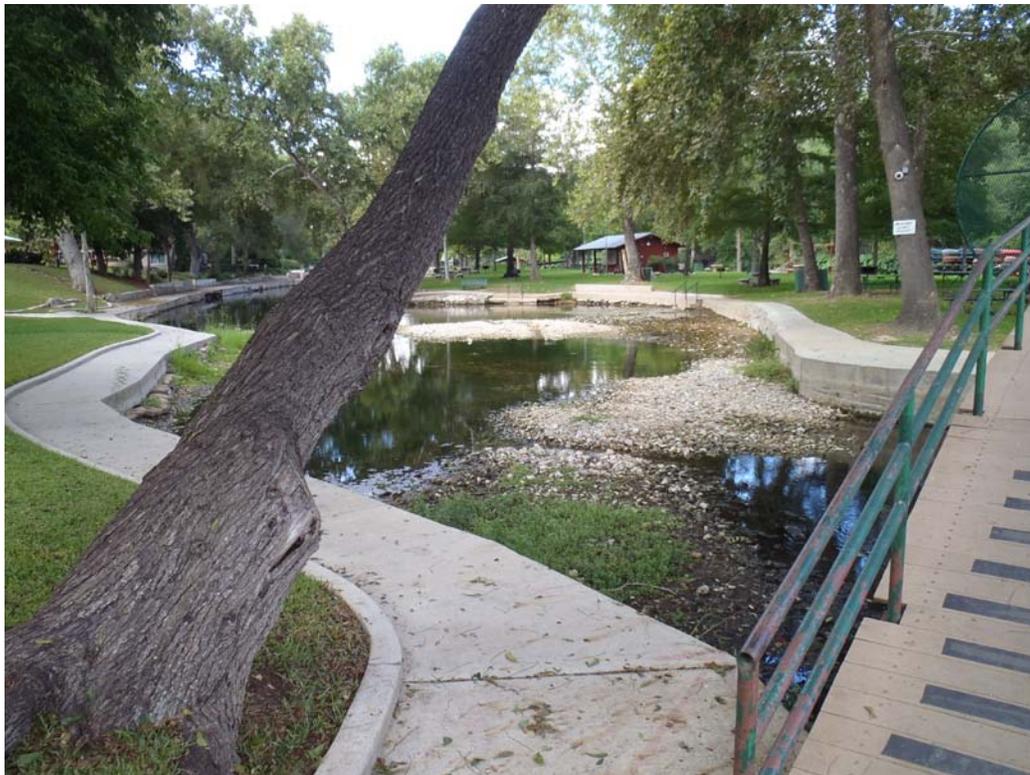
Figure 4: Exposed surface habitat adjacent to Spring Island remains similar.

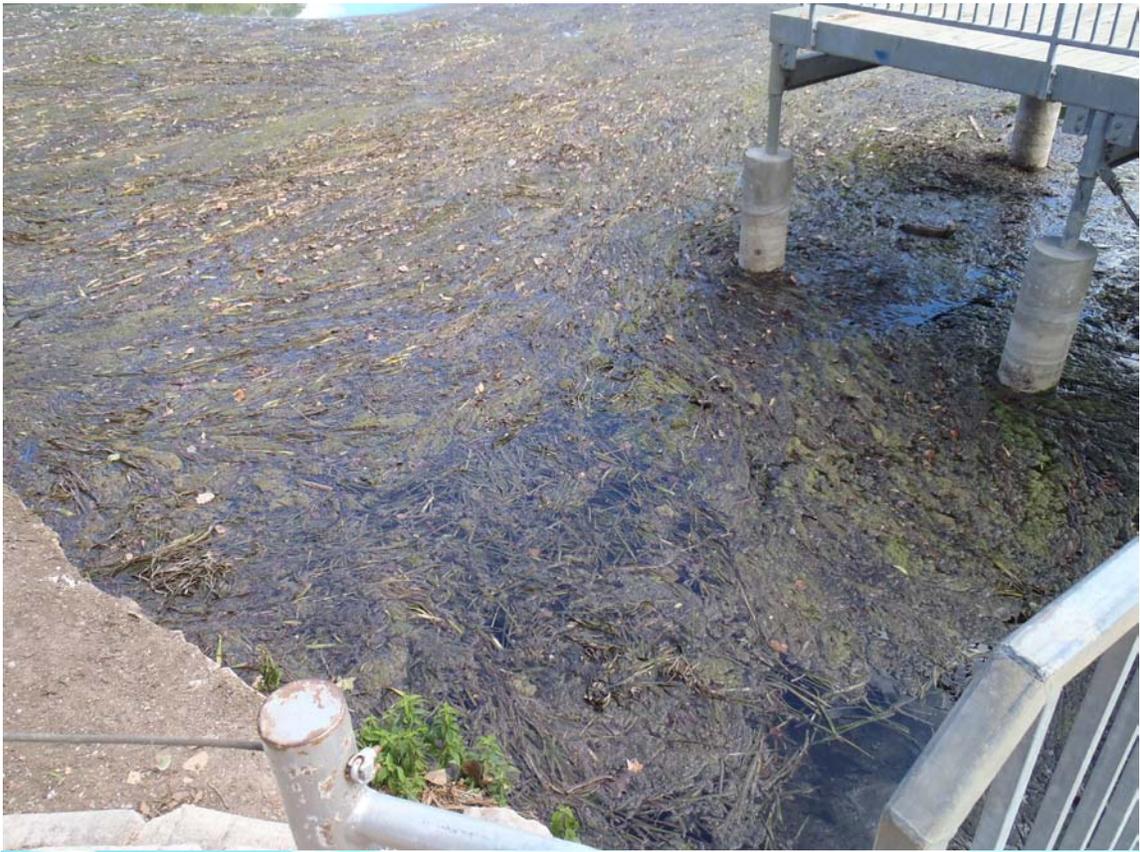
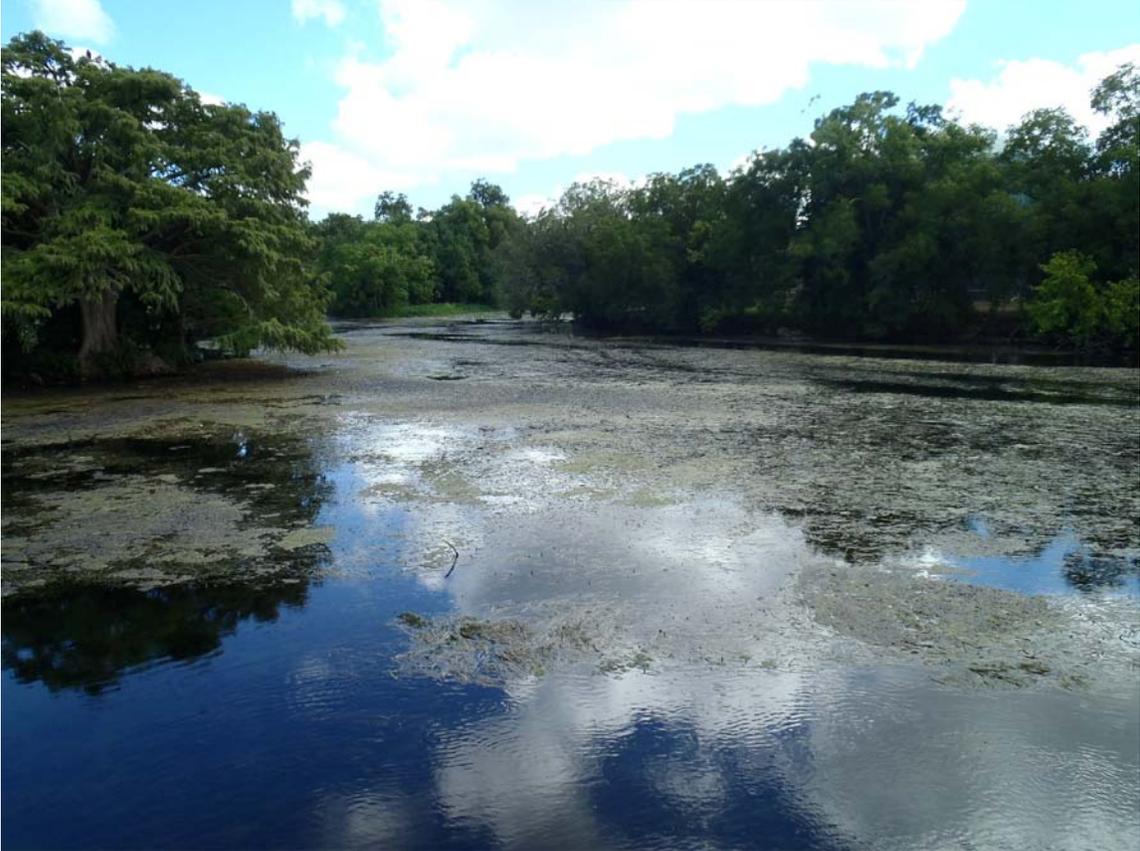
On a less positive note, floating mats of aquatic vegetation continue to build up at these lower than average discharge conditions and are at considerable high levels right now (Figure 5). Coupled with the lower than average water levels in the lake right now, this coverage is having impacts on the underlying aquatic vegetation in both restored and existing areas and likely also contributing to the low DOs during the night as this material decays.

Figure 5: Floating vegetation mats near Landa Lake fishing pier (upper photo) and in the main body of Landa Lake (lower photo).

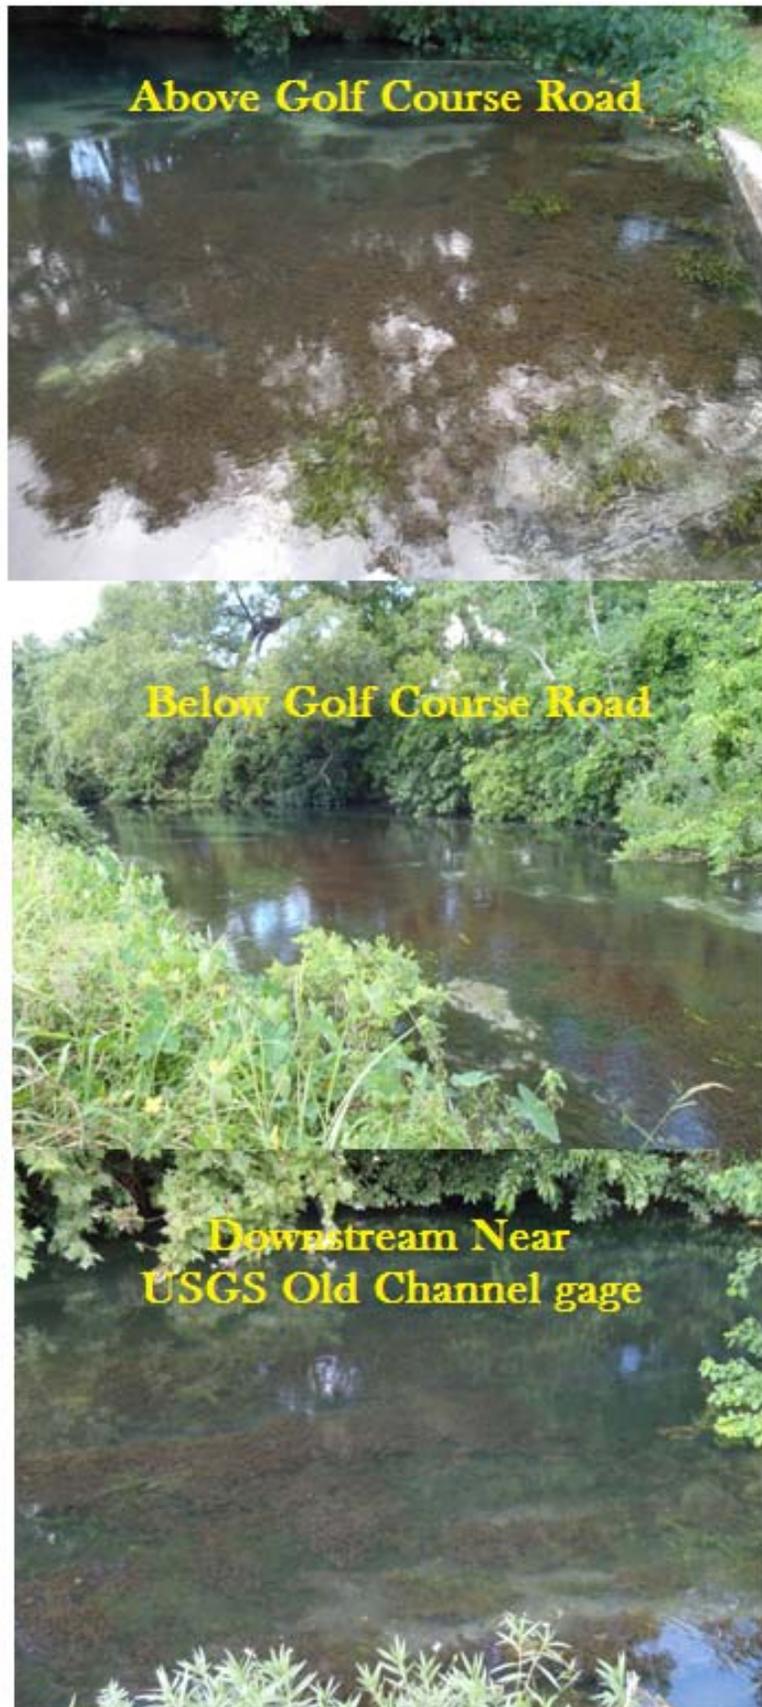
The Old Channel continues to support high quality fountain darter habitat with thriving restored native aquatic vegetation (Figure 6). The New Channel continues to support aquatic vegetation throughout most of the reach above the confluence of the Old Channel, but fountain darter habitat remains of lesser quality than in either Landa Lake or the Old Channel at this time. It is encouraging that water temperature and DO conditions continue to be maintained at levels supportive of fountain darters even at the most downstream extent of each channel.

Figure 6: Restored native aquatic vegetation in Old Channel.
