HABITAT CONSERVATION PLAN BIOLOGICAL MONITORING PROGRAM San Marcos Springs/River Ecosystem

HIGH FLOW ADDENDUM TO 2015 ANNUAL REPORT

February 2016

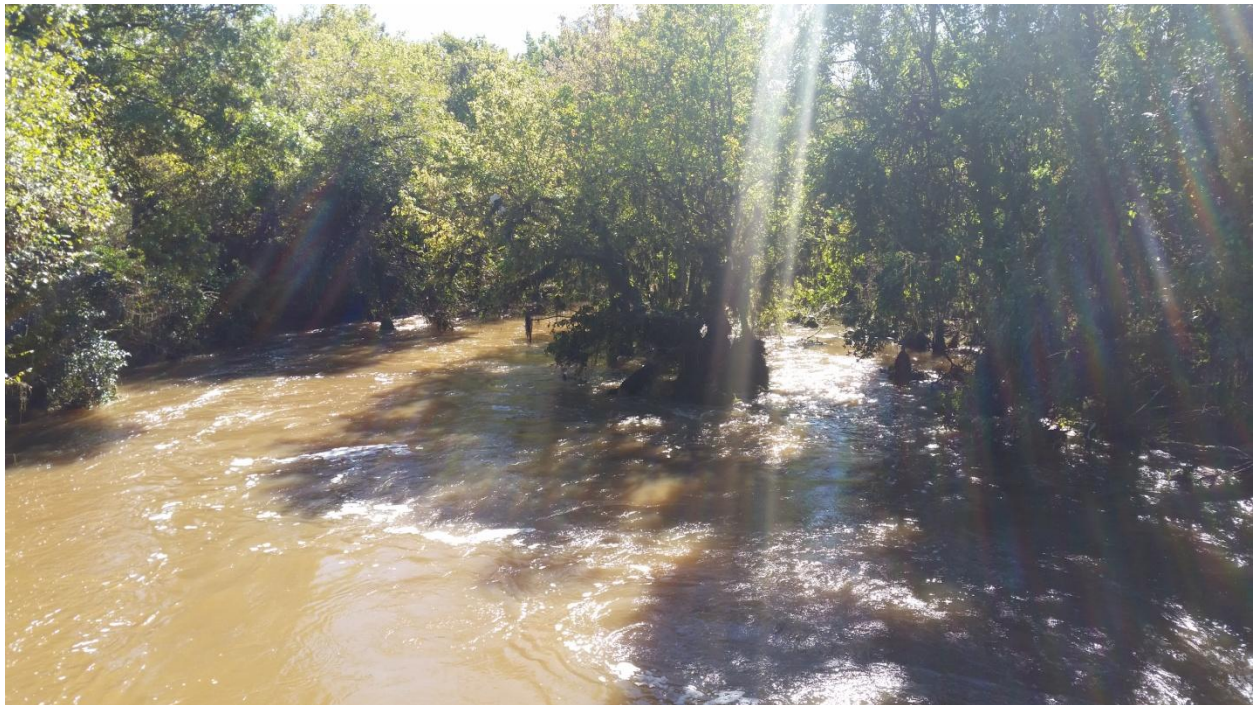
The top of the I-35 Reach, looking downstream from Cheatham Street bridge, October 2015.

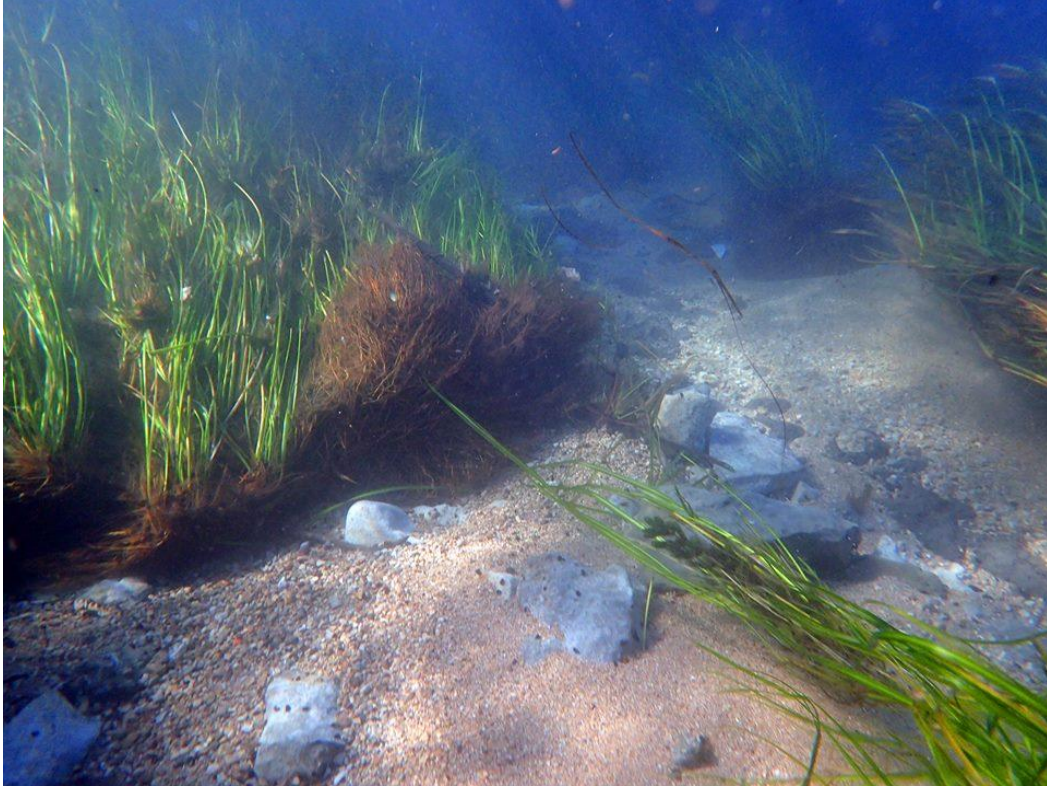
Disturbance of Texas wild-rice roots showing how root undermining can result in complete loss of stands. Photo courtesy of Susan Carper Hanson.

In general river bed scour from the October flood was observed to be the main action resulting in severe to extreme damage to Texas wild-rice stands in many locations. River bed scour typically damages Texas wild-rice as sand and gravel is removed from around the roots undermining the root structure leading to the complete uprooting of large clumps of plants. Sediment accretion was also observed in some locations but to a lesser extent. Accretion of large amounts of sediment and sand can smother Texas wild-rice plants although the ability of Texas wild-rice to recover from sediment accretion is possible since the root zone remains intact. In areas where Texas wild-rice remained intact a decrease in top growth biomass was evident, but this type of damage is typically short lived until Texas wild-rice re-grows culms and leaves.

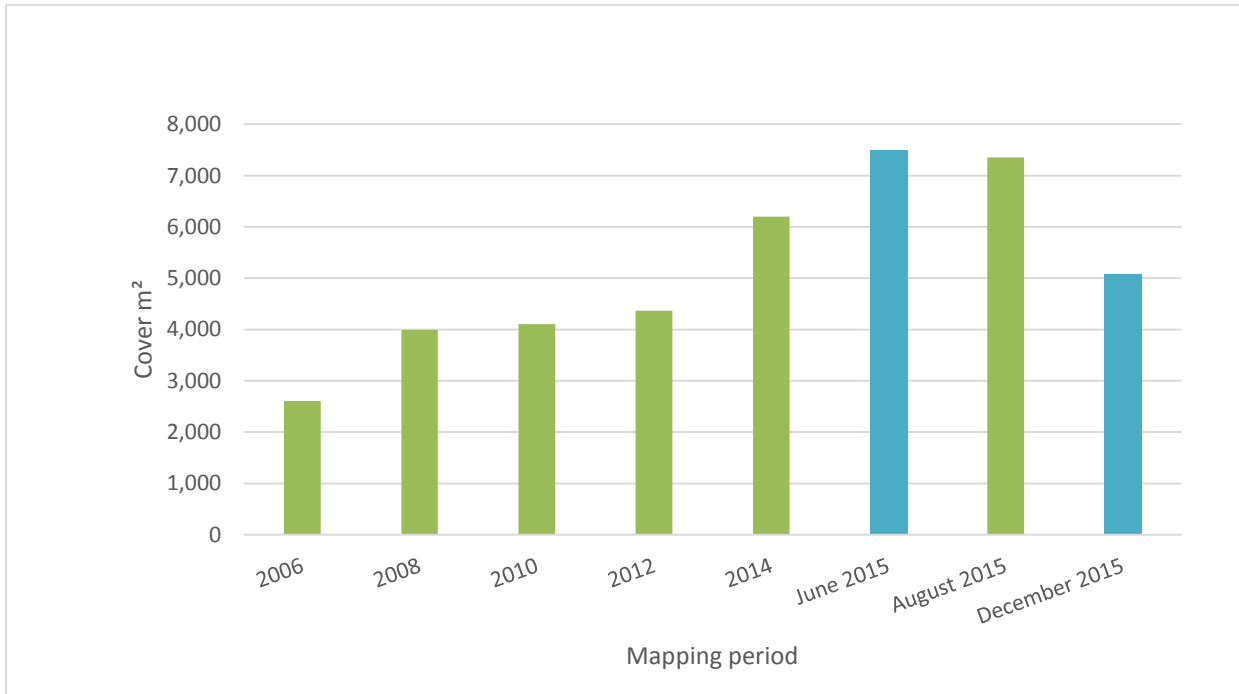
Figure 4. Total surface area of Texas wild-rice stands across selected years in the San Marcos River. Blue represents high-flow Critical Period mapping efforts.

Texas wild-rice maps for the entire San Marcos River broken out by river segment can be found in Appendix A. In June 2015, total surface area of Texas wild-rice in the San Marcos River was the highest it has been since mapping began for this project in 2001. Texas wild-rice covered 7,489.0 m² in late June due to HCP restoration/planting efforts taking place throughout the river. In August 2014, monitoring observed 54 stands of Texas wild-rice occurring below the I-35 highway covering 121 m². The June 2015 flood reduced this number to just 4 stands with these stands only occurring between I-35 and Cape's Dam and covering only 19 m². These stands were observed during the August 2015 survey but after the October flood event these remaining stands were not found and only two small plants (collected as points) were observed in the nearly one mile stretch from I-35 to the historical limit of Texas wild-rice distribution below the San Marcos Waste Water Treatment Plant. It was not apparent that any Texas wild-rice roots remained intact in this lower reach as much of the river bed below I-35 was subjected to extreme scour evident by deeper pools, exposed bedrock, and the lack of other types of aquatic vegetation.

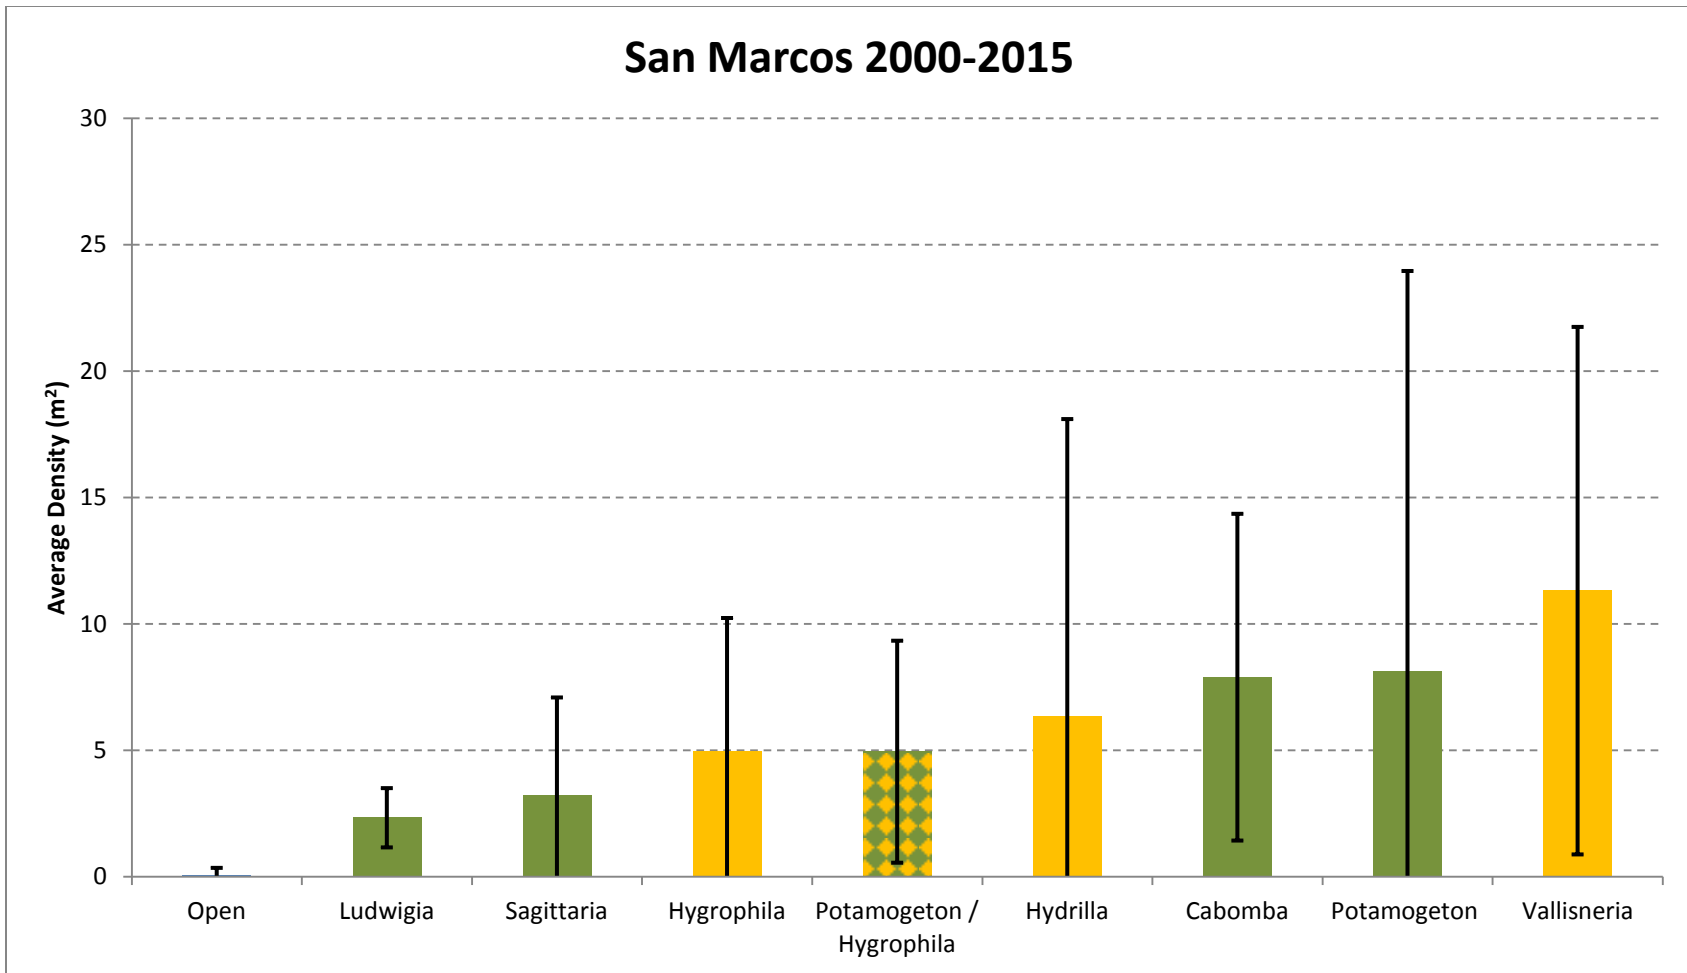
Figure 5. Average fountain darter density for each sampled vegetation type in the San Marcos River from 2000–2015. Green represents native vegetation, while yellow reflects nonnative types. Long-term study averages are provided with error bars representing one standard deviation from the mean.

From these drop net samples, a total of 162 fountain darters were collected following the October flood. In 2015, 307 darters were collected during the spring effort, and 202 darters were collected during the fall. Submerged aquatic vegetation is a critical component of fountain darter habitat in the San Marcos River, as demonstrated by the density of fountain darters in open habitats (0.10/m²) versus vegetated habitats (2.3–11.6/m²) (Figure 5). Although variation is high between vegetation types, native vegetation types that provide thick cover at or near the substrate such as *Cabomba* (8.0/m²) tend to have the highest fountain darter densities, whereas open substrate with no vegetation has relatively low densities.

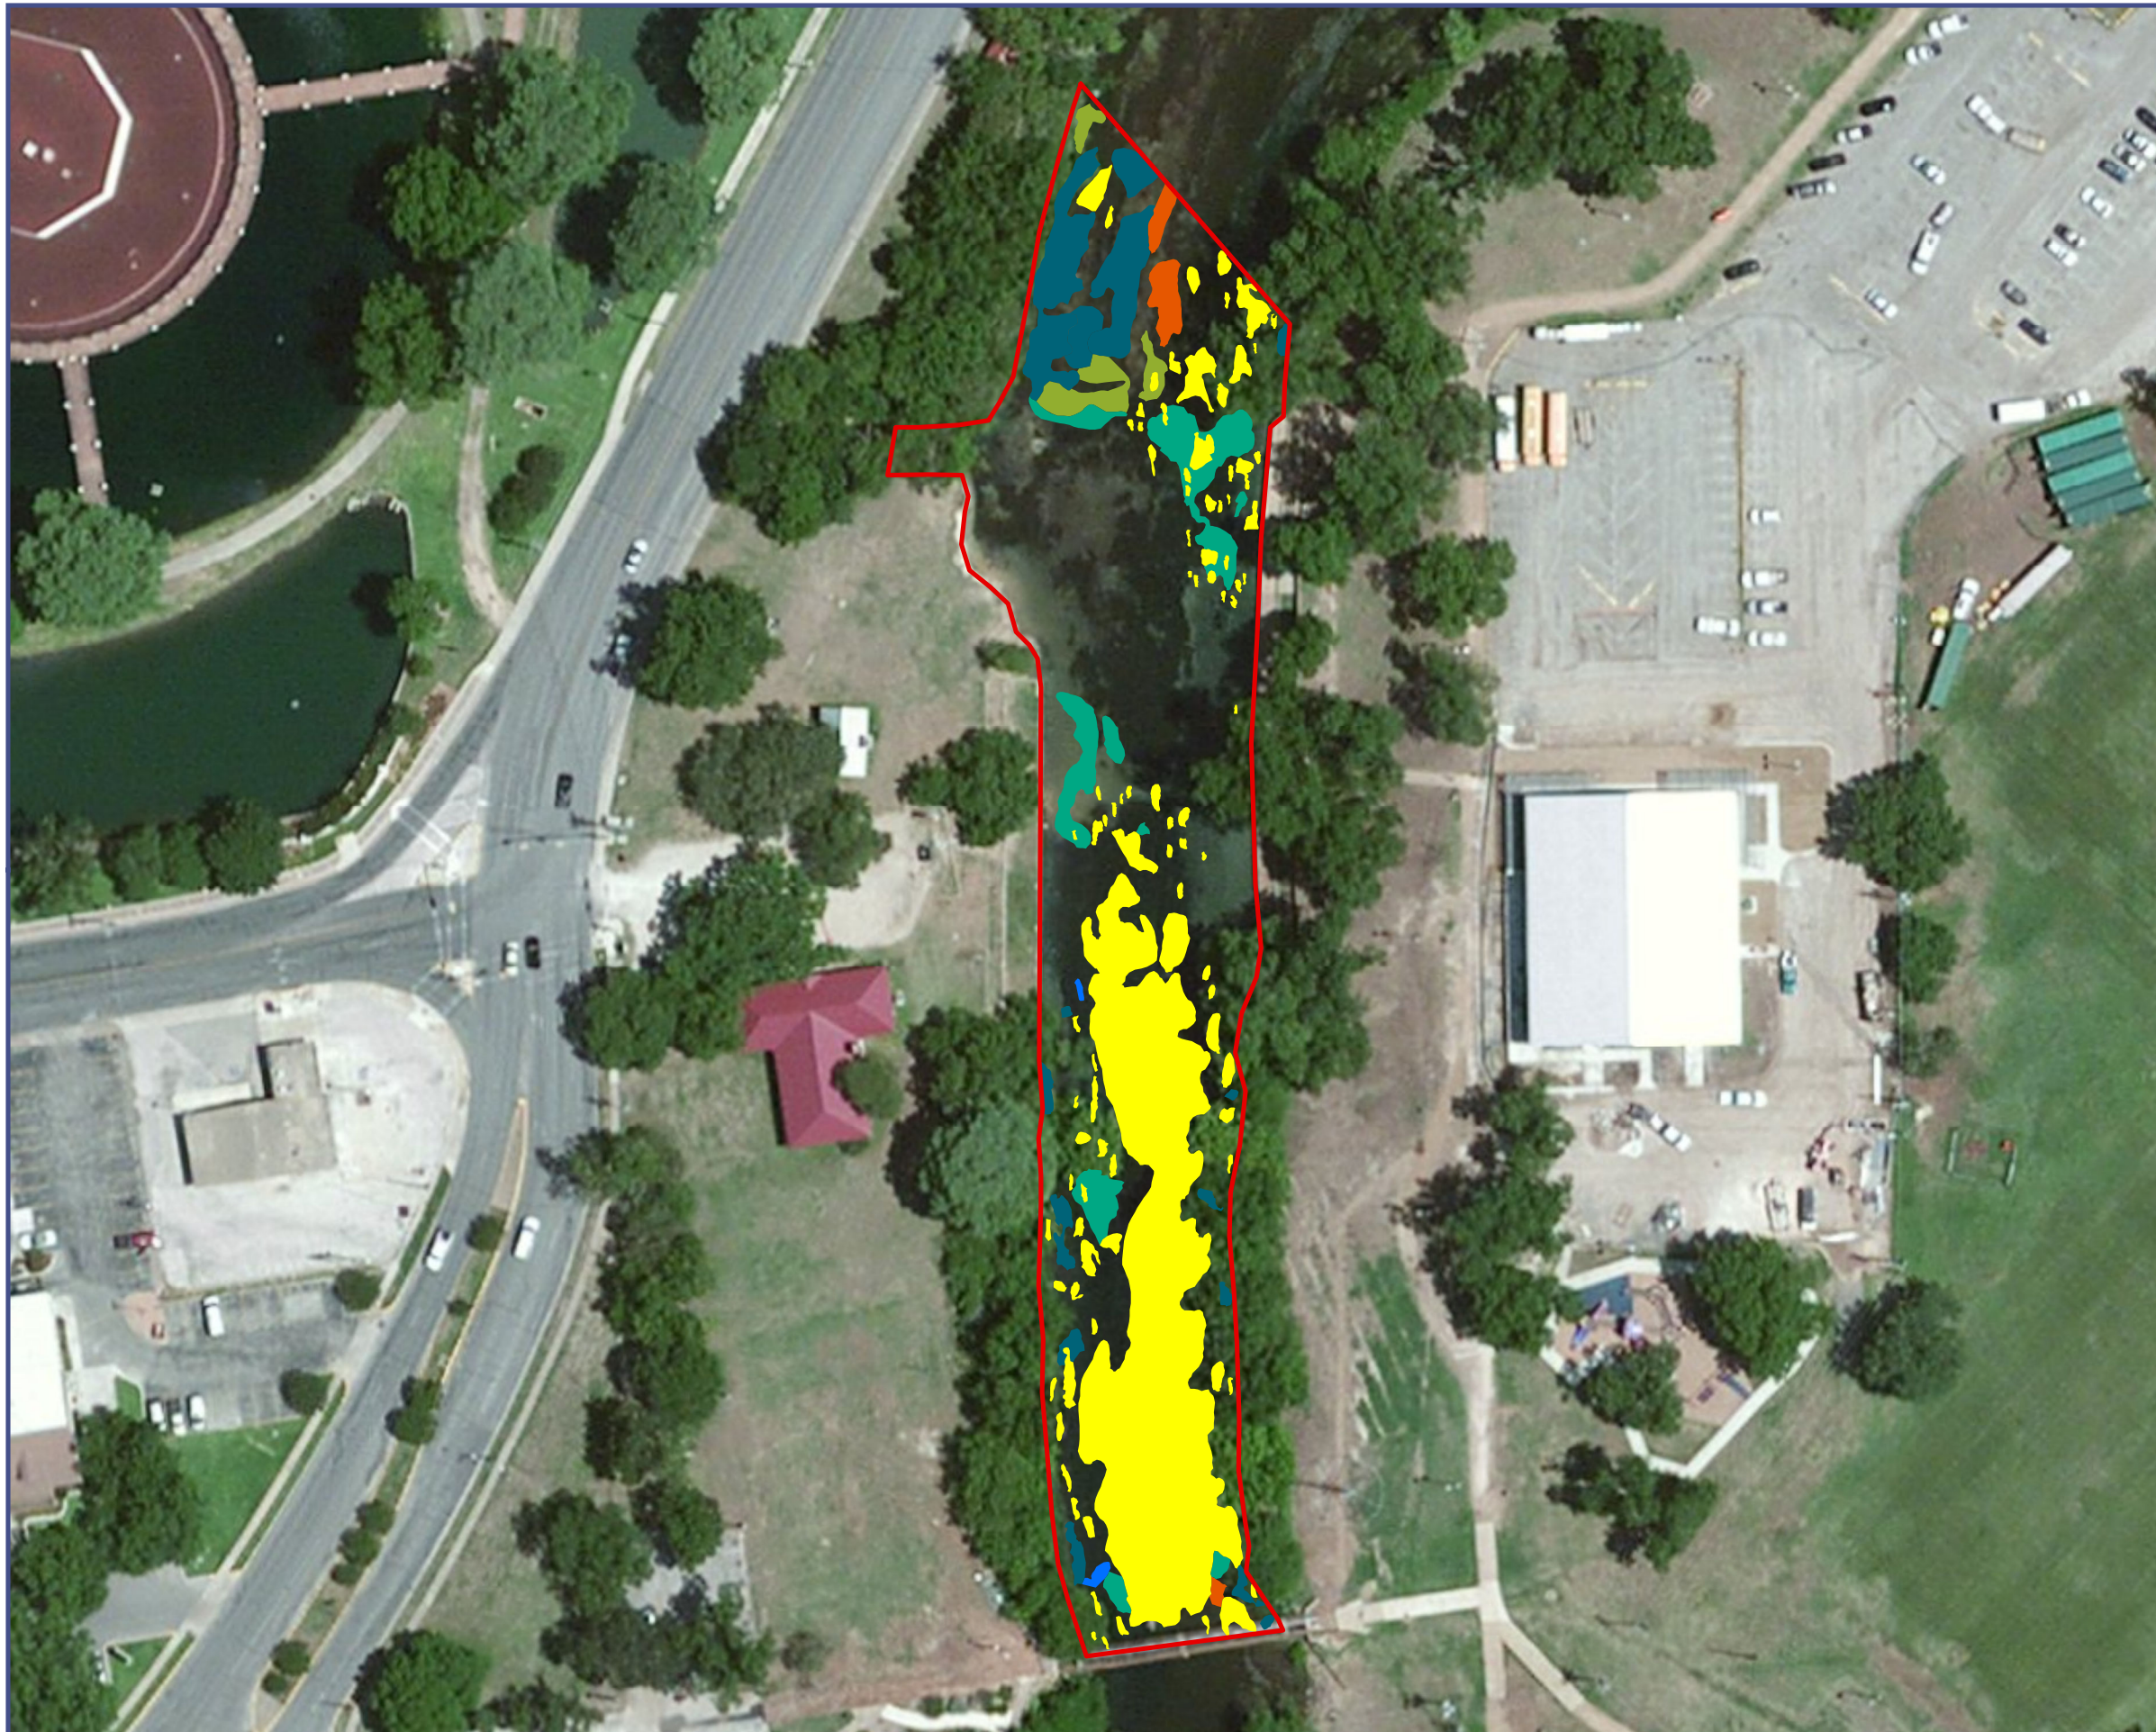
City Park Reach

Aquatic Vegetation Study Reach

Study Reach	6,389.0 m ²
Vegetation Types

Zizania	1,260.7 m ²
