# **Comprehensive and Critical Period Monitoring Program to Evaluate the Effects of Variable Flow On Biological Resources in the San Marcos Springs/River Aquatic Ecosystem**

## **Final 2006 ANNUAL REPORT**

BIO-WEST, Inc  
Austin Office  
1812 Central Commerce Court  
Round Rock, Texas 78664-8546

**February 2007**

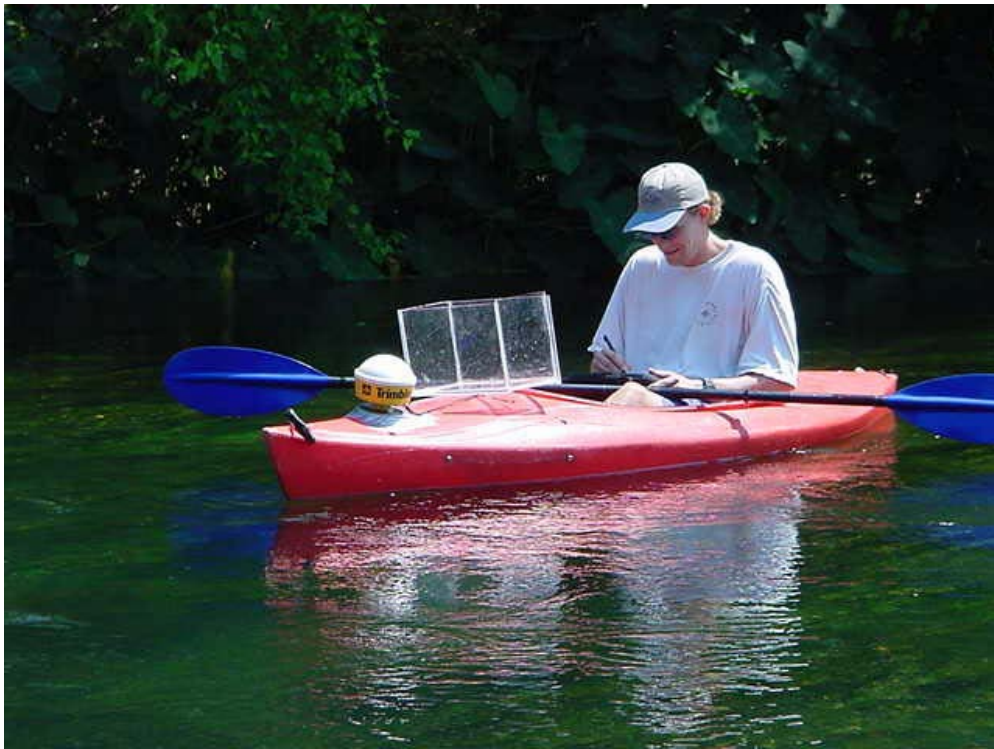
GPS and kayak setup used during aquatic vegetation mapping

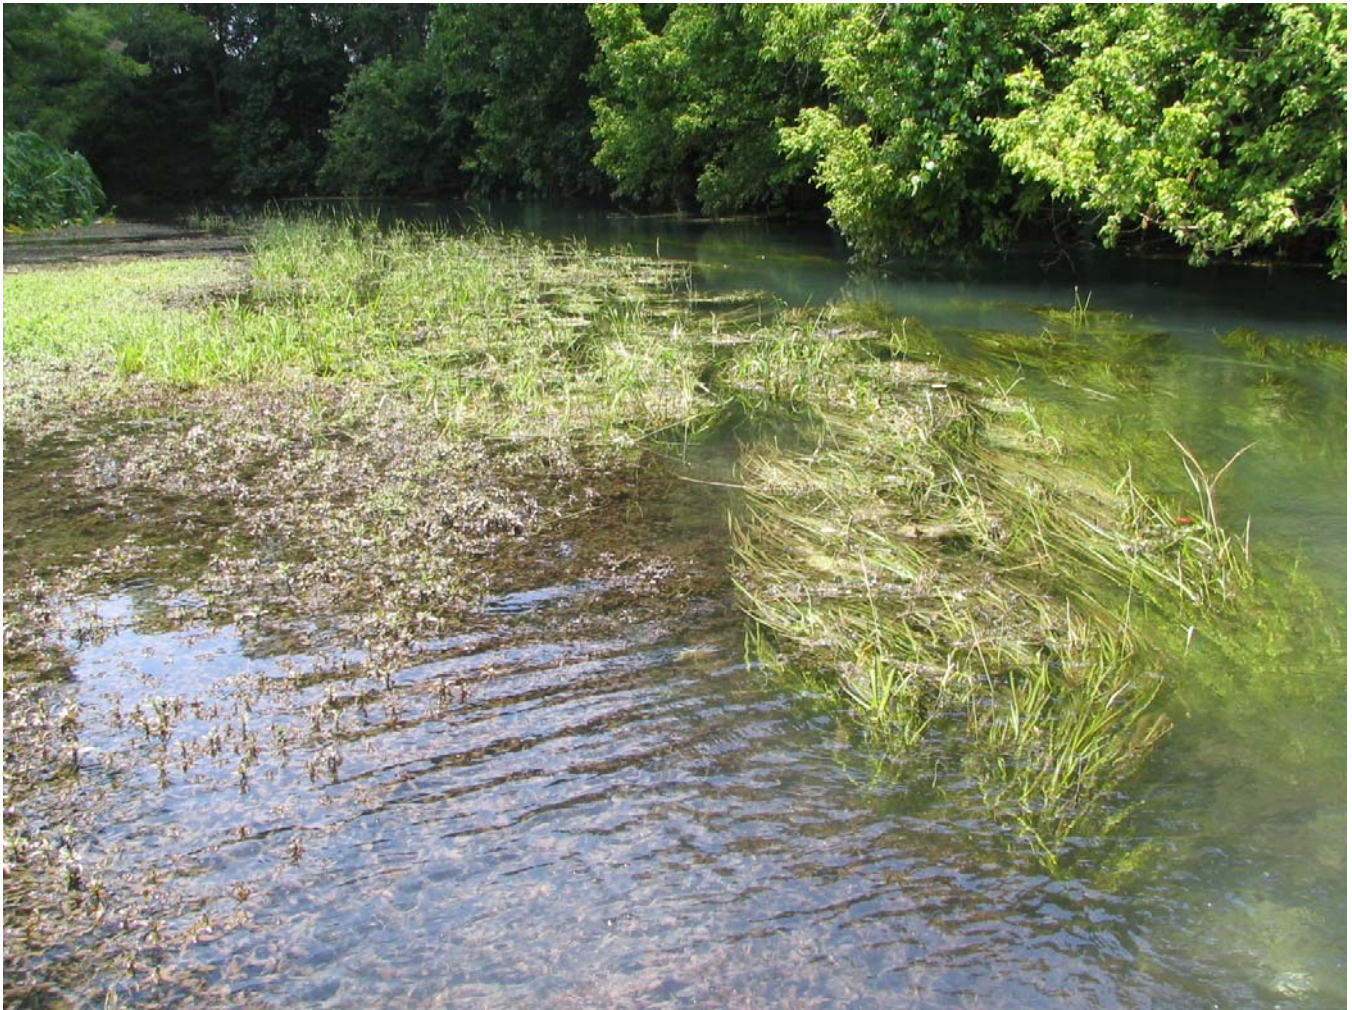
Texas wild-rice stand in the IH-35 reach

The aerial coverage of Texas wild-rice stands in vulnerable locations were determined by GPS mapping (described above), but some smaller stands were measured using maximum length and maximum width. The length measurement was taken at the water surface parallel to streamflow and included the distance between the base of the roots to the tip of the longest leaf. The width was measured at the widest point

perpendicular to the stream current (this usually did not include roots). The length and width measurements were used to calculate the area of each stand according to a method used by the Texas Parks and Wildlife Department (J. Poole, TPWD, pers. comm.) in which percent cover was estimated for the imaginary rectangle created from the maximum length and maximum width measurements.

Qualitative observations were also made on the condition of each Texas wild-rice stand. These qualitative measurements included the following categories: the percent of the stand that was emergent (and how much of that was in seed), the percent covered with vegetation mats or algae buildup, any evidence of foliage predation, and a categorical estimation of root exposure. Notes were also made regarding the observed (or presumed) impacts of recreational activities. Each category was assigned a number from 1 to 10 for each stand, with 10 representing the most significant impact.

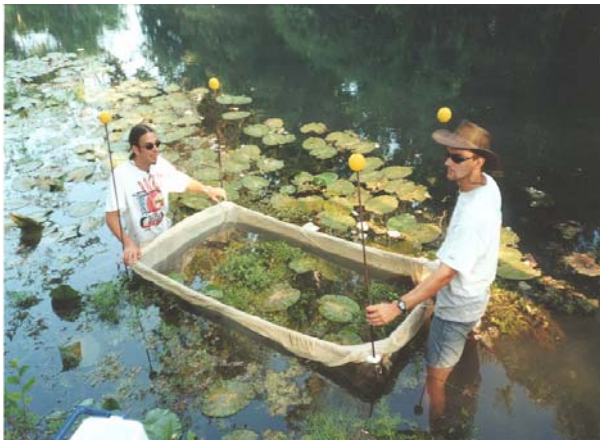
Typical drop net setup

A drop net is a type of sampling device previously used by the U.S. Fish and Wildlife Service (USFWS) to sample fountain darters and other fish species in the Comal and San Marcos Springs/River ecosystems. The design of the net is such that it encloses a known area (2 square meters [ $\text{m}^2$ ]) and allows thorough sampling by preventing escape of fishes occupying that area. A large dip net (1  $\text{m}^2$ ) is used within the drop net and is swept along the length of the river substrate 15 times to ensure complete enumeration of all fish trapped within the net. For sampling during this study, a drop net was placed in randomly selected sites within specific aquatic vegetation types. The vegetation types used in each reach were defined at the beginning of the study as the dominant species found in that reach. Sampling sites were randomly selected per dominant vegetation type for each Comprehensive and Critical Period event from a grid overlain on the most recent map (created using GPS-collected data during the previous week) of that reach.

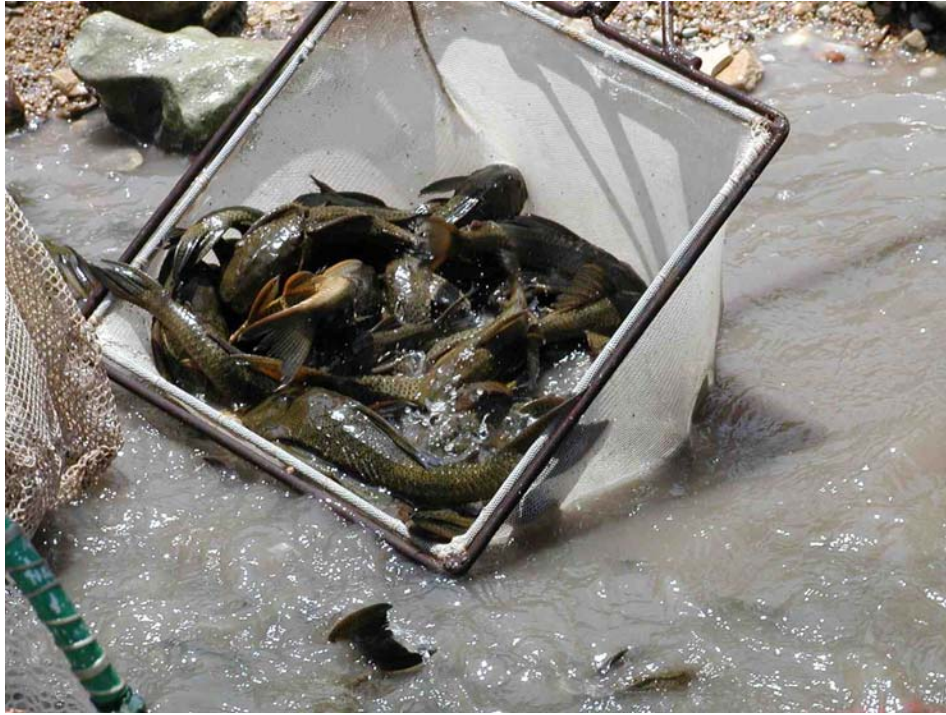
**Figure13. Suckermouth catfish captured in the San Marcos River near Rio Vista Dam. Photo courtesy of the U.S. Fish and Wildlife Service.**

In addition to fountain darters, there have been 18,206 fishes representing 26 other taxa collected by drop netting since 2001 (Table 14). Of these, 7 species are considered introduced or exotic to the San Marcos Springs/River ecosystem. The most abundant exotic or introduced species in the system include the rock bass (*Ambloplites rupestris*) and the sailfin molly (*Poecilia latipinna*). Another exotic species of particular concern is the suckermouth catfish (*Hypostomus sp.*). Although these fish are rarely captured in drop nets, based on visual observations they are extremely abundant in the system. This species has the potential to drastically affect the vegetation community and thus impact critical fountain darter habitats and food supplies. The sheer number and varying sizes of suckermouth catfish that were removed by the U.S. Fish and Wildlife Service biologists during the reconstruction of Rio Vista Dam (Figure 13) is cause for concern and close future observation of this exotic species.
