SPRING LAKE AQUATIC VEGETATION SURVEY

Edwards Aquifer Authority
900 E. Quincy Street, San Antonio, TX 78215

May 4, 2020

EXECUTIVE SUMMARY

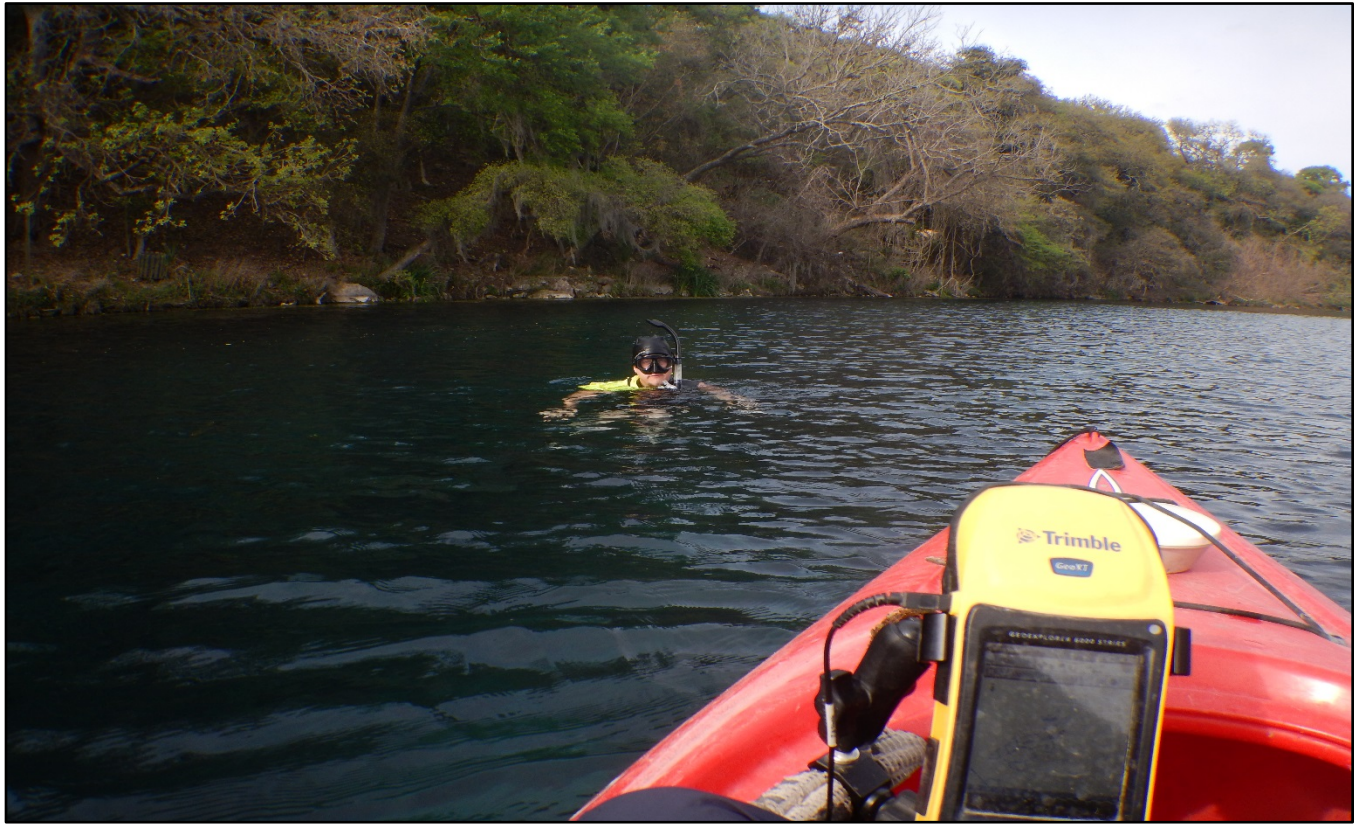
Figure 2. Vegetation mapping with a kayak and the aid of a free diver.

The team used a 10 foot sit in kayak with a plexiglass window for visual observations to complete the field mapping portion of the project. A Trimble GPS unit and external Tempest antenna set on the bow of the kayak was used to collect high accuracy (10 cm – 60 cm) geospatial data. A data dictionary along with pre-determined attributes was loaded into the GPS unit for data collection in the field, and a team member in the kayak recorded discrete patches and density of vegetation and substrate observed from the surface while an accompany free diver verified these observations (Figure 2).

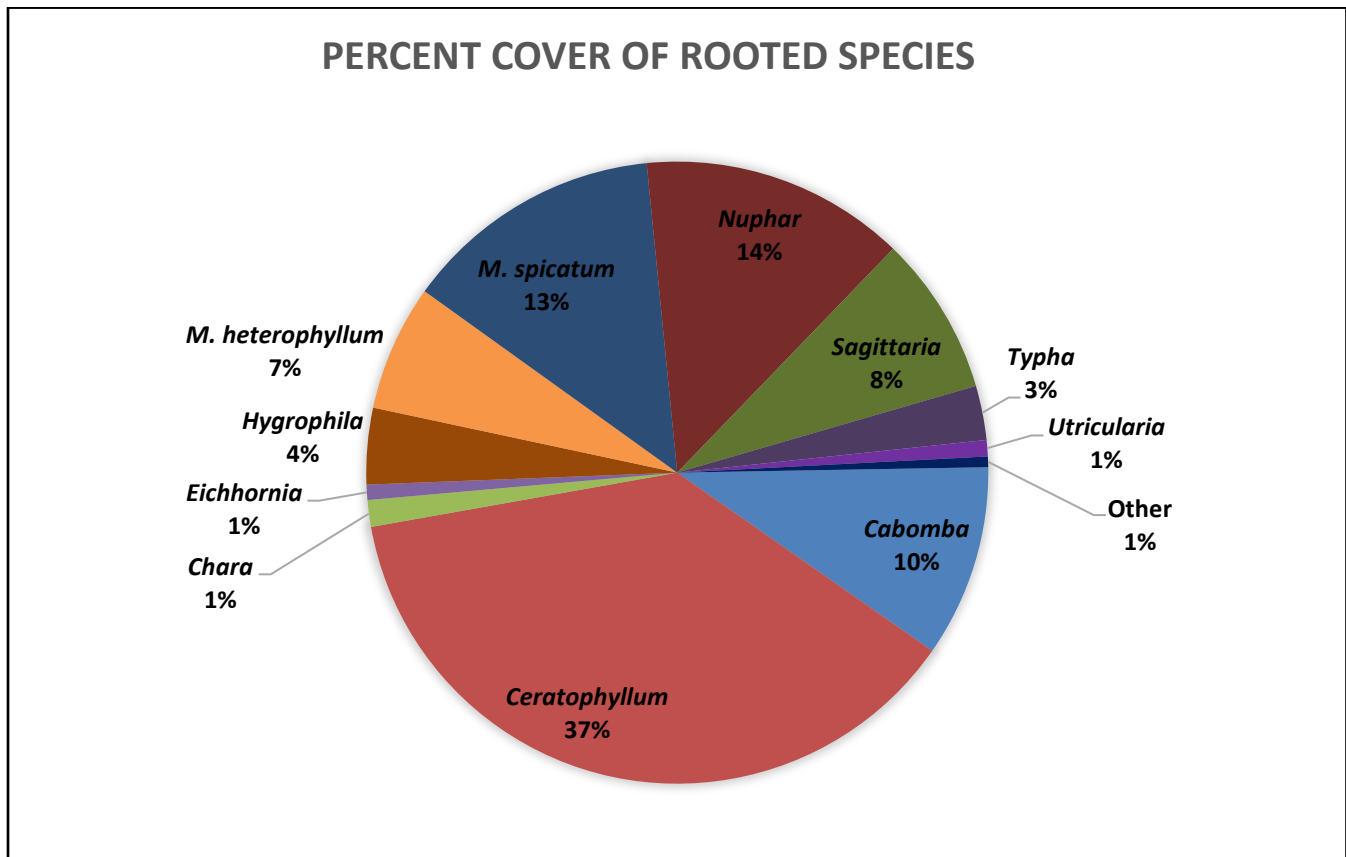
Figure 3. Percent composition of the rooted aquatic plant community.

Figure 3 below highlights the makeup of the rooted aquatic vegetation community. The single most dominant plant species in Spring Lake is *C. demersum* accounting for nearly 40% of the vegetation community. This plant is not exclusive to any one section of the lake but present throughout the system. *Ceratophyllum demersum* is not a rooted plant and generally anchors itself by growing wrapped around other submerged aquatic species or by becoming partially buried in sediment. It can also grow suspended in the water column or even floating at the water surface. The variety of growth habitats allows *C. demersum* to grow virtually anywhere within Spring Lake and facilitates its abundance. The second most dominant species, at a distant 14% coverage, is *N. lutea* although its distribution is mostly limited to portions of the Slough Arm. This rooted waterlily species is heavily concentrated in the Slough Arm of Spring Lake with a few patches located in the lower section of the lake. It is uncommon in the Spring Arm. The third most dominant species mapped is *M. spicatum* which is heavily concentrated in the Spring Arm of the lake, extending to the lower lake section. *Myriophyllum spicatum* appears to be most dense in areas with moving water, especially adjacent to the spring openings. It is less common in the Slough Arm and other lentic locations. *Cabomba caroliniana* is the fourth dominant species. While small amounts of *C. caroliniana* are noted throughout Spring Lake, there are notable areas where the plant dominated, such as the uppermost end of the Spring Arm and the upper end of the Slough Arm. Less dense patches of *C. caroliniana* are common adjacent to the floating boardwalk of Spring Lake. *Sagittaria platyphylla* is present and common in the Spring Arm and Lower Lake sections, but is completely absent in the Slough Arm. *Myriophyllum heterophyllum*, a native milfoil, is generally common throughout the Spring Arm and the Lower Lake section of Spring Lake and occasionally present in the littoral areas of the Slough Arm. This species appears to be most dominant in shallower areas between 2 and 4 feet (0.6 to 1.2 meters) of depth and in areas with silty substrate. *Hygrophila polysperma* is almost exclusively limited to the Lower Lake section where it is found dominant in flowing water and silty locations, although it is also observed in a few locations along the edge of the Spring Arm.

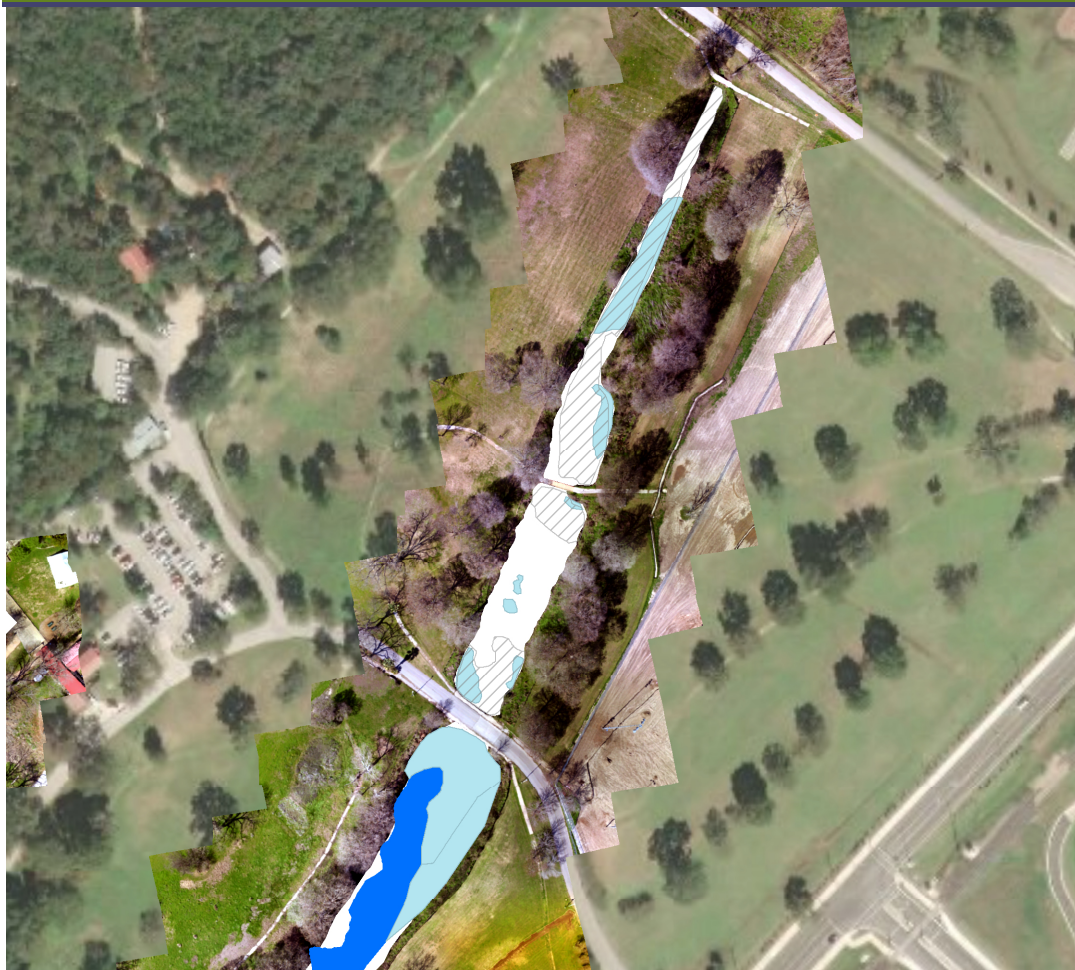
Spring Lake: Upper Slough

Created 4/10/2020. Projected in NAD 1983 UTM 14N at 1:3400. Imagery composed of UAS flown imagery and Esri World Imagery.

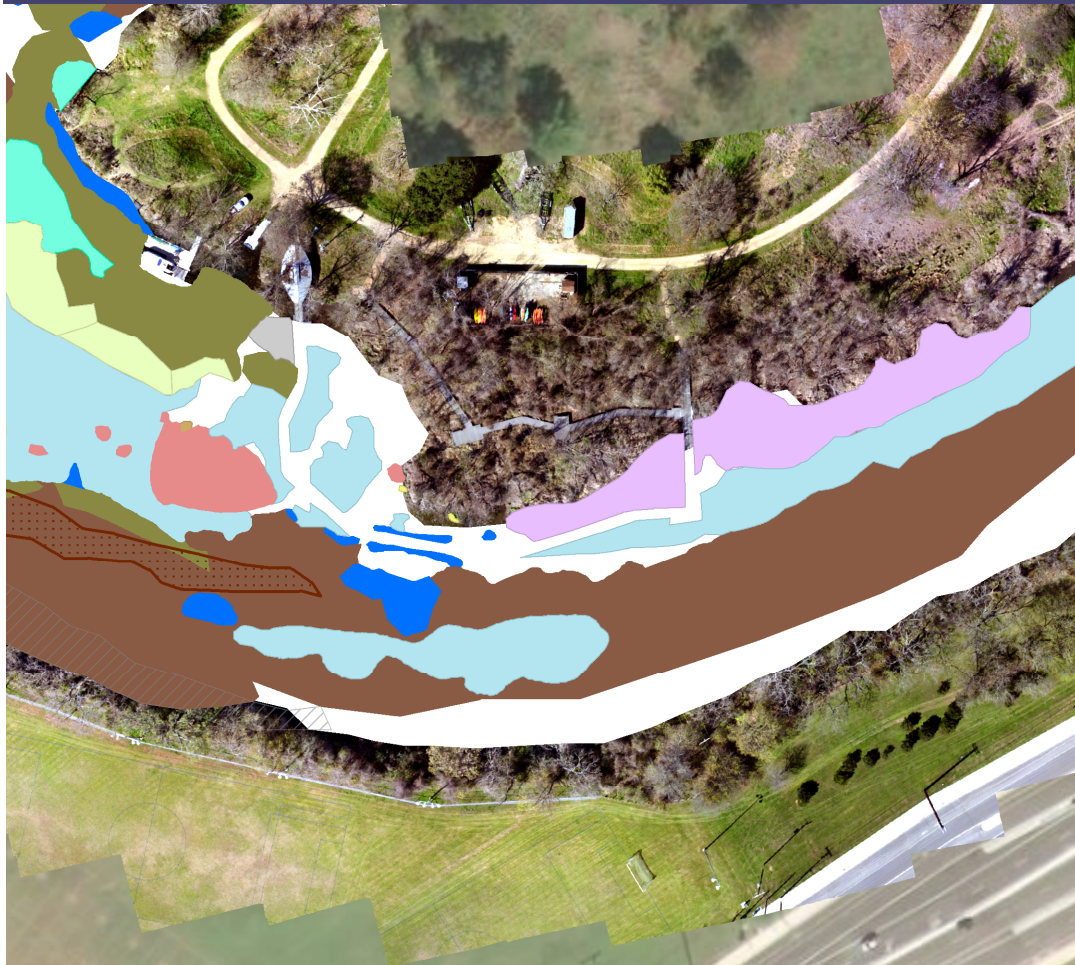
Spring Lake: Middle Slough

Created 4/10/2020. Projected in NAD 1983 UTM 14N at 1:1800. Imagery composed of UAS flown imagery and Esri World Imagery.

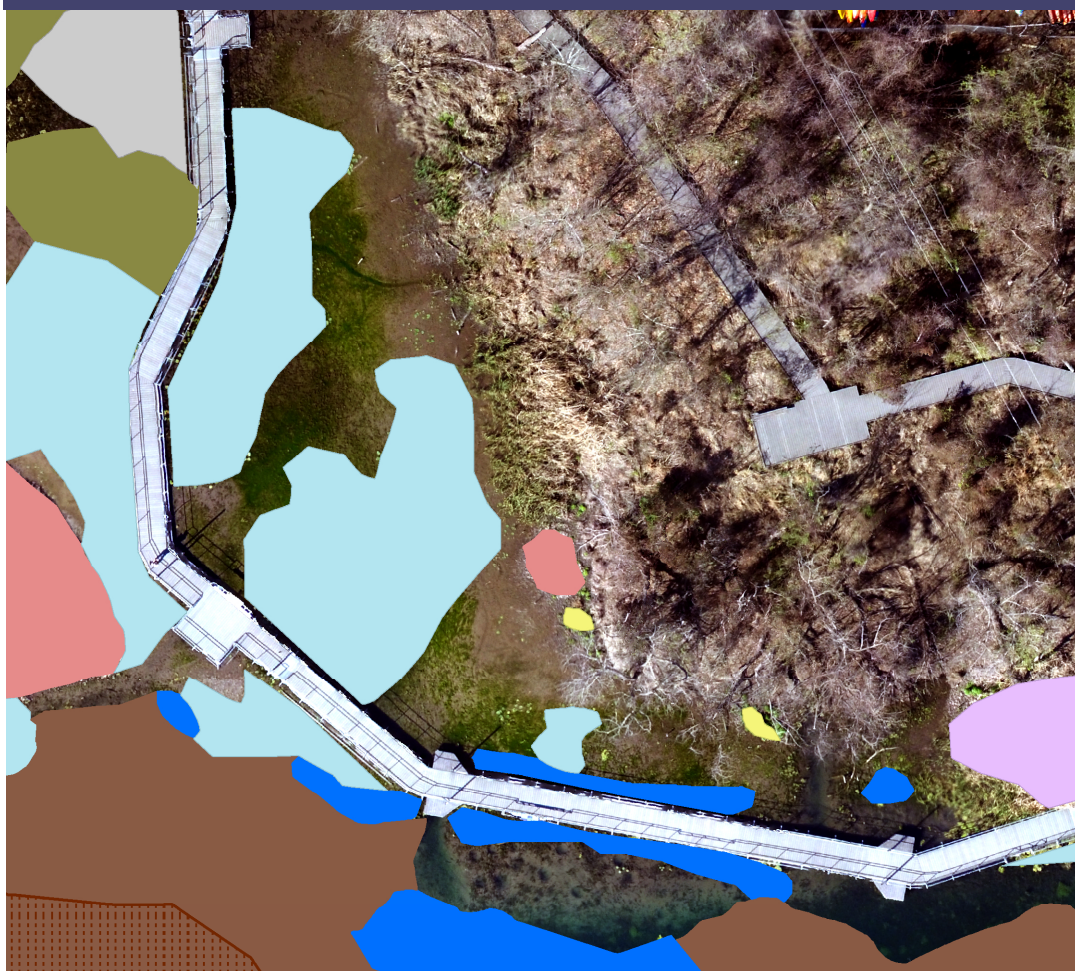
Spring Lake: Wetland Area

Created 4/10/2020. Projected in NAD 1983 UTM 14N at 1:500. Imagery composed of UAS flown imagery and Esri World Imagery.

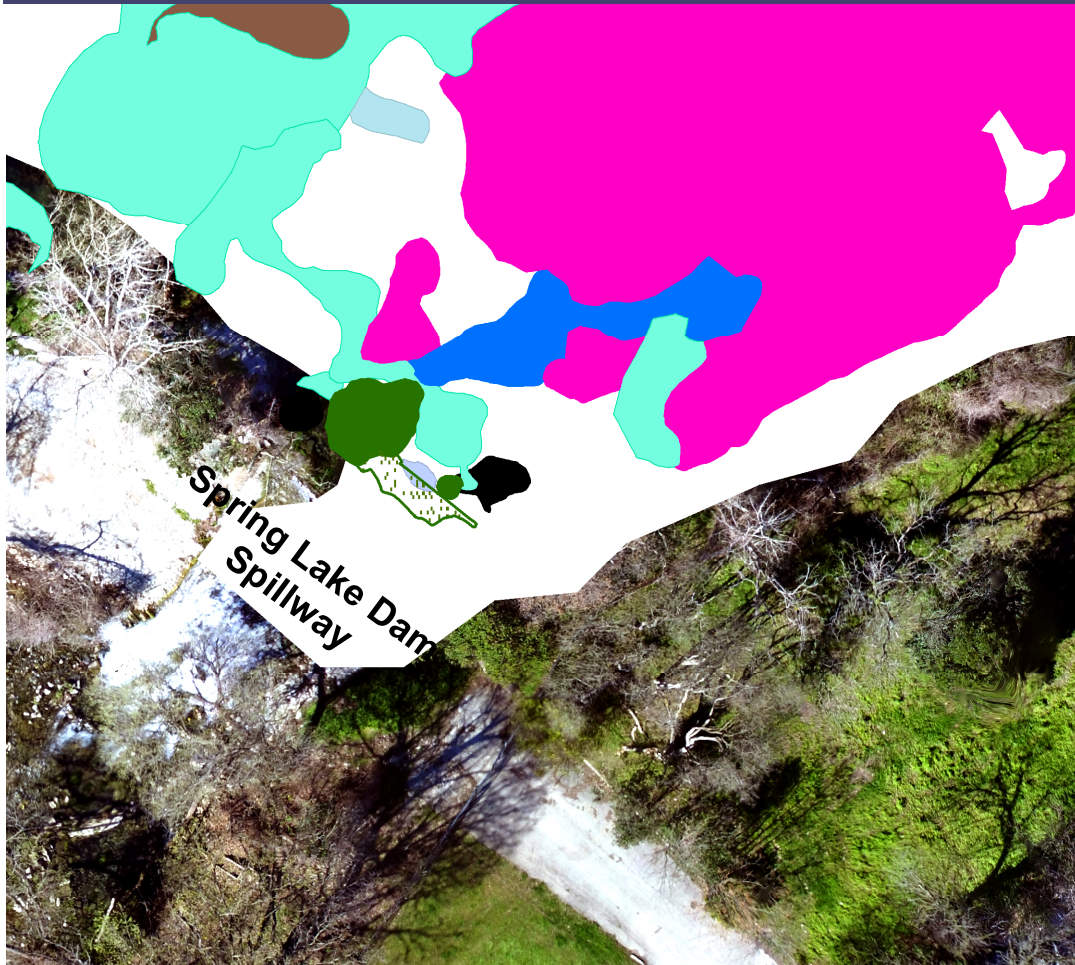
Spring Lake: Dam Spillway

Created 4/10/2020. Projected in NAD 1983 UTM 14N at 1:500. Imagery composed of UAS flown imagery and Esri World Imagery.

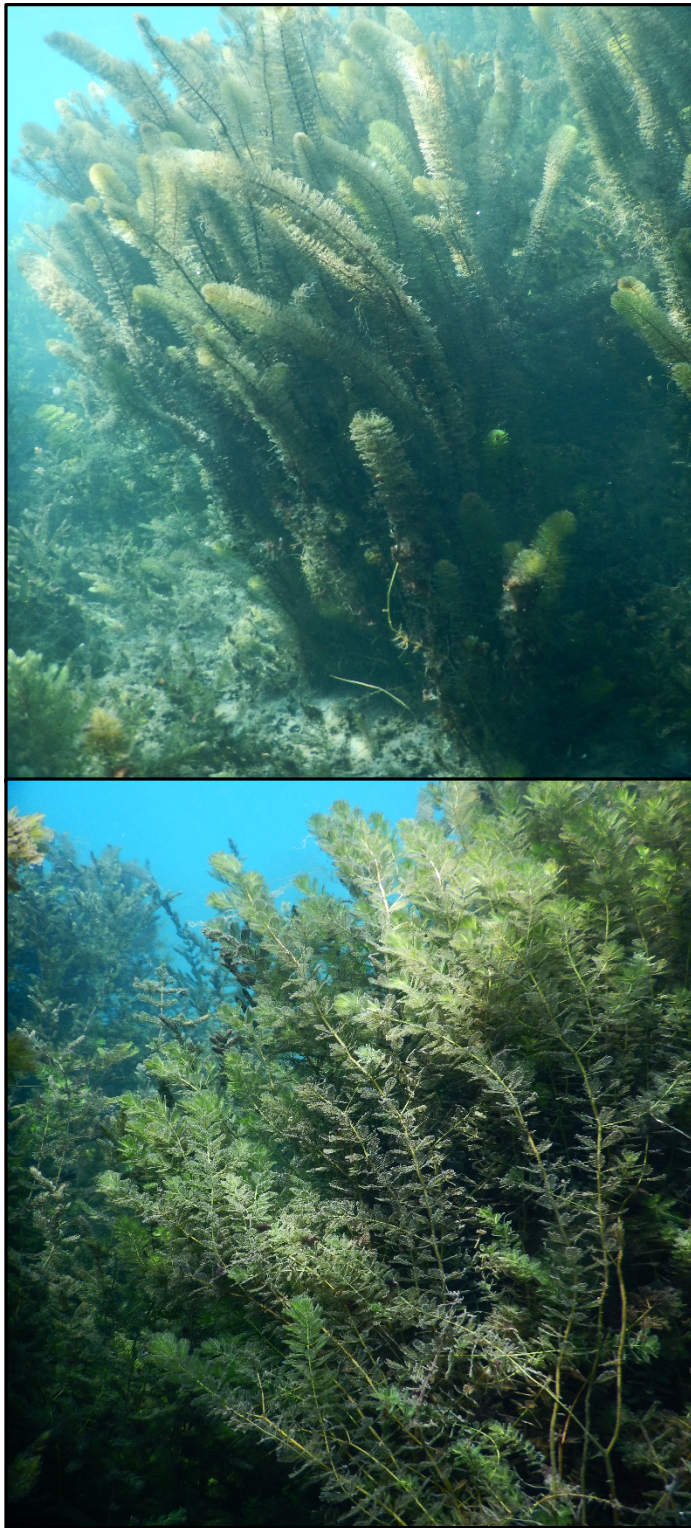
Figure 6 (top) The native milfoil *Myriophyllum heterophyllum* compared to *Myriophyllum spicatum* a non-native milfoil (bottom).

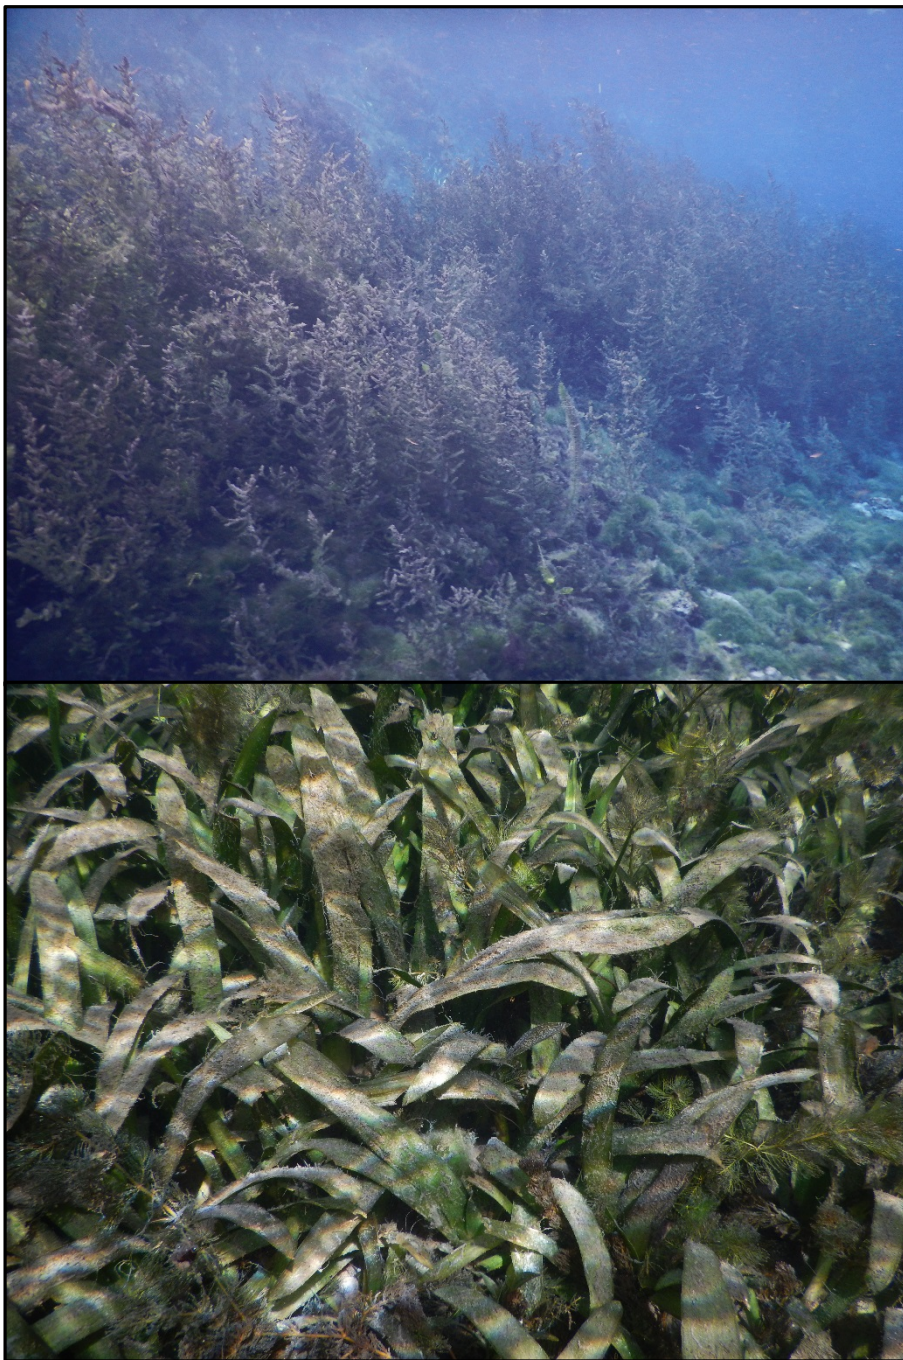
Figure 7. (top) Colony of *Ceratophyllum demersum* a non-rooted but attached macrophyte. (bottom) *Sagittaria platyphylla* creates dense low growing turf like colonies.

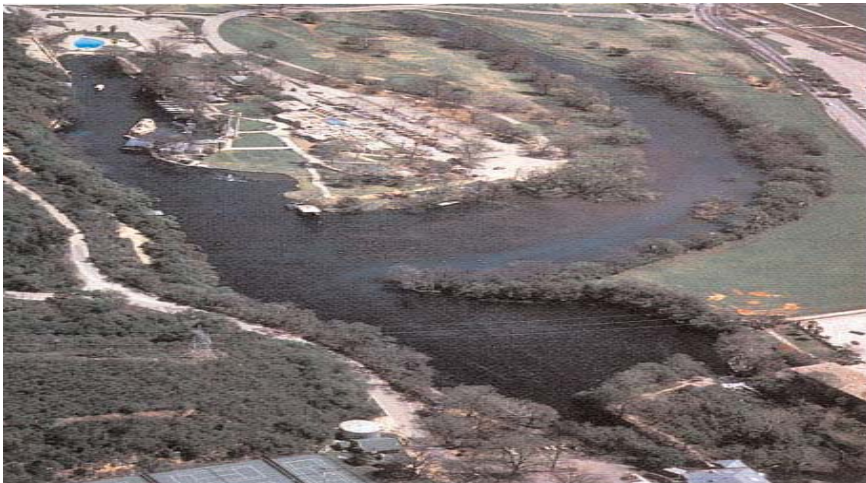
Figure 1. An aerial photograph of Spring lake looking northeast. The Spring section is located on the left, while the Slough section is located on the right. Courtesy of Texas Water Development Board

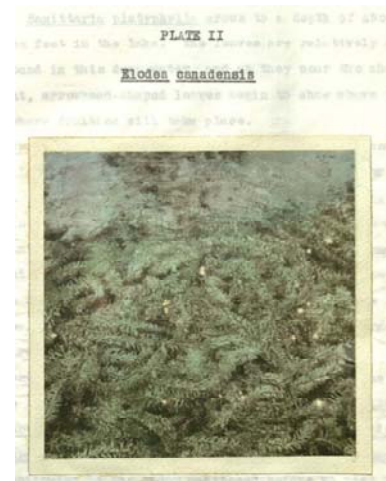
Figure 3. Devall’s purported *Elodea canadensis*. The large blooms on the plant indicate *Egeria densa*.

Hydrilla verticillata*/*Egeria densa*/*Elodea canadensis- The presence of these three species is one of contention. *Elodea canadensis*, a North American native, was listed and photographed (Figure 3.) by Devall who stated that “ Since being planted in the lake some ten or eleven years ago, *Elodea canadensis* has spread over the entire lake and is found to be more abundant than any other single form.” However, the USDA PLANTS database does not list this species as occurring in Texas and no Texas record exists in the Lundell Herbarium,

University of Texas or the Texas State University Herbarium. Since *Elodea canadense* is very similar in appearance to *Egeria densa*, a South American native, it is possible there is a point of confusion between the two species (Bowles and Bowles, 2001). Several herbarium vouchers exist in the Lundell Herbarium for *Egeria densa* collected from Spring Lake, the latest collected in 1962. Bruchmiller(1973) was the first to list *Egeria densa* in the flora of Spring Lake and provided a key to its identification but no further records exist for *Egeria densa* in Spring Lake.

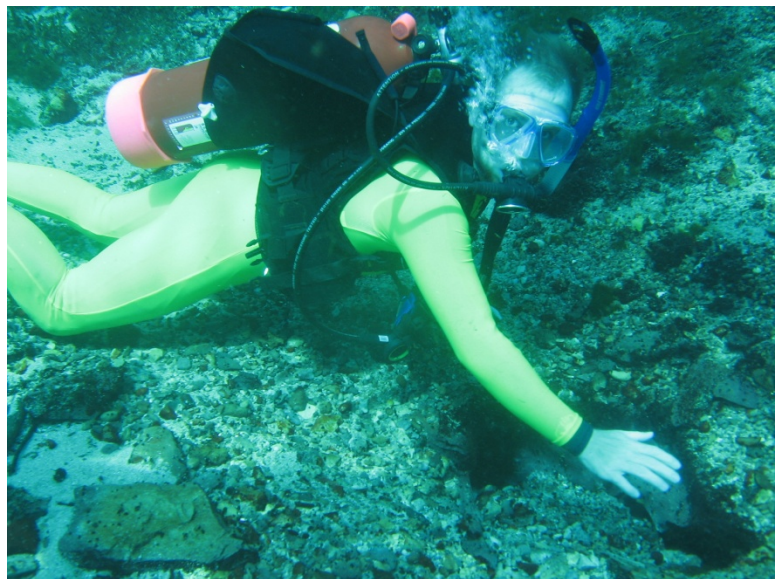
Spring Lake 2010. notice
lack of surface vegetation
compared to picture above

Aquarena Center
utilizes SCUBA divers to
maintain lake
