# House Natural Resources Committee

EDWARDS AQUIFER AUTHORITY

SEPTEMBER 13, 2018

# Abandoned and Deteriorated Wells

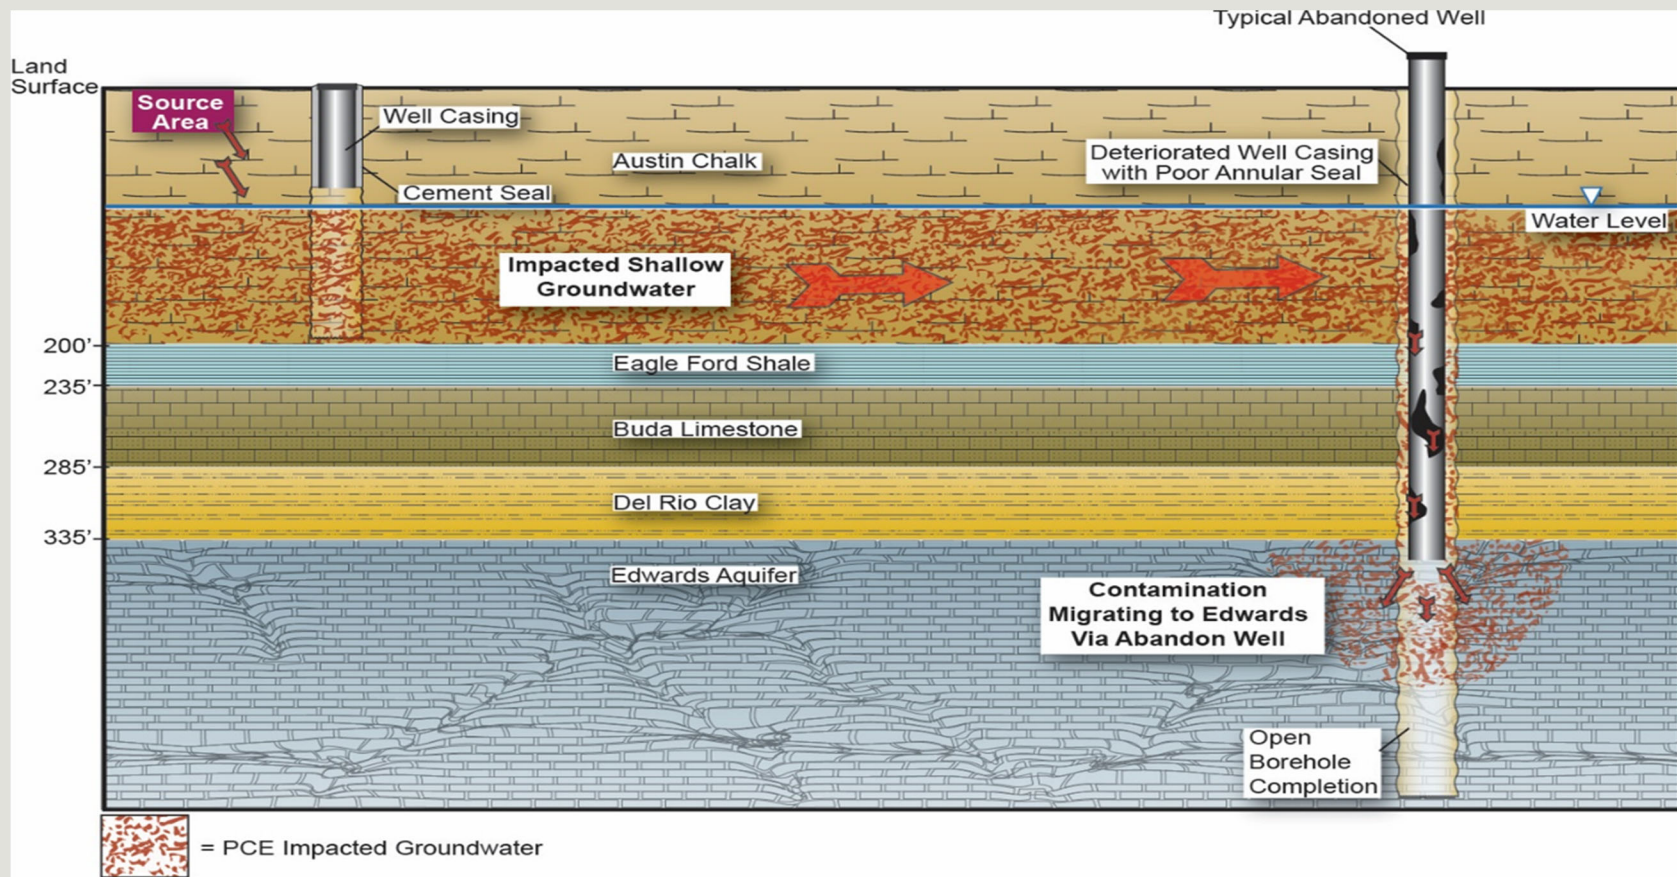
# Mechanism for How Abandoned Wells can contribute to Groundwater Contamination

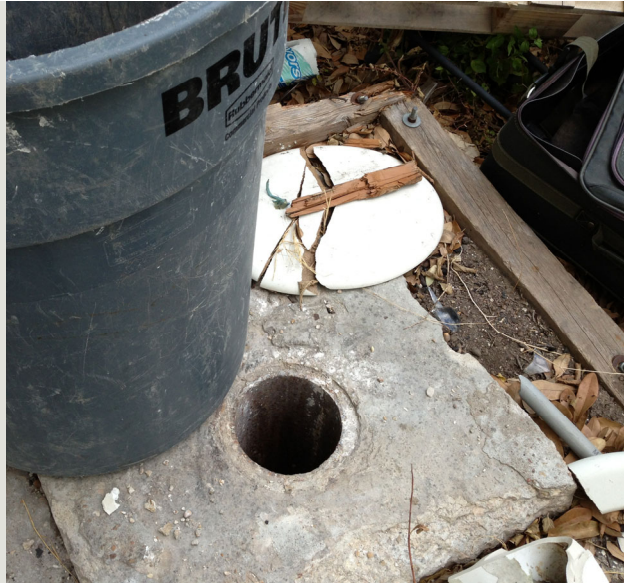
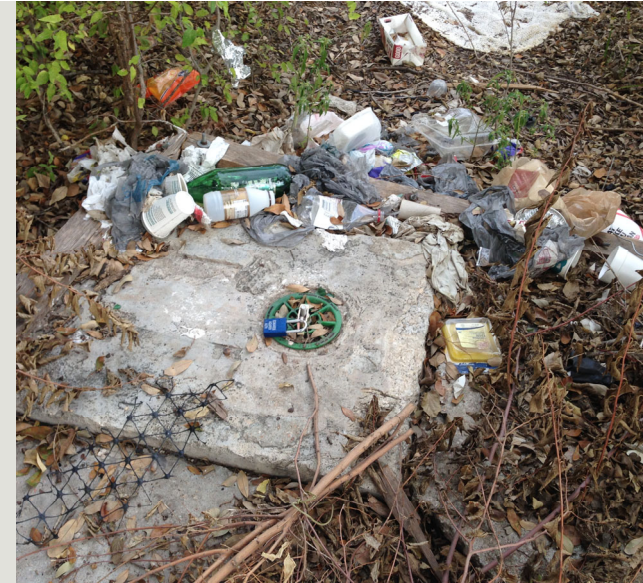
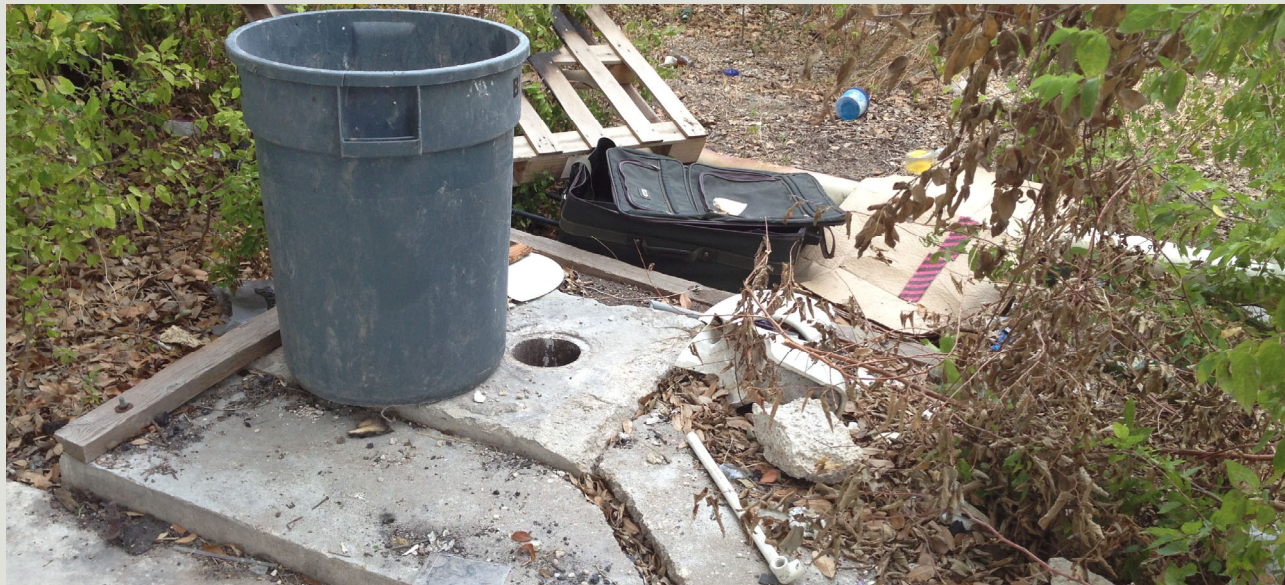
Abandoned well on  
Perrin Beitel Rd  
(NE San Antonio)

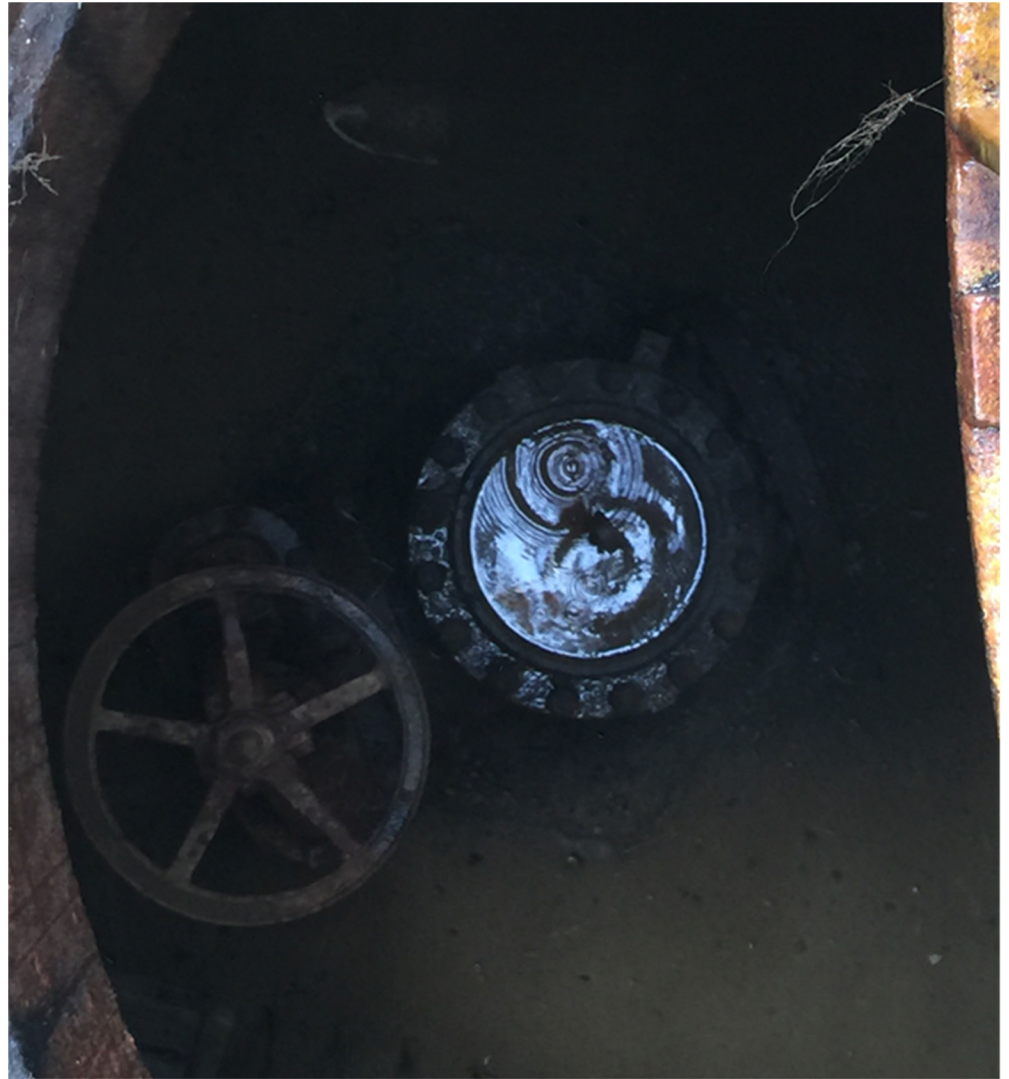
Only one well  
visible at ground  
surface.

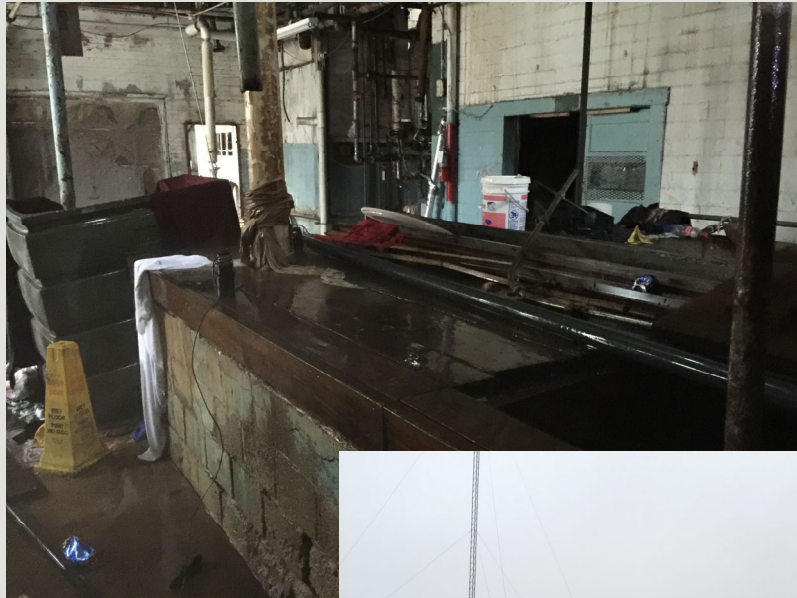
Abandoned well  
flowing inside  
building

Water flowing over  
top of building –  
through makeshift  
standpipe

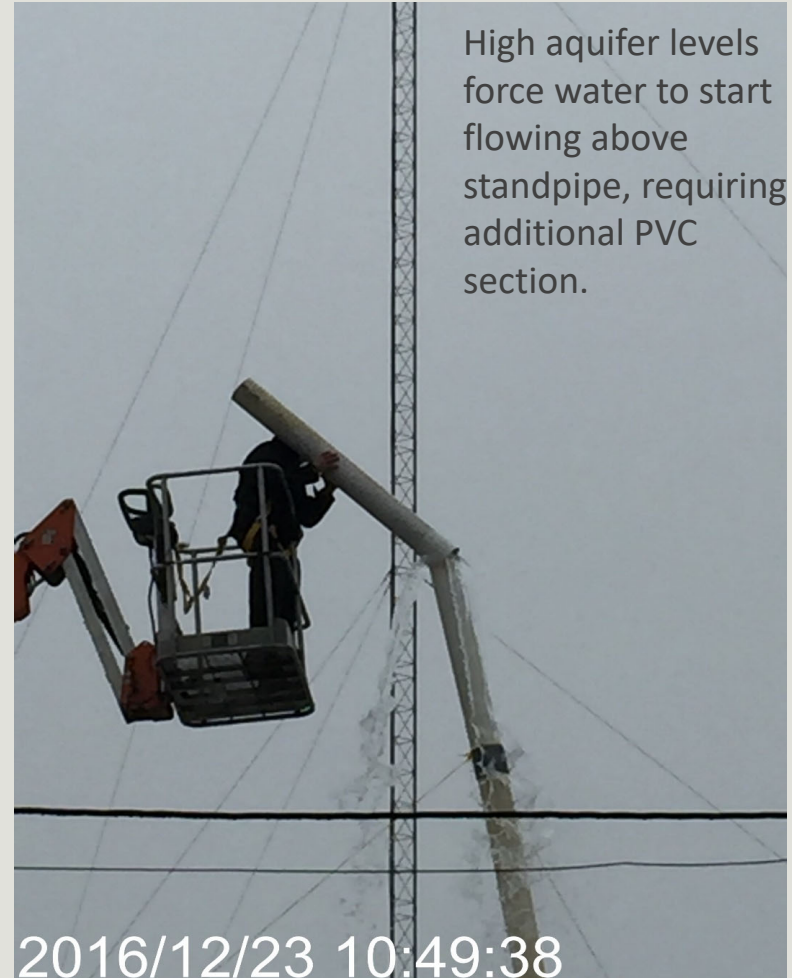
High aquifer levels  
force water to start  
flowing above  
standpipe, requiring  
additional PVC  
section.

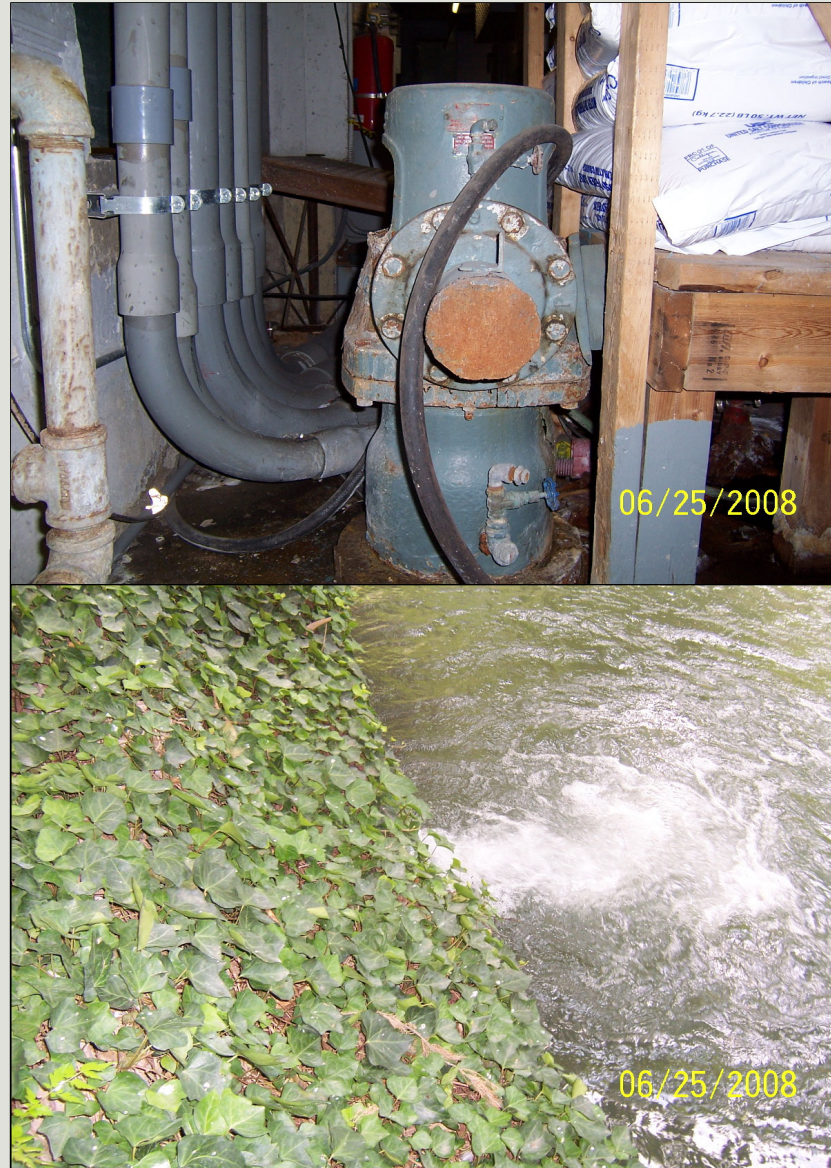
Abandoned well  
in basement of  
Downtown SA  
hospital  
flowing into  
San Antonio  
River
