## MEMORANDUM

DATE: December 28, 2023

SUBJECT: **ITEM M NET DISTURBANCE AND INCIDENTAL TAKE  
ASSESSMENT FOR 2023 EARIP ITP ANNUAL REPORT**

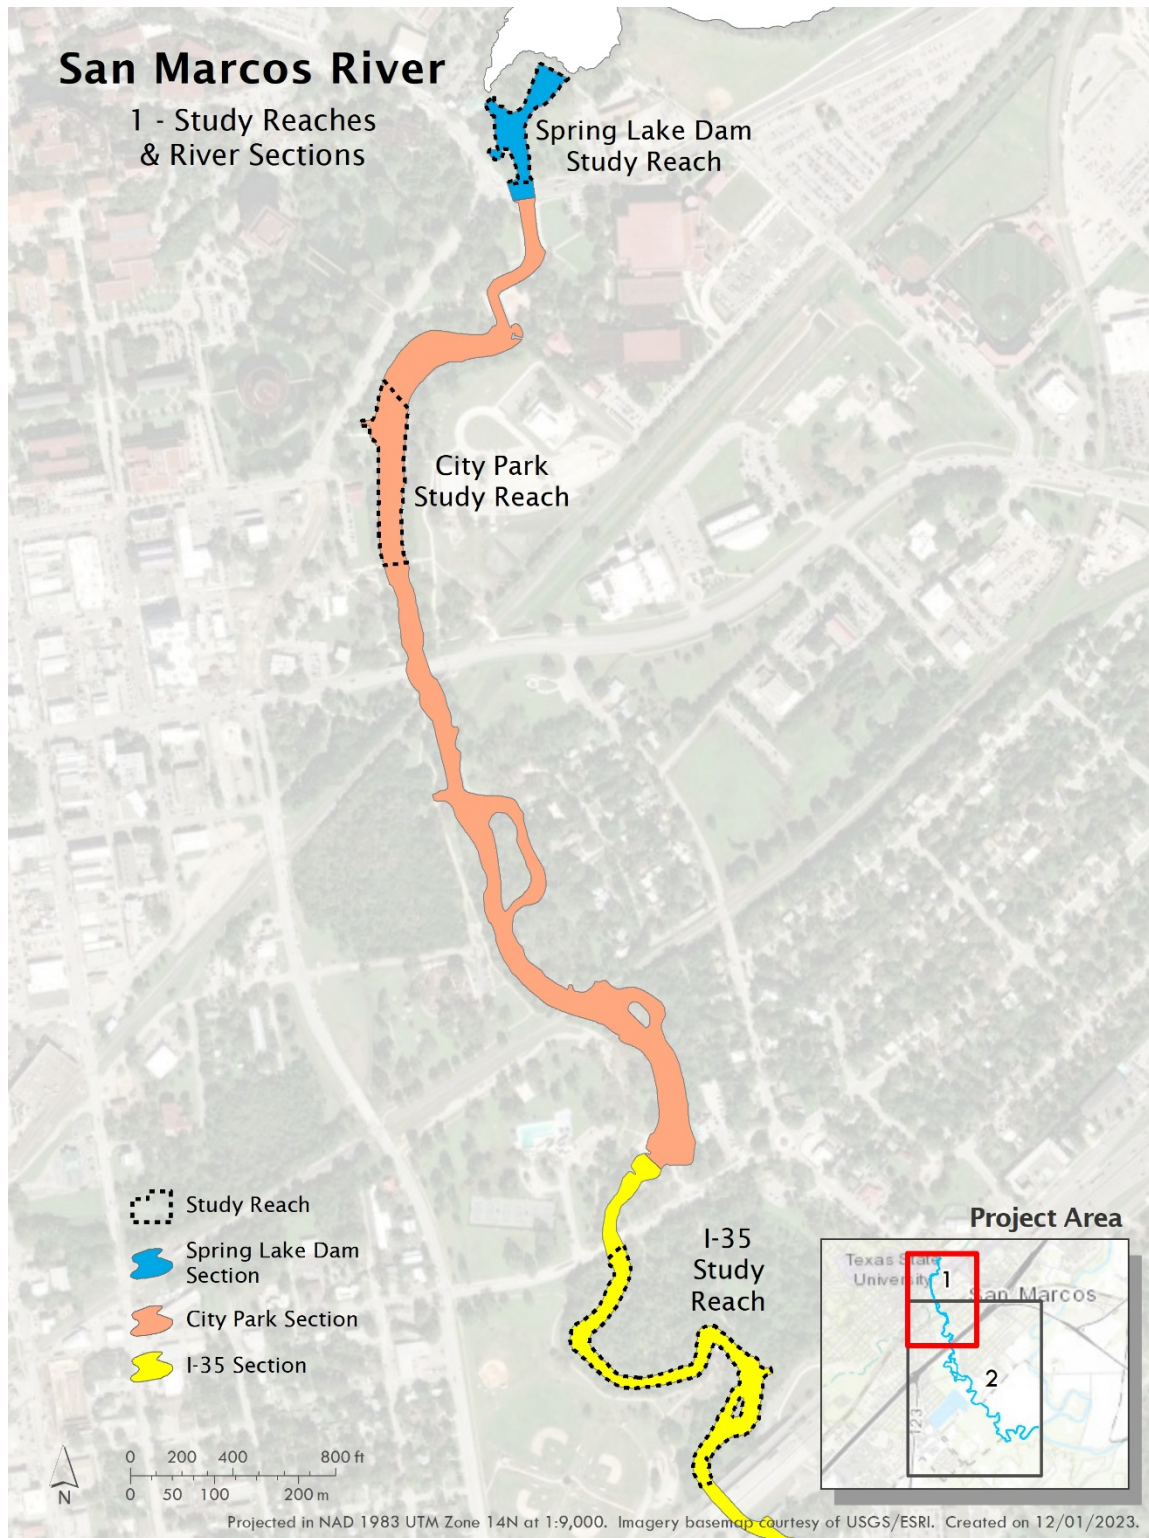
**Figure 8.** Study Reaches (3) for the San Marcos System and Corresponding River Section.

A wealth of aquatic vegetation data over time is available per the long-term biological monitoring that has been conducted by EAA since 2000. The health and abundance of the Fountain Darter is strongly tied to the quantity and quality of aquatic vegetation present in both the San Marcos and Comal systems. As such, the determination was made to use the current aquatic vegetation data to characterize and quantify the amount of impacted habitat that occurred in 2023 relative to HCP measures and drought. Spring and fall sampling efforts for aquatic vegetation have been conducted in seven sample reaches (4 in Comal and 3 in San Marcos) since 2002. The sample reaches for the Comal System are shown in Figure 7 and include the Upper Spring Run sample reach, Landa Lake sample reach, New Channel sample reach, and Old Channel sample reach. The sample reaches for the San Marcos system are shown in Figure 8 and include the Spring Lake Dam sample reach, City Park sample reach, and the I35 sample reach. For both systems (Figures 8 and 8), the corresponding river section that corresponds to each sample reach is also shown.

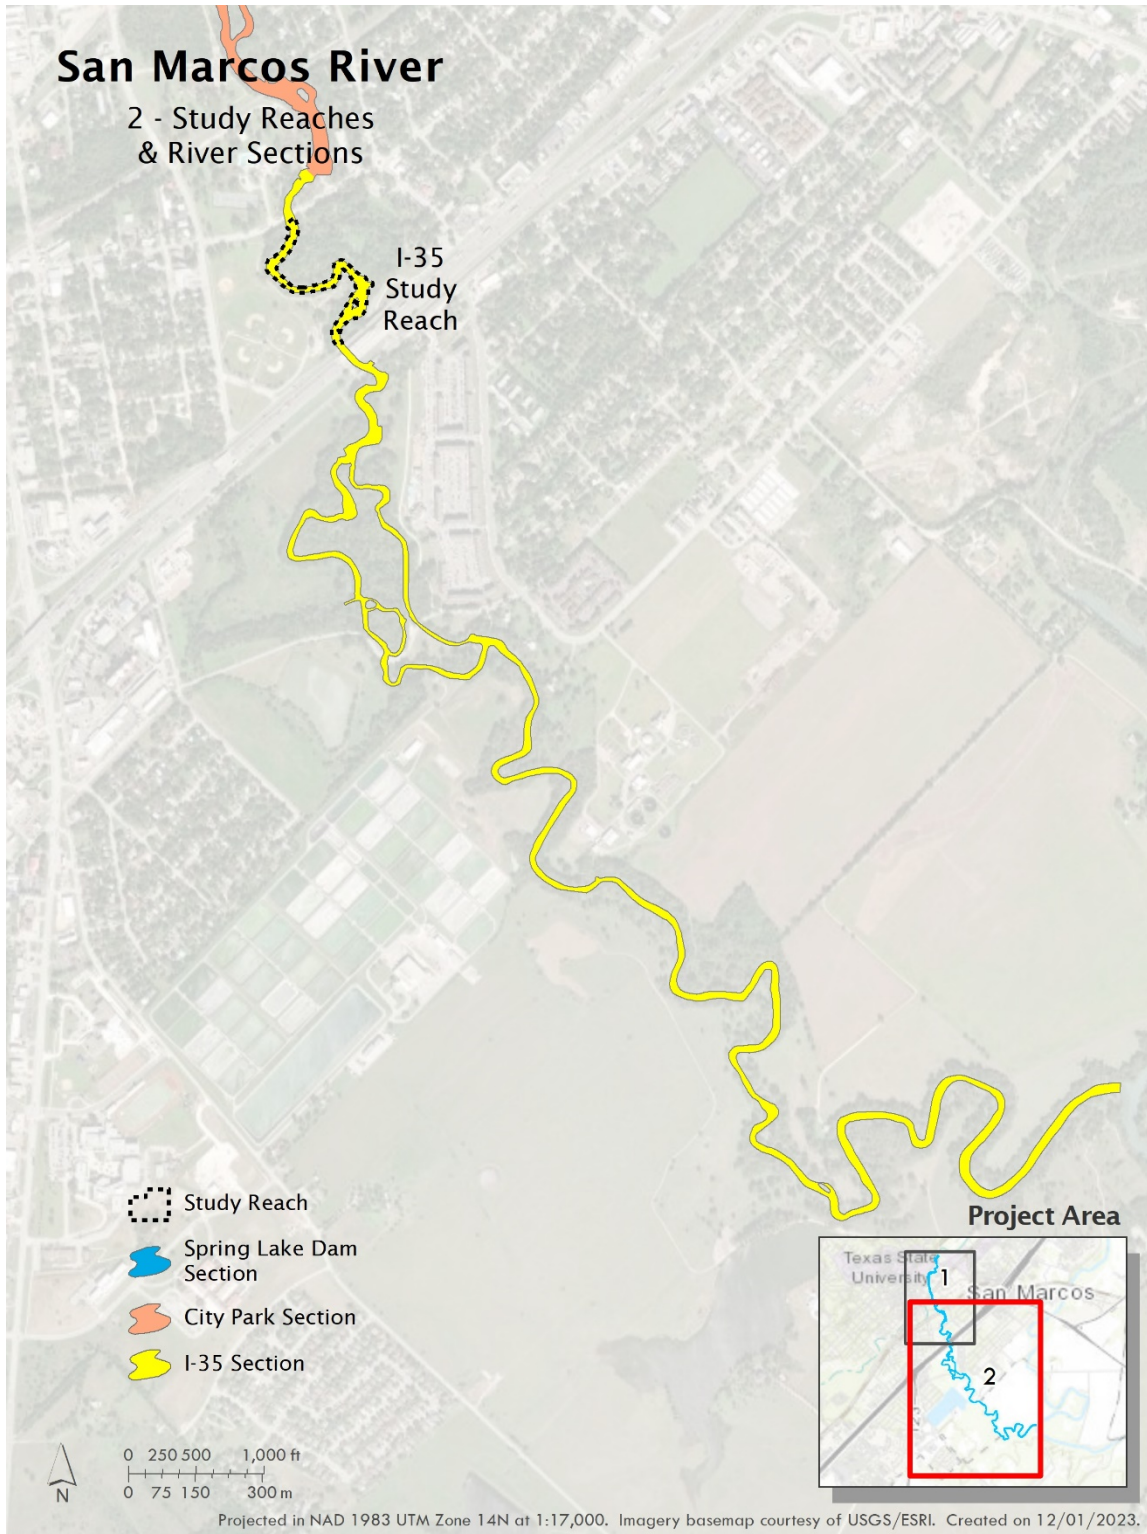
**Figure 8 cont.** I35 Study Reach and Corresponding Lower River Section in the San Marcos System.
