Appendix H | 2024 City of New Braunfels Reports

Appendix H2 | Native Aquatic Vegetation Restoration in the Comal River System

SUBJECT: City of New Braunfels Aquatic Vegetation Restoration

LANDA PARK GOLF COURSE ROAD PARKING AREA AND BIOFILTRATION SYSTEM

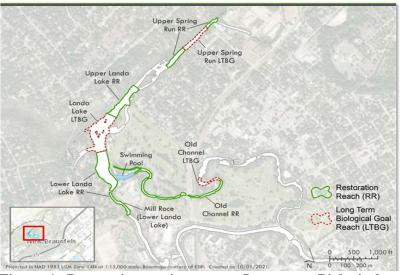
Figure 1. Restoration project areas. Long-term Biological Goal Reaches are in red. Restoration Reaches are outlined in green.

project include Landa Lake, Upper Spring Run and the Old Channel. Extents and boundaries of these sections are shown in **Figure 1**. Restoration activities occur in Longterm Biological Goal Reaches (LTBG) designated by the EAHCP biomonitoring program as well as supportive restoration reaches which provide further habitat enhancement objectives.

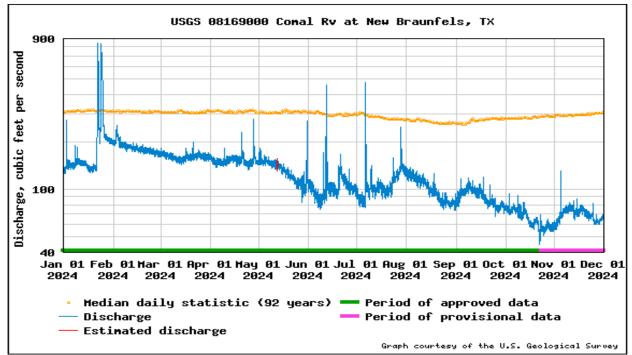
Figure 2. Discharge in the Comal River from January to December 2024 (USGS 2024).

unnecessary disturbance to Fountain Darter habitat during these sensitive time periods. Low flow conditions this year were observed in the Comal system from May 17 onward (**Figure 2**). During this time, any activities digging in or disturbing the substrate were excluded. This included utilizing Mobile Underwater Plant Propagation Trays (MUPPTs) to grow plants, moving or setting benthic barriers, large-scale vegetation removal and large-scale plantings. In general, the BIO-WEST team strives to limit any disturbance during low flows to as small of a footprint and impact as possible. For example, instead of using mature rooted plants grown in MUPPTs, BIO-WEST uses sprigging to accomplish planting. Sprigging is defined as inserting cut stems of plants into the soil by hand. With sprigging there is less disturbance to the sediment compared to digging holes for pot grown plants. Sprigged plants may not be as successful, but they allow for work to continue during times of low flow with minimized impact.

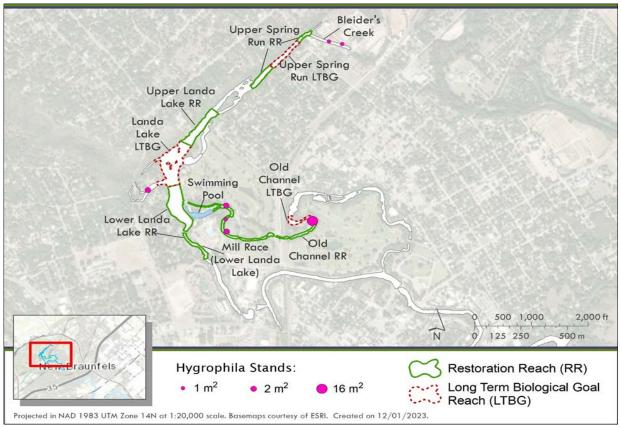
Figure 3. Locations of Hygrophila polysperma removed in the project area.

An additional part of regular activities includes continued surveys and removal of *Hygrophila polysperma* (Hygrophila). This submerged aquatic invasive plant was the only non-native aquatic plant present in the Comal system in large quantities at the beginning of EAHCP restoration activities. It was of major concern and accounted for nearly 60% of the aquatic plant coverage in the Old Channel, 3% of aquatic vegetation habitat in Landa Lake and 20% of aquatic vegetation coverage in the Upper Spring Run. In the years since, the team has succeeded in limiting this non-native plant in all project areas. This year approximately 24 m² of Hygrophila was removed from locations shown in **Figure 3**. Plant material was disposed of in an on-site city dumpster.

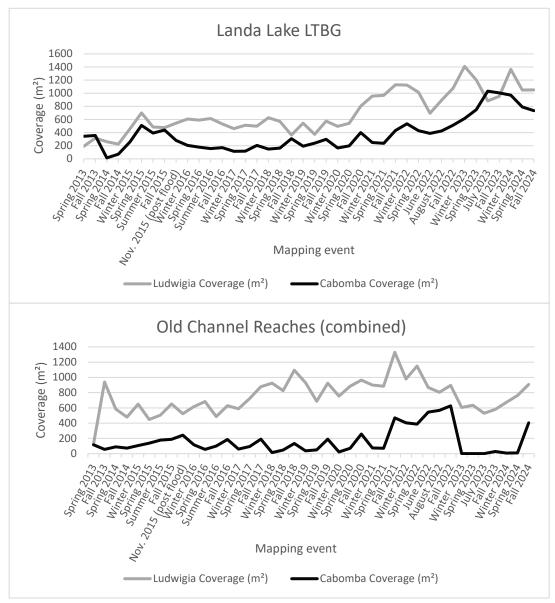
Figure 4. Eleven-year trend for Ludwigia and Cabomba coverage in Landa Lake LTBG Reach (top) and both Old Channel reaches (bottom).

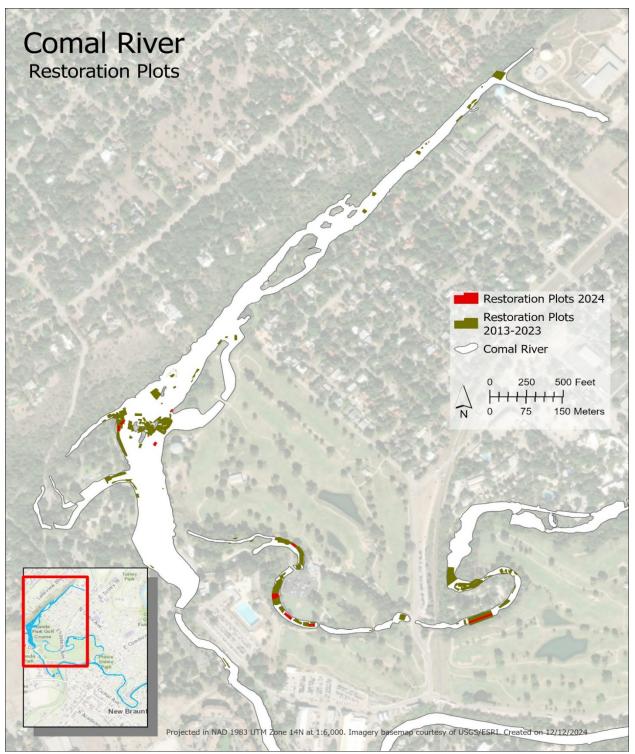
Figure A1. Locations of the 2024 planted restoration plots (red) in Landa Lake and the Old Channel project reaches.

In total, the team planted five restoration plots in Landa Lake covering 385 m² (Appendix A **Figure A-1**). Restoration plots were planted with a single species or mixed species depending on the site conditions. During 2024, the coverage of target species reached some of the highest levels that have been documented for Landa Lake since the implementation of the Biological Monitoring Program in 2001 (**Table 2**). Ludwigia exceeded the EAHCP goal of 900 m² in the Landa Lake LTBG reach and remained above that coverage level for the entirety of the year. The coverage of Cabomba also remained high in 2024 compared to previous restoration years. Unlike

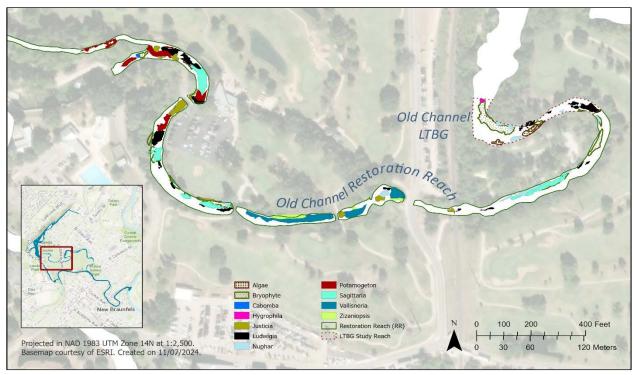
Figure A2. Distribution of aquatic vegetation during baseline 2024 mapping in the Old Channel reaches.

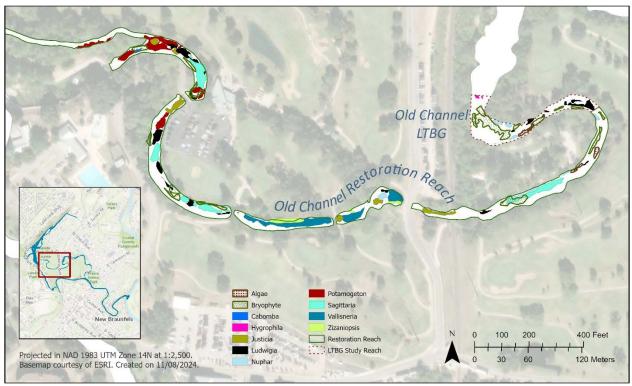
Figure A3. Distribution of aquatic vegetation during Spring 2024 in the Old Channel reaches.

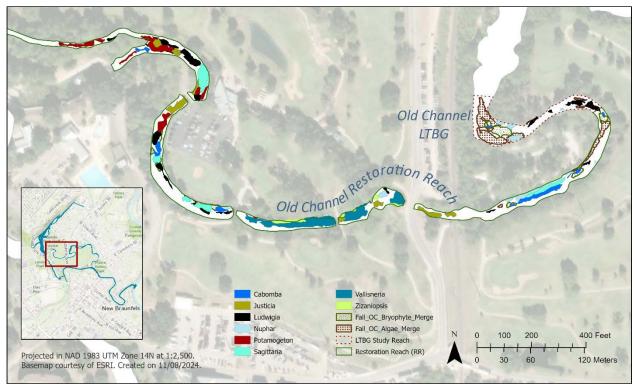
Figure A4. Distribution of aquatic vegetation during Fall 2024 in the Old Channel reaches.

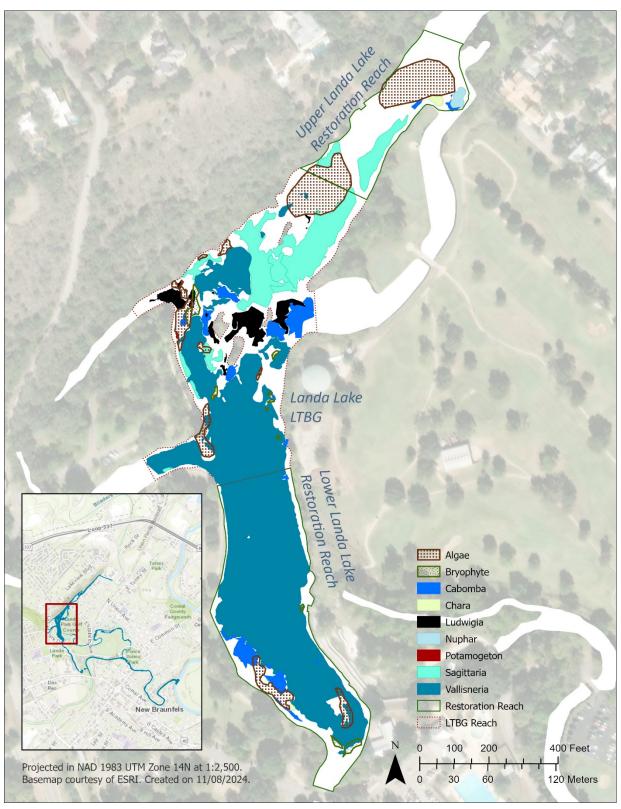
Figure A5. Distribution of aquatic vegetation during the baseline 2024 mapping in the Landa Lake reaches.

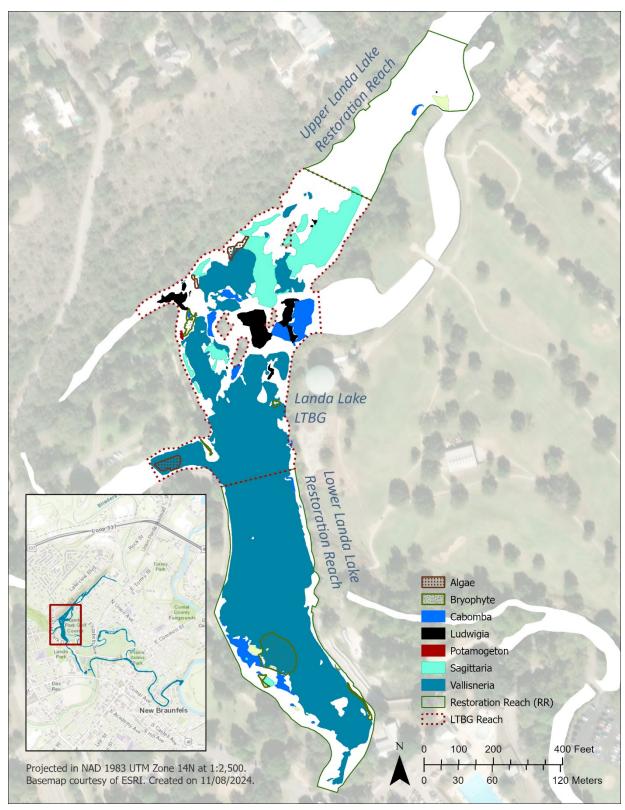
Figure A6. Distribution of aquatic vegetation during the Spring 2024 mapping in the Landa Lake reaches.

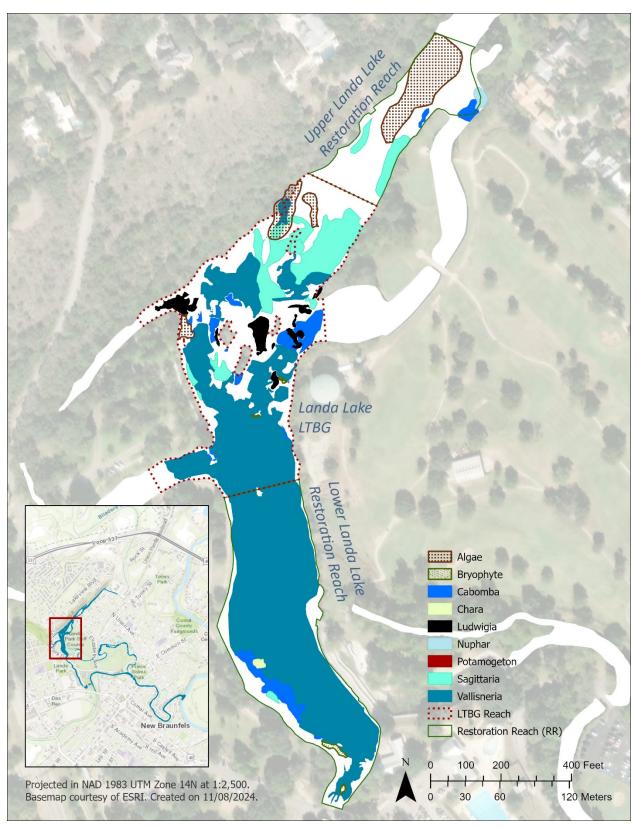
Figure A7. Distribution of aquatic vegetation during the Fall 2024 mapping in the Landa Lake reaches.

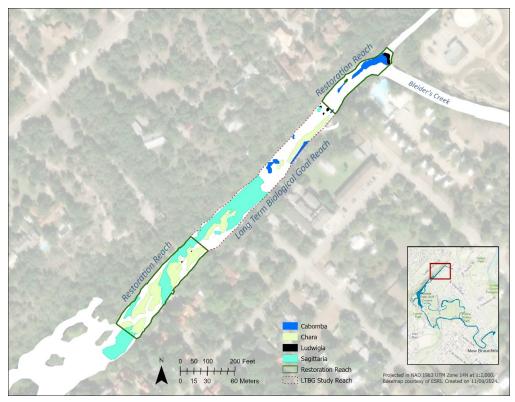
Figure A8. Distribution of aquatic vegetation during the baseline mapping in the Upper Spring Run reaches.

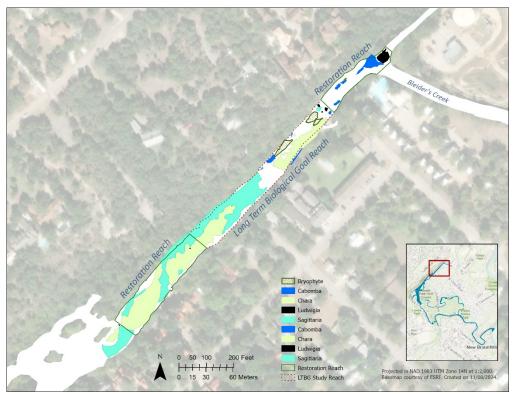
Figure A9. Distribution of aquatic vegetation during the Spring 2024 mapping in the Upper Spring Run reaches.

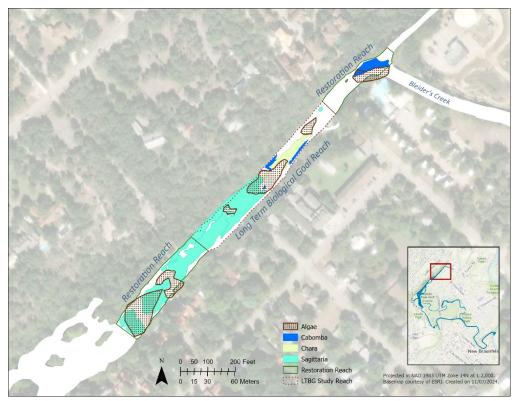
Figure A10. Distribution of aquatic vegetation during the Fall 2024 mapping in the Upper Spring Run reaches.

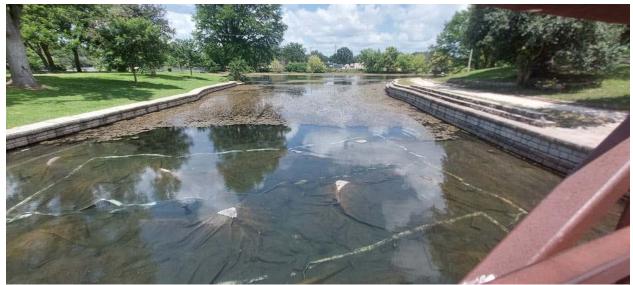
Figure B3. Spring Run 1looking into Landa Lake from pedestrian bridge with benthic barriers in place. Benthic barriers are being used to passively remove Vallisneria. June 17, 2024.

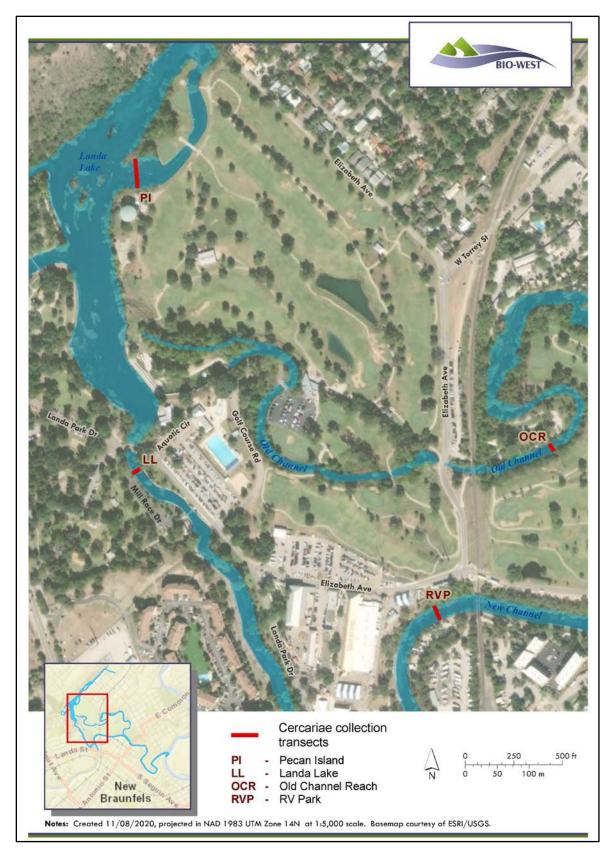
Figure 1. Map of cercariae collection transects in the Comal River system.

From 2014 through 2018, parasite cercariae monitoring was conducted three times per year (Winter, Spring, and Summer seasons) at three transects (Landa Lake [LL], Old Channel Reach [OCR], and RV Park [RVP]; **Figure 1**). In 2019, at the request of the City of New Braunfels and Edwards Aquifer Authority, monitoring efforts were decreased to one event per year, and a fourth sampling transect was added at Pecan Island (PI) due to concerns of potentially high parasite concentrations at this location (**Figure 1**). Since 2019, BIO-WEST biologists have conducted a single summer-season parasite monitoring event at these four transects in the Comal River system. In 2024, this data collection took place on September 5–6, and included quantification of cercariae densities for both *C. formosanus* and *H. pumilio* at each transect. These data were combined with previously collected data from 2014–2023 and the full dataset was analyzed with updated statistical techniques to examine the relationship between multiple predictor variables (discharge, year, season, and site) and parasite concentrations. Details of the methods utilized, a summary of the results and subsequent analyses, a discussion on the utility of this information, and recommendations for further research and monitoring are provided below.

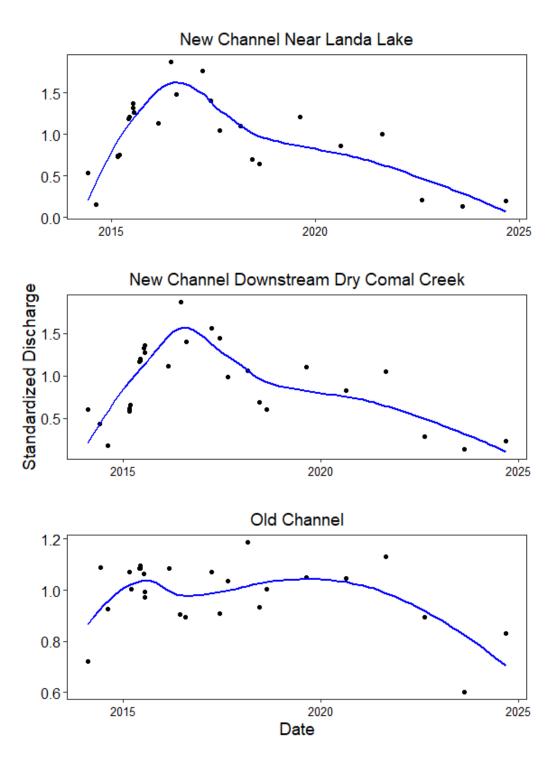
Figure 2. Times series displaying trends in standardized discharge during parasite monitoring at PI (top panel), LL (top panel), RVP (middle panel), and OCR (bottom panel). The blue line denotes LOESS smoothed regression fitted to observed standardized discharge values (black dots).

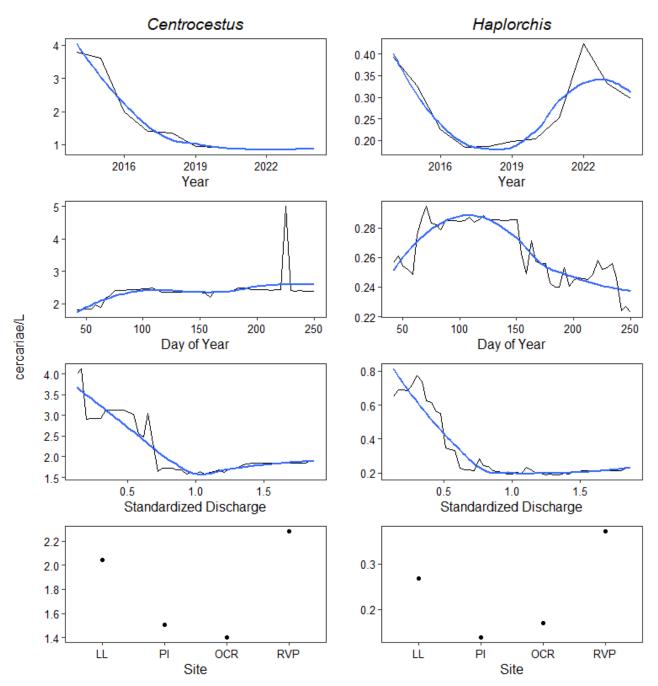
Figure 4. Partial dependence plots displaying variation of cercariae density as a function of year, day of year, standardized discharge, and site for *Centrocestus formosanus* and *Haplorchis pumilio* in the Comal Springs/River system. The blue line denotes a loess smoothed regression of the fitted function. Note differences in y-axis scales for each panel.

Random Forest Models were fit based on 516 observations in PI (n = 36), LL (n = 156), OCR (n = 162) and RVP (n = 162). Both models performed well with correlations between observed and predicted values \geq 0.69, though model correlation and percent variation explained were much higher for *C. formosanus* (0.92 and 84.8%, respectively) than *H. pumilio* (0.69 and 47.4%, respectively) (**Table 2**). Based on percent increase in MSE, standardized discharge (30.9%) was the most influential predictor of *C. formosanus* density, followed by site (26.4%), day of year (24.2%), and year (20.1%). Site (43.0%) and standardized discharge (38.6%) were more important for predicting *H. pumilio* density relative to year (25.5%) and day of year (17.2%) (**Figure 3**).

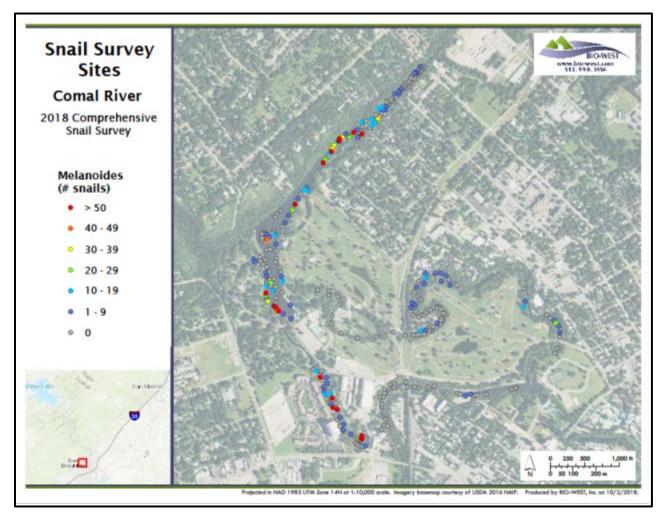
Figure 5. 2018 comprehensive survey of *M. tuberculata* in the Comal River.

Specific mechanisms driving recent declines in C. formosanus concentrations in the Comal Springs/River are currently unknown. In 2018, BIO-WEST collected data on snail distributional and density patterns of *M. tuberculata* throughout the study reaches, which showed large densities of snails upstream of the LL and RVP transects (Figure 5). However, M. tuberculata data have not been collected since 2018, and it is unclear if snail densities have changed. Collecting current data on snail distribution and density could help elucidate whether recent declines in C. formosanus concentration align with recent M. tuberculata population trends. In addition to snail distribution and density, changes in snail infection rates may be influencing C. formosanus concentrations. However, there is also a lack of data on temporal changes in snail infection rates in the Comal system. A previous study from the late 1990s found ~6% of M. tuberculata were shedding C. formosanus (Mitchell et al. 2000), yet it is unknown whether that percentage has changed through time. Lastly, there is a lack of data on definitive host (i.e., bird) infection rates or data on the number and intensity of infected fish in the system. Available information on fish infection rates is limited to manipulated experiments (McDonald et al. 2006; Huston et al. 2014; Scott 2019). Greater knowledge of all the different life history stages of C. formosanus would be required to develop a mechanistic understanding of the spatiotemporal patterns observed during this study.

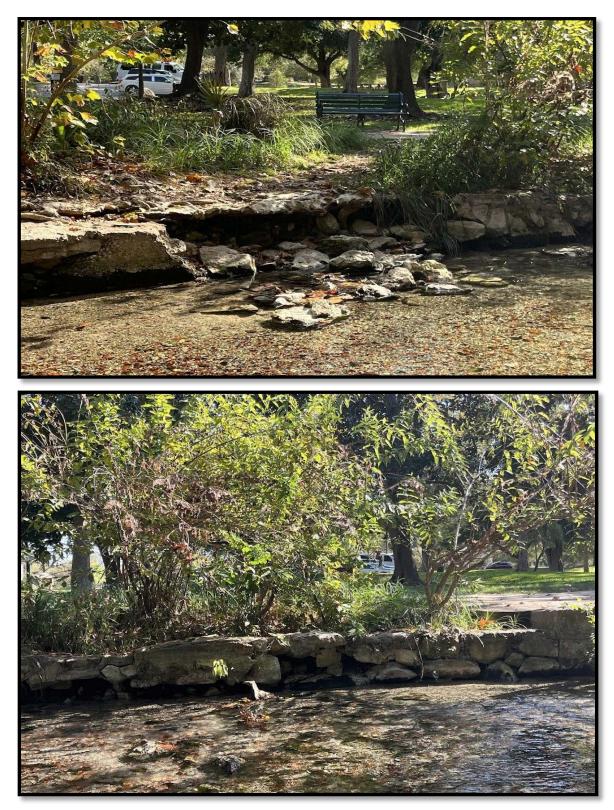
Figure 3. Low water levels have undermined several portions of the rock wall along Spring Run 3. Some areas of the wall have completely caved in undermining vegetation roots. Areas like this are susceptible to collapse and further erosion.

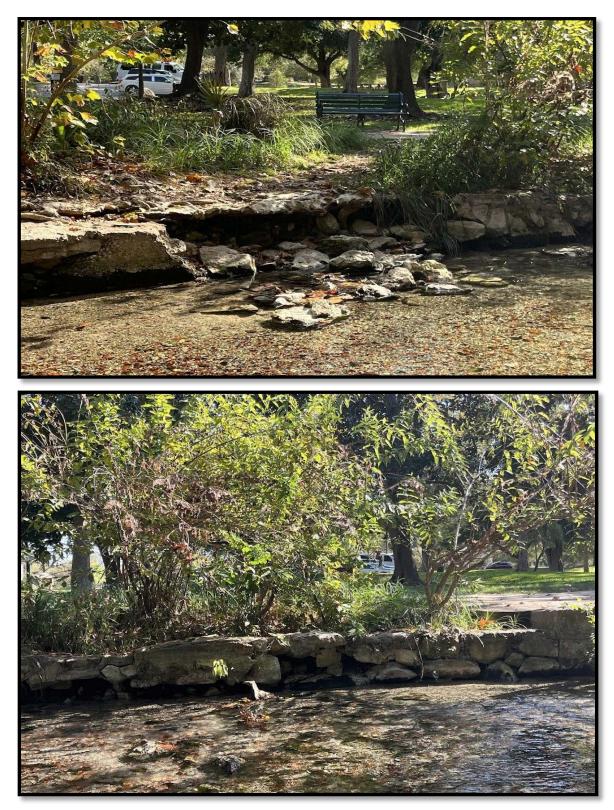
Figure 3. Low water levels have undermined several portions of the rock wall along Spring Run 3. Some areas of the wall have completely caved in undermining vegetation roots. Areas like this are susceptible to collapse and further erosion.

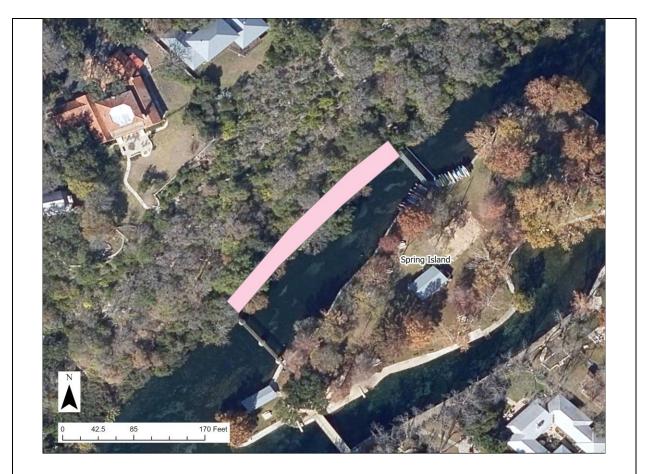
Figure 1. Location of 2024 riparian restoration along the banks of Landa Lake adjacent to the Spring Island which is owned by the Comal Country Water Recreation District #1. Restoration in these areas included removal of non-native vegetation and planting of native plants.

The primary riparian restoration activities conducted in 2024 include: 1) removal and control of non-native riparian vegetation along Landa Lake on Comal County Water Recreation District property near Spring Island and Hinman Island Park 2) planting of native vegetation in areas where non-native vegetation was previously treated/ removed, 3) establishment of erosion/ sediment control berms and, 4) maintenance of previously restored areas within the riparian zone of Landa Lake and the Old Channel for the Comal River. **Figure 1 and Figure 2** illustrate the areas where riparian restoration activities occurred for the first time in 2024.

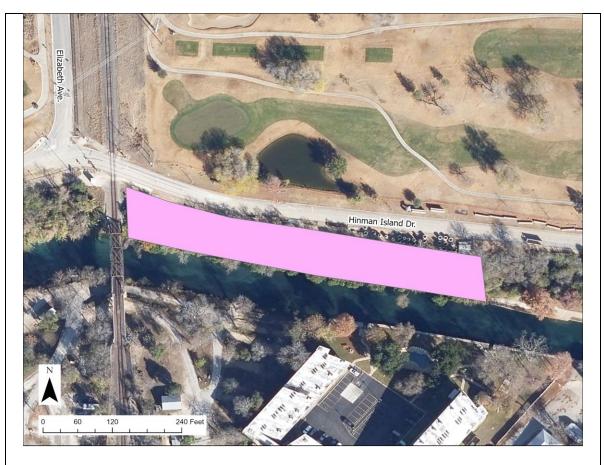
Figure 2. Location of 2024 riparian restoration in Hinman Island City Park along the Comal River. Restoration in this area to include removal of non-native vegetation, installation of erosion/ sediment control berms, and planting of native plants.

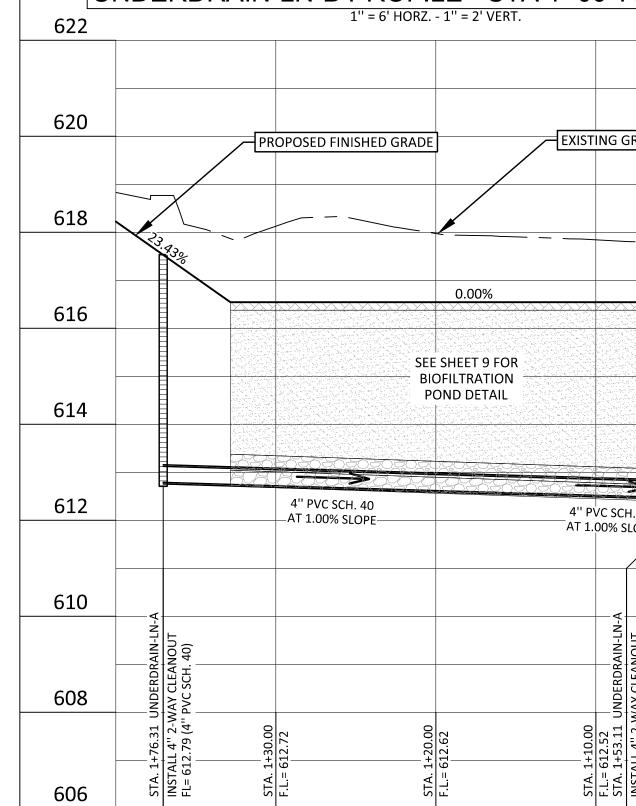
UNDERDRAIN-LN-B PROFILE - STA 1+00 TO STA 1+40	
1" = 6' HORZ 1" = 2' VERT.	UNDERDRAIN-LN-B THESE PLANS ARE RELEASED UNDER THE AUTHORITY OF
622 622 6	NUMBER LENGTH LINE DIRECTION START END JONATHAN CAREY, P.E., CFM TBPE# 131936, ON 12/20/24 STA 1+00.00 STA 1+13.00 TBPE# 131936, ON 12/20/24
	L11 13.00 N6° 01' 36.38"W X: 2243789.71 Y: 13807069.10 X: 2243788.35 Y: 13807082.03 FOR THE PURPOSES OF REVIEW AND ARE NOT TO BE USED FOR CONSTRUCTION
620 PROPOSED FINISHED GRADE EXISTING GROUND	20 L12 2.83 N51° 01' 36.38"W STA 1+13.00 X: 2243788.35 Y: 13807082.03 STA 1+15.83 X: 2243786.15 Y: 13807083.81 PRIOR TO APPROVAL BY ALL GOVERNING JURISDICTIONS
	L13 24.17 S83° 58' 23.62"W X: 2243786.15 X: 2243762.11
618 6	18

0.00%	DAVID A. CLARK
	16
SEE SHEET 9 FOR BIOFILTRATION	July 12/20/2024
614 POND DETAIL 6	14 DOUCET ENGINEERS TBPELS Firm No. F-3937
612 4" PVC SCH. 40 AT 1.00% SLOPE AT 1.00% SLOPE AT 1.00% SLOPE	
	60 6. F-3937 10194551
	10 10 10 10 10 10 10 10 10 10
9 00 Way CLEANOUT Way CLEANOUT Way CLEANOUT Way CLEANOUT Way CLEANOUT Way CLEANOUT	01 01 01 01 01 01 01 01 01 01
6 <u>NCC</u> <u>NONDERI</u> 800	
909 STA. 1+76.31 U INSTALL 4" 2-W FL= 612.79 (4" F.L= 612.72 (4" STA. 1+20.00 F.L= 612.62 F.L= 612.62 F.L= 612.47 (4" STA. 1+05.00 F.L= 612.47 (4"	ngineering Austin, TX www.dou TBPELS 5
1+40 1+00	
UNDERDRAIN-LN-C PROFILE - STA 1+00 TO STA 1+40	UNDERDRAIN-IN-C
	22 NUMBER LENGTH LINE DIRECTION START END END END
	$ \begin{array}{c c c c c c c c c c c c c c c c c c c $
	L21 13.00 S6° 01' 36.38"E X: 2243786.65 X: 2243788.01 Y: 13807078.84 Y: 13807065.91 J S L S L S L S L S L S L S L S L S L S
620 6	20 L22 2.83 S38° 58' 23.62"W X: 2243786.05 X: 2243786.23 X: 2243786.05 X: 2243788.01 Y: 13807078.84 Y: 13807065.91 X: 2243786.23 X: 2243786.23 X: 2243786.23 Y: 13807065.91

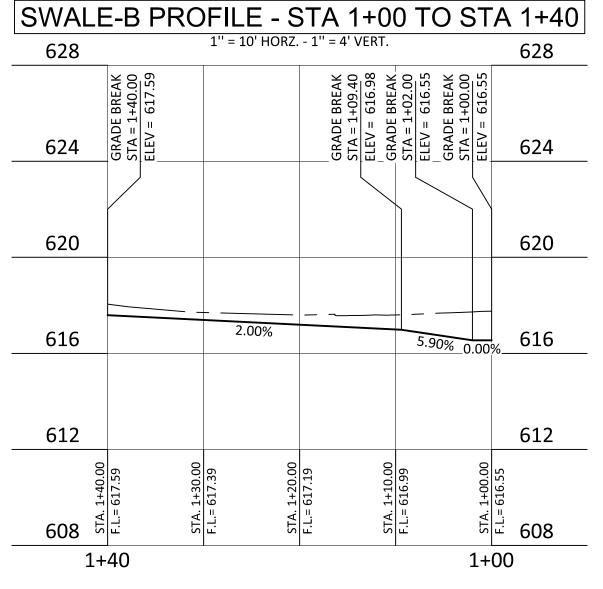
SWALE-B						
NUMBER	LENGTH	RADIUS	Line/Chord Direction START		END	
L201	9.40		S1° 49' 35.65"E	STA 1+00.00 X: 2243780.49 Y: 13807058.14	STA 1+09.40 X: 2243780.79 Y: 13807048.75	
C201	6.76	20.00	S7° 51' 17.09"W	STA 1+09.40 X: 2243780.79 Y: 13807048.75	STA 1+16.16 X: 2243779.87 Y: 13807042.09	
L202	23.84		S17° 32' 09.84"W	STA 1+16.16 X: 2243779.87 Y: 13807042.09	STA 1+40.00 X: 2243772.68 Y: 13807019.35
