Appendix I | **2024 COSM & Texas State University Reports**

Appendix I1 | **Aquatic Vegetation Restoration and Floating Vegetation Mat Management**

**Texas Wild-Rice Enhancement, Non-Native Aquatic Vegetation Removal and Floating Vegetation
Mat Mitigation in the Upper San Marcos River for Year 2024**

Prepared for:
City of San Marcos / Edwards Aquifer Habitat Conservation Plan

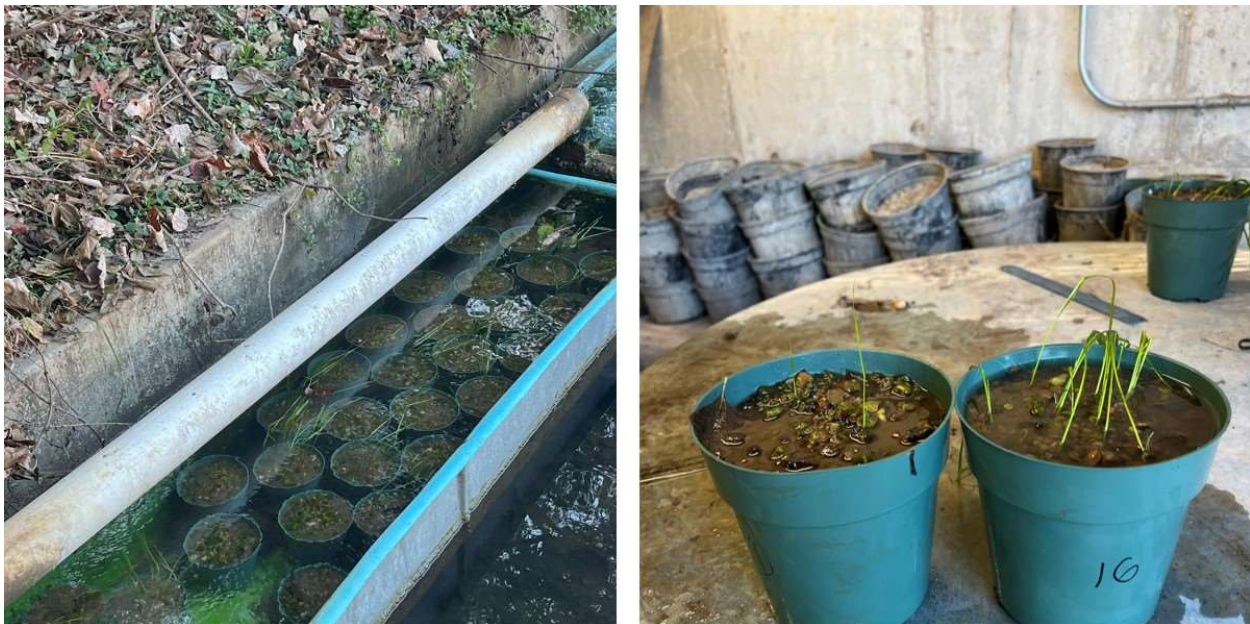
Figure 1. Texas wild-rice seed propagation trough and seedling growth in Texas State University raceways.

Texas wild-rice that was grown from seedlings is maintained in the outdoor, aquifer fed, raceways at the Freeman Aquatic Building (FAB) on the campus of Texas State University (Fig 1). Texas wild-rice expansion is continually observed in the river via both seed and tiller reproduction, with seedling growth occurring in freshly denuded areas. Care is taken to allow this expansion to take place naturally when non-native SAV is removed in those areas.

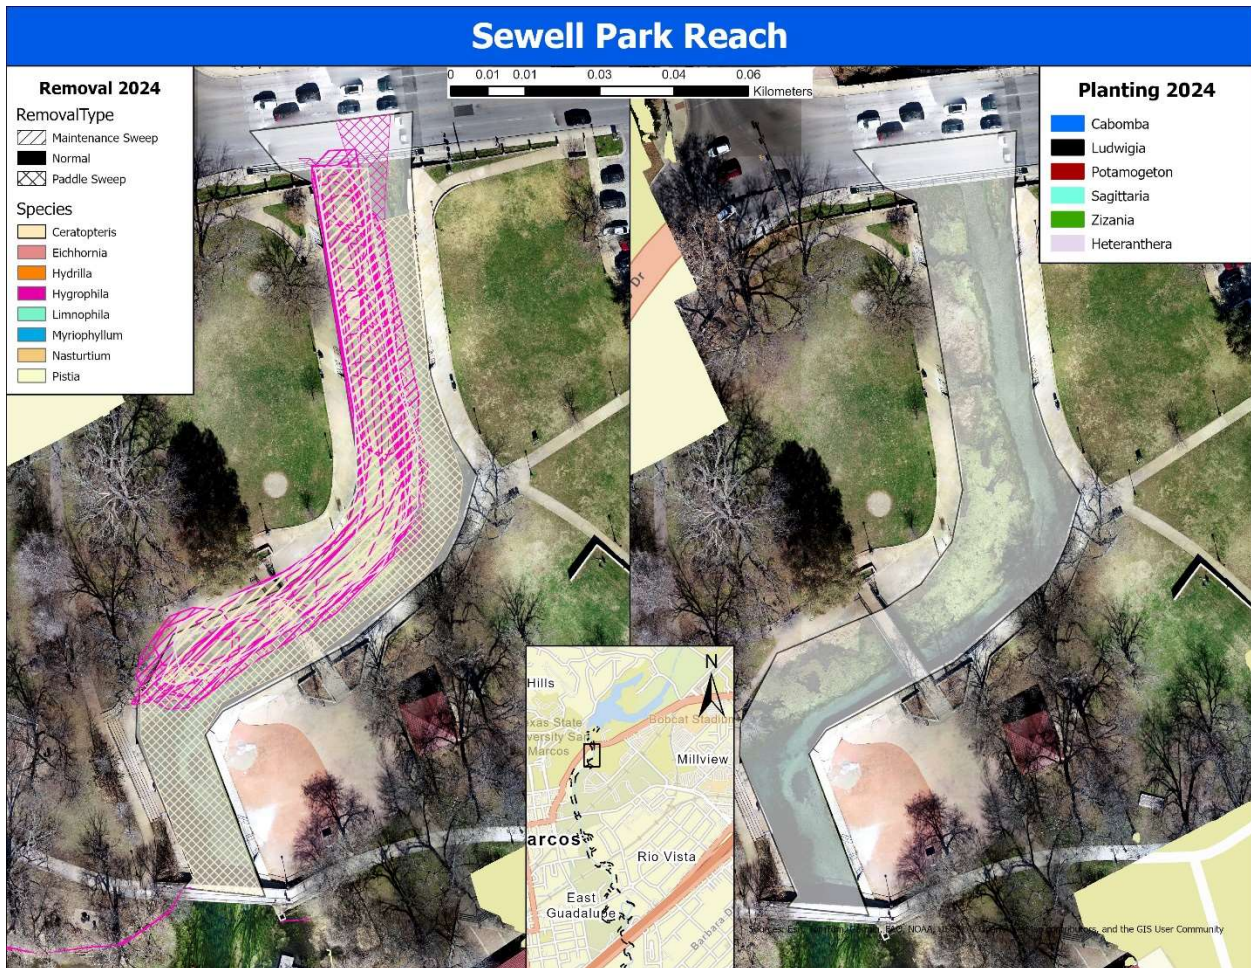
Figure 5. The location of non-native vegetation removal in Sewell Park Restoration reach in 2024. No planting occurred in 2024 for this reach.

The Sewell Park Restoration reach continued its designation as Maintenance Zone in 2024 which required occasional maintenance to remove non-native SAV within existing patches of native SAV. Maintenance effort resulted in the removal of **39.78 m²** of Ceratopteris, **36.7 m²** of Hygrophila, **0.99 m²** of Myriophyllum, **0.2 m²** of Hydrilla, and **0.08 m²** of Nasturtium (Fig 5). Persistent low-flow conditions experienced throughout 2024 caused native SAV within shallow areas to be overtaken by other semi-aquatic and terrestrial species. Non-native floating vegetation also expanded in areas where river levels declined and created extremely shallow or dewatered areas because of low-flow conditions. This is anticipated to continue to be problematic so long as source populations persist upstream. This reach will be designated as a maintenance zone in 2025 and will continue to receive routine maintenance and limited native, non-TWR SAV planting.

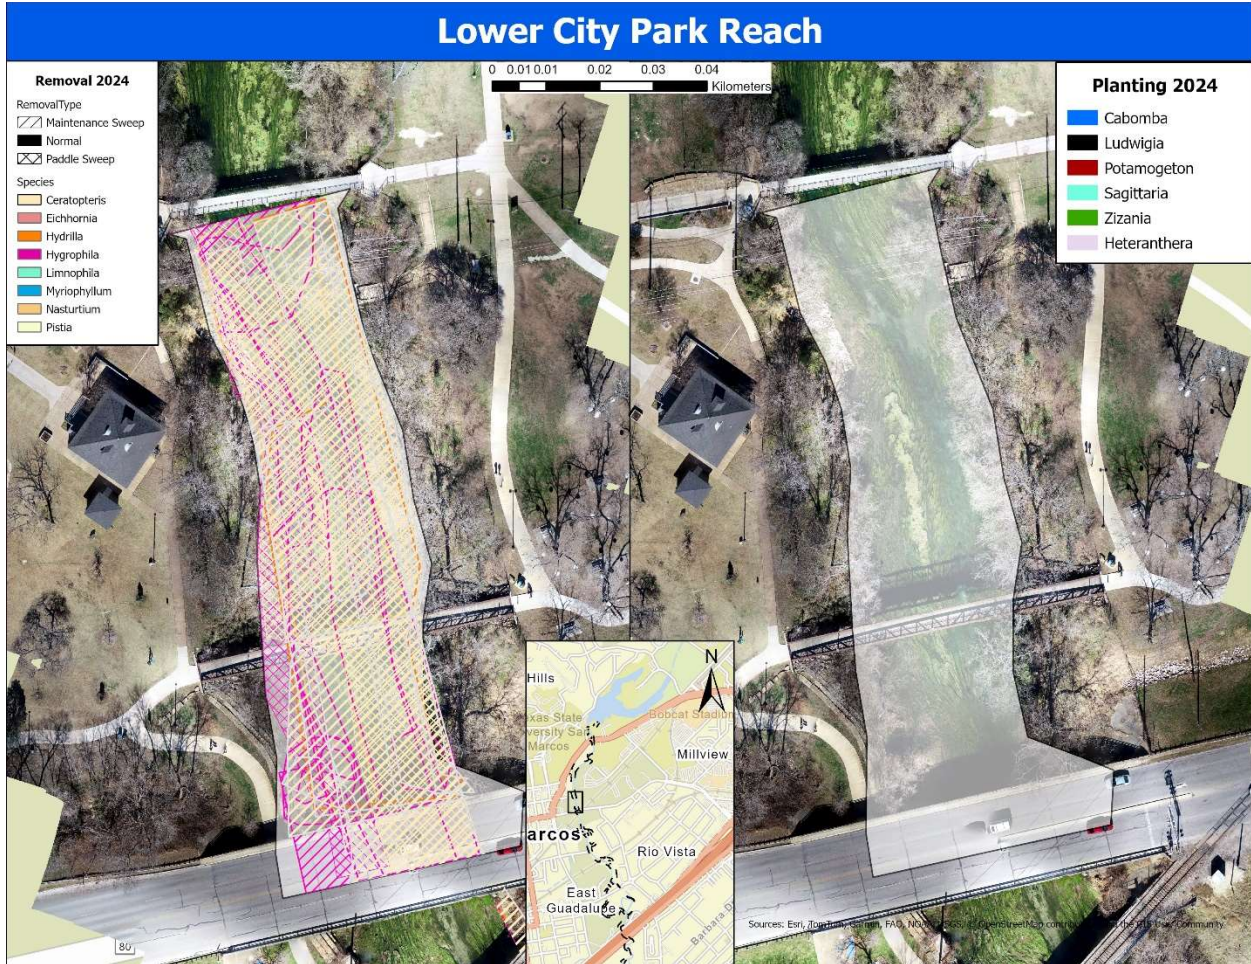
Figure 8. The location of non-native vegetation removal within the Lower City Park reach in 2024. No planting occurred in 2024 for this reach.

The Lower City Park reach is a non-designated reach that was a maintenance zone for 2024 which required occasional maintenance to remove non-native SAV within existing patches of native SAV. Maintenance effort resulted in the removal of **113.12 m²** of Ceratopteris, **62.42 m²** of Nasturtium, **57.97 m²** of Hygrophila, **2.65 m²** Hydrilla, and **0.51 m²** of Pistia (Fig 8). This reach will remain a maintenance zone in 2025.

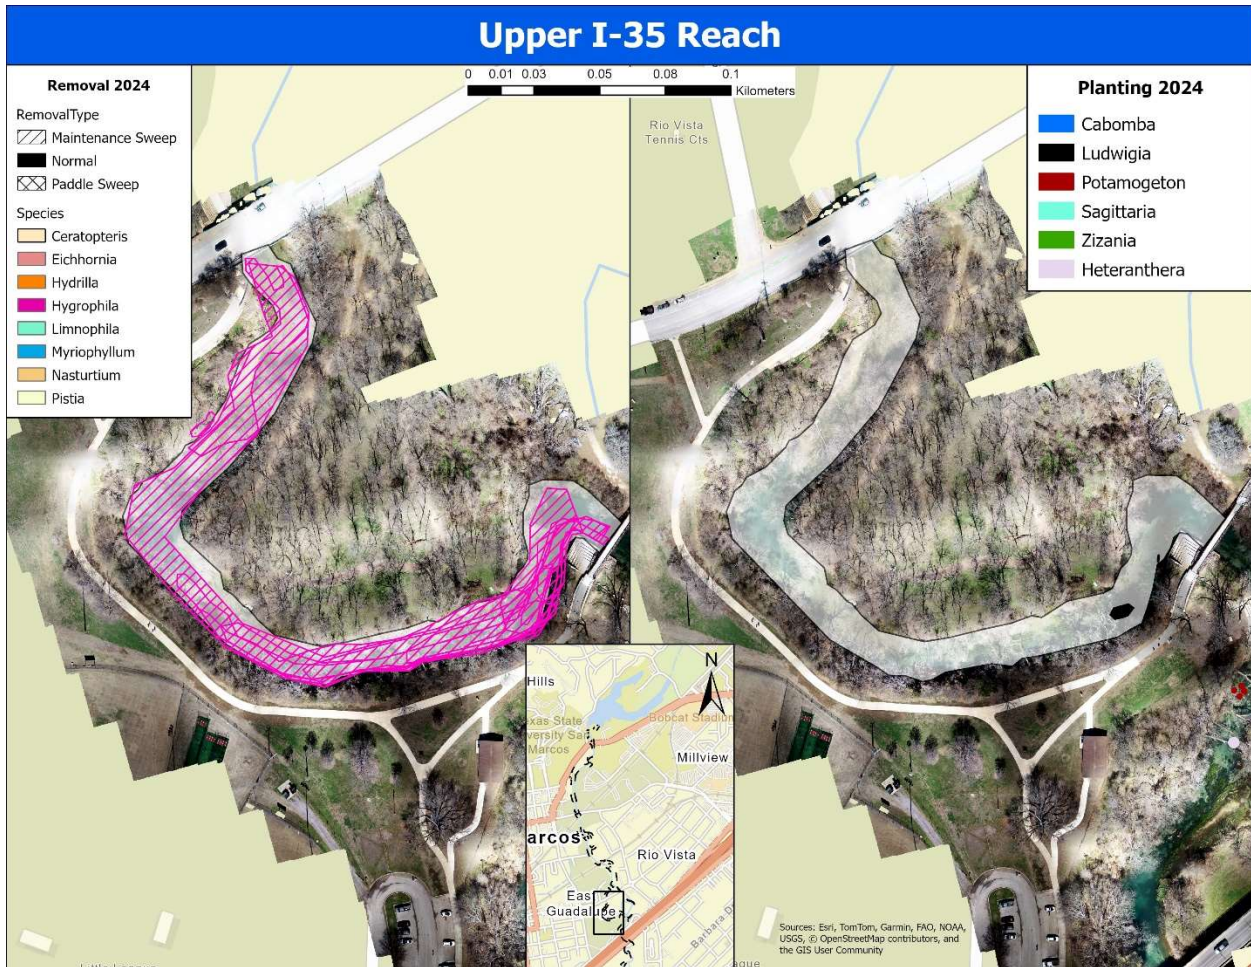
Figure 13. The location of non-native vegetation removal and native SAV planting within the Upper I-35 reach in 2024.

This reach was designated a work zone in 2024 which received some removal work to minimize regrowth and expansion of non-natives. A total of **85.1 m²** of Hygrophila, **2.43 m²** of Hydrilla, and **0.77 m²** of Nasturtium were removed by maintenance sweeps (Fig 13). Additionally, **288 individuals** of Ludwigia were planted. This reach was treated heavily for removal efforts early in the implementation of the EAHCP; thus, an effort was made to maintain progress. Native SAV was planted in previous years and continues to occupy suitable habitat in this reach, suggesting successful restoration of the native SAV community.

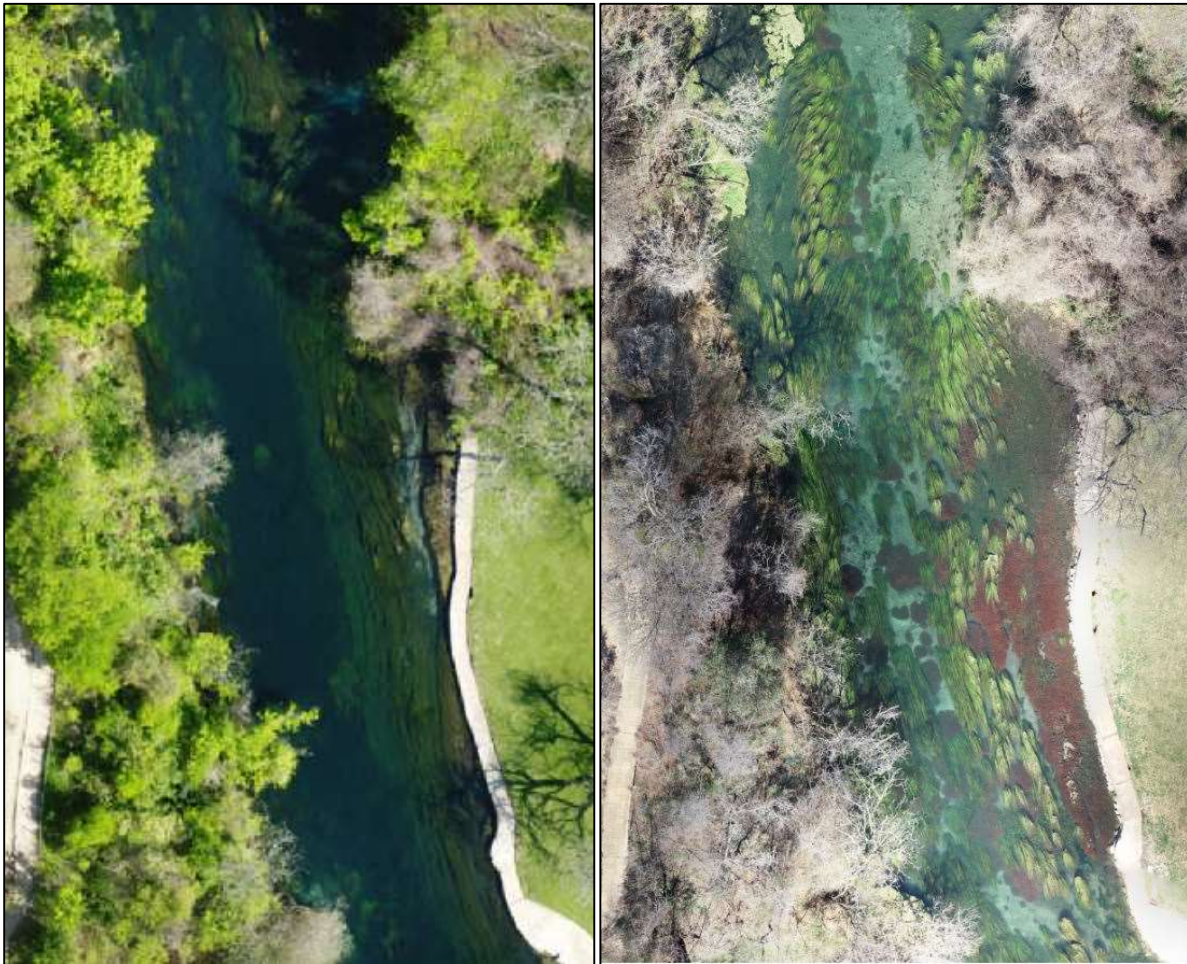
Figure 16. Hopkins Street to Snake Island restoration reach removal and planting progress in early 2023. Before treatment (left, 2020) and progress of native SAV expansion 2 years after treatment and initial planting (right, Jan 2023). This reach provides an example of restoration efforts that focus on obtaining a diverse composition of SAV species and coverage that have continued to expand downstream throughout 2024.

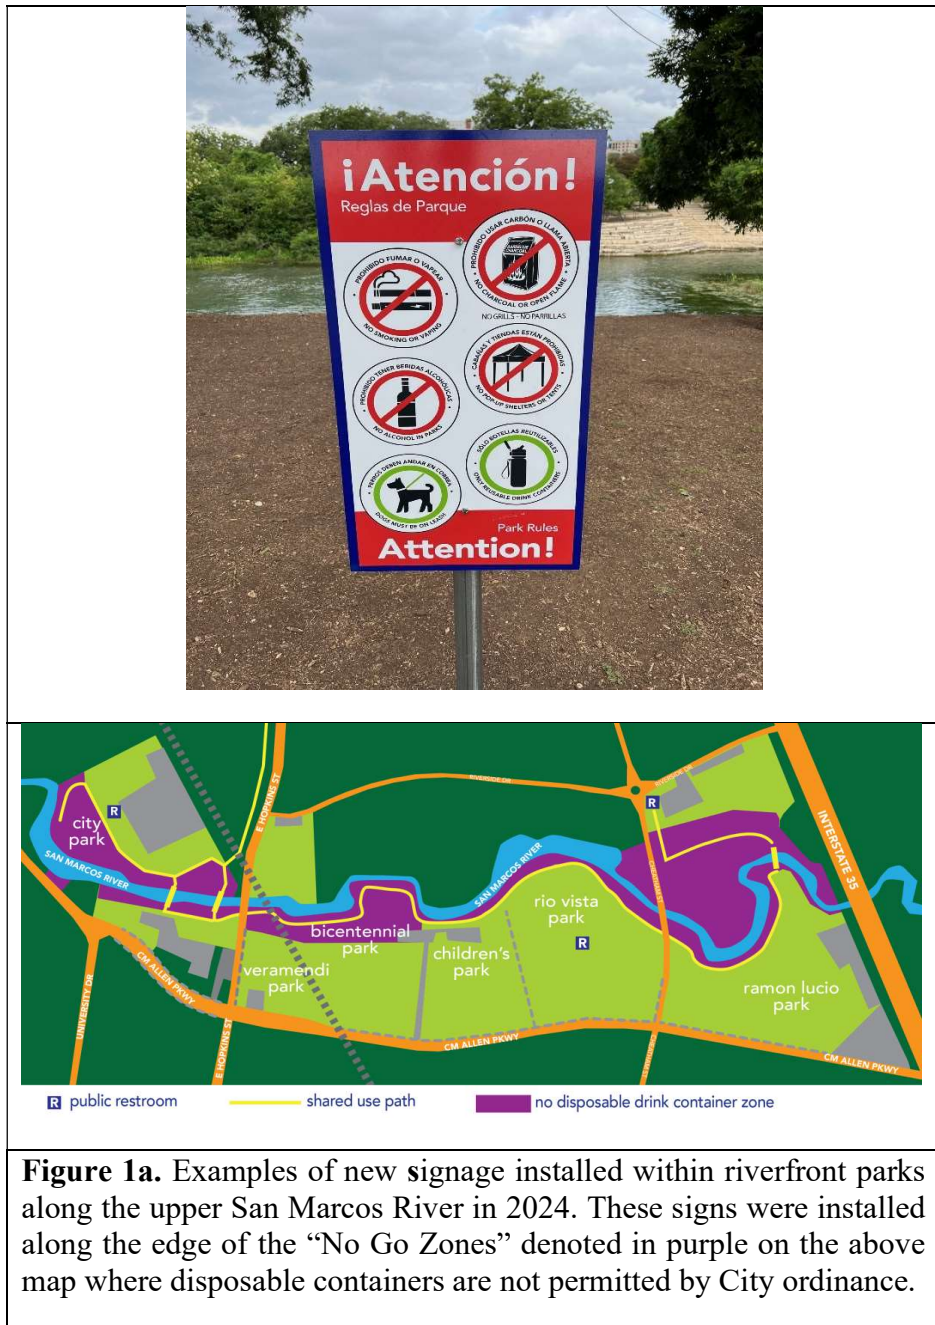
Figure 1a. Examples of new signage installed within riverfront parks along the upper San Marcos River in 2024. These signs were installed along the edge of the “No Go Zones” denoted in purple on the above map where disposable containers are not permitted by City ordinance.

signage at multiple locations within City riverfront parks to educate visitors of park rules and regulations (**Figure 1a**). The signage helps to inform river and park visitors of the EAHCP, threatened/ endangered species, general park regulations and environmental protection initiatives. **Figure 1b** shows examples of existing signage located within CoSM and TXST riverfront parks. **Figure 1c** shows examples of new signage installed in 2023 within CoSM riverfront parks and remained in place through 2024.

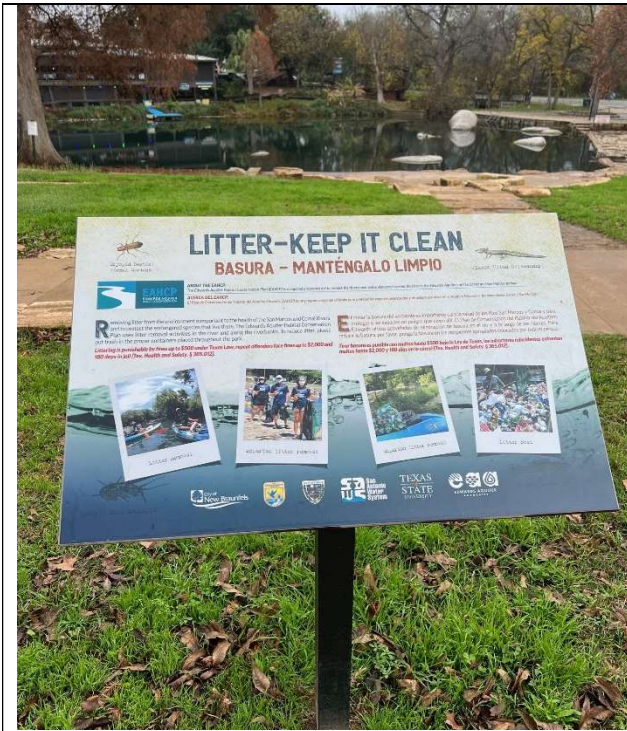
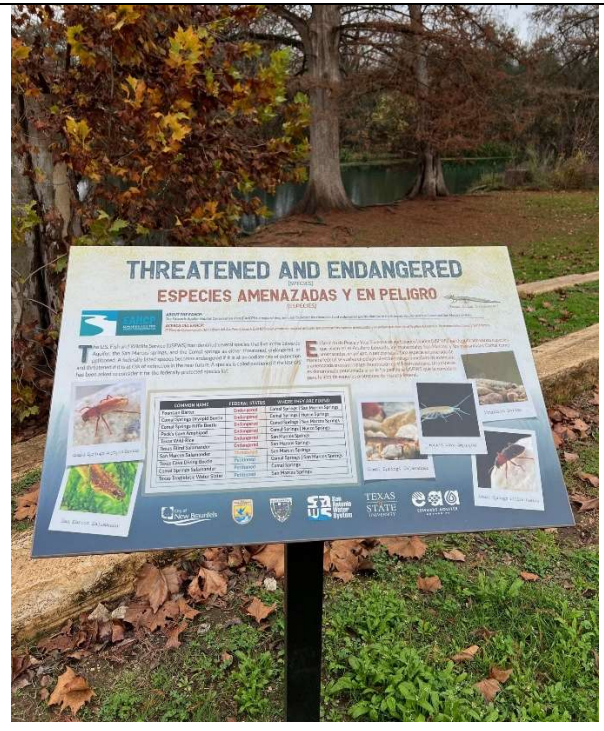
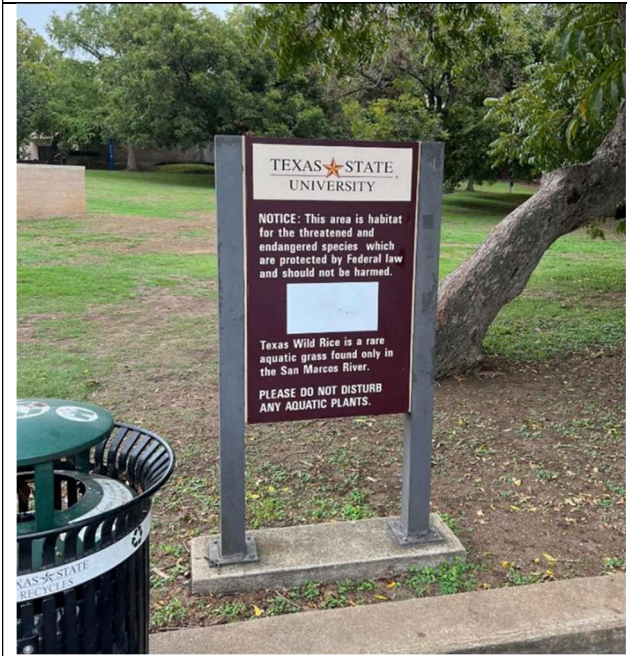
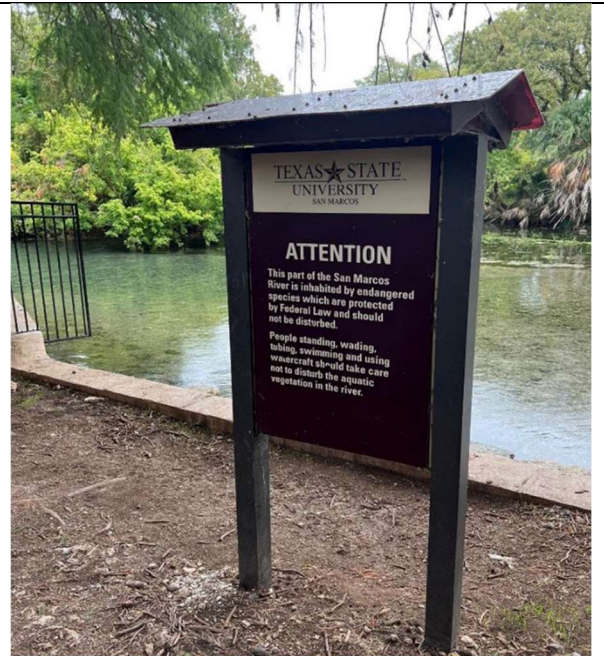
Figure 1b. Examples of existing signage installed within riverfront parks along the upper San Marcos River. The top two signs are located in CoSM’s Rio Vista Park and the bottom two signs are located in TXSTs Sewell and Upper Sewell Parks. The TXST signs will be replaced with new signage in early 2025.

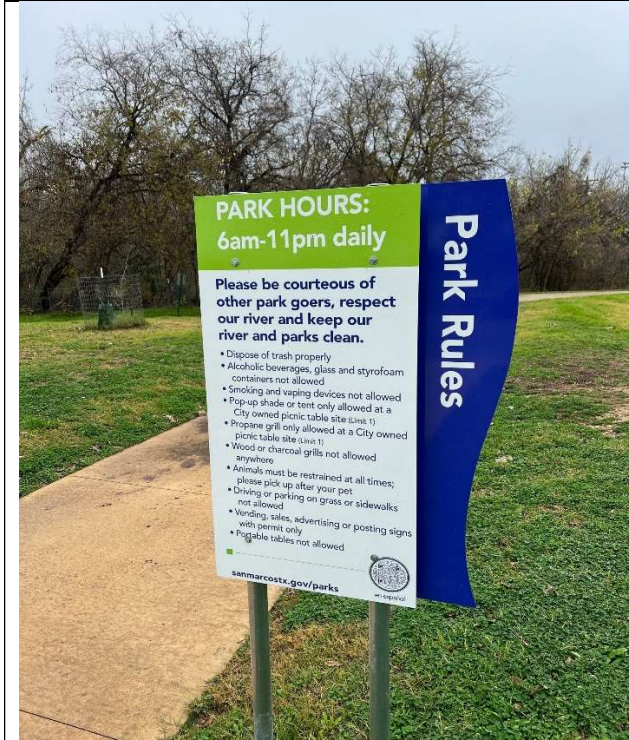
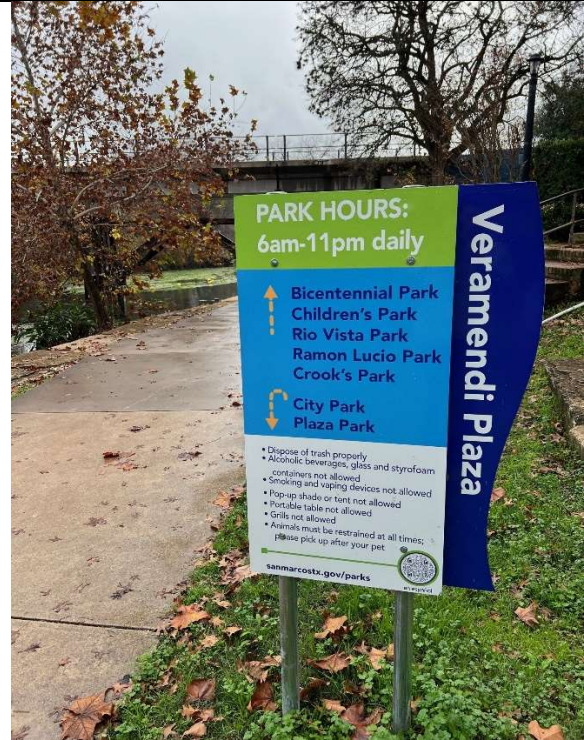
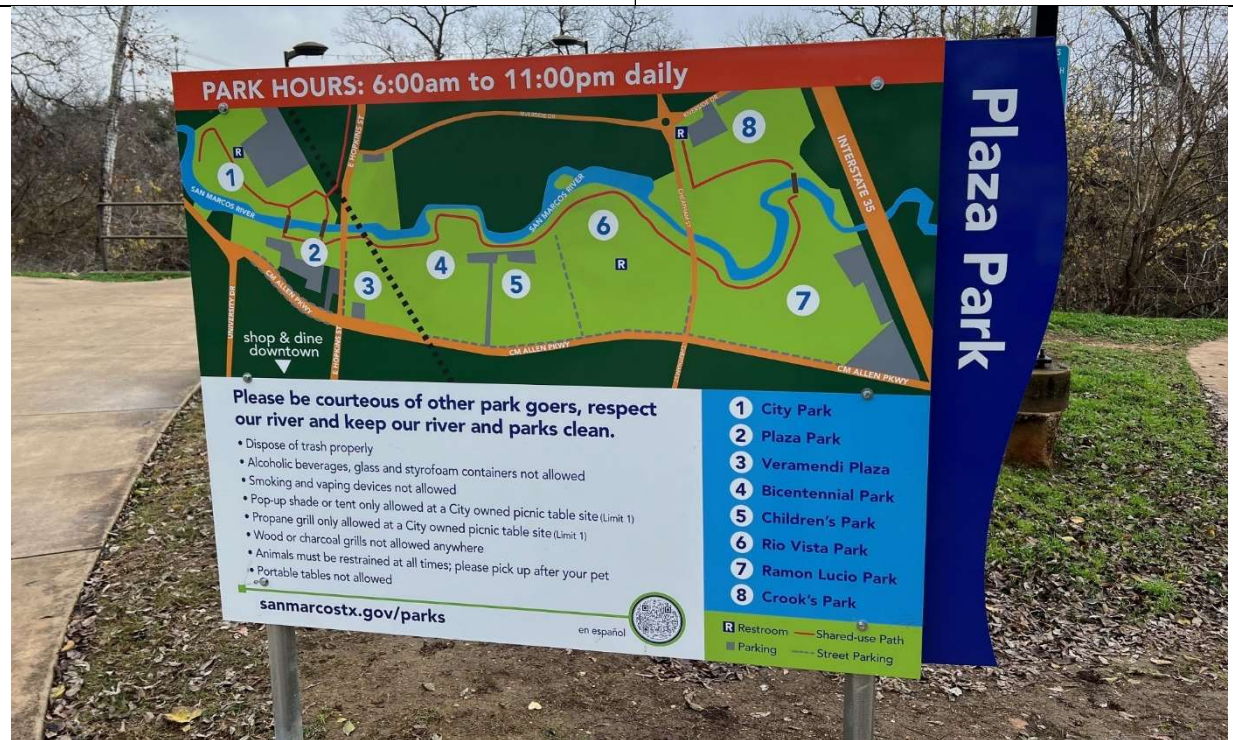
Figure 1c. Example of signage that remained in place in CoSM riverfront parks along the upper San Marcos River throughout 2024.

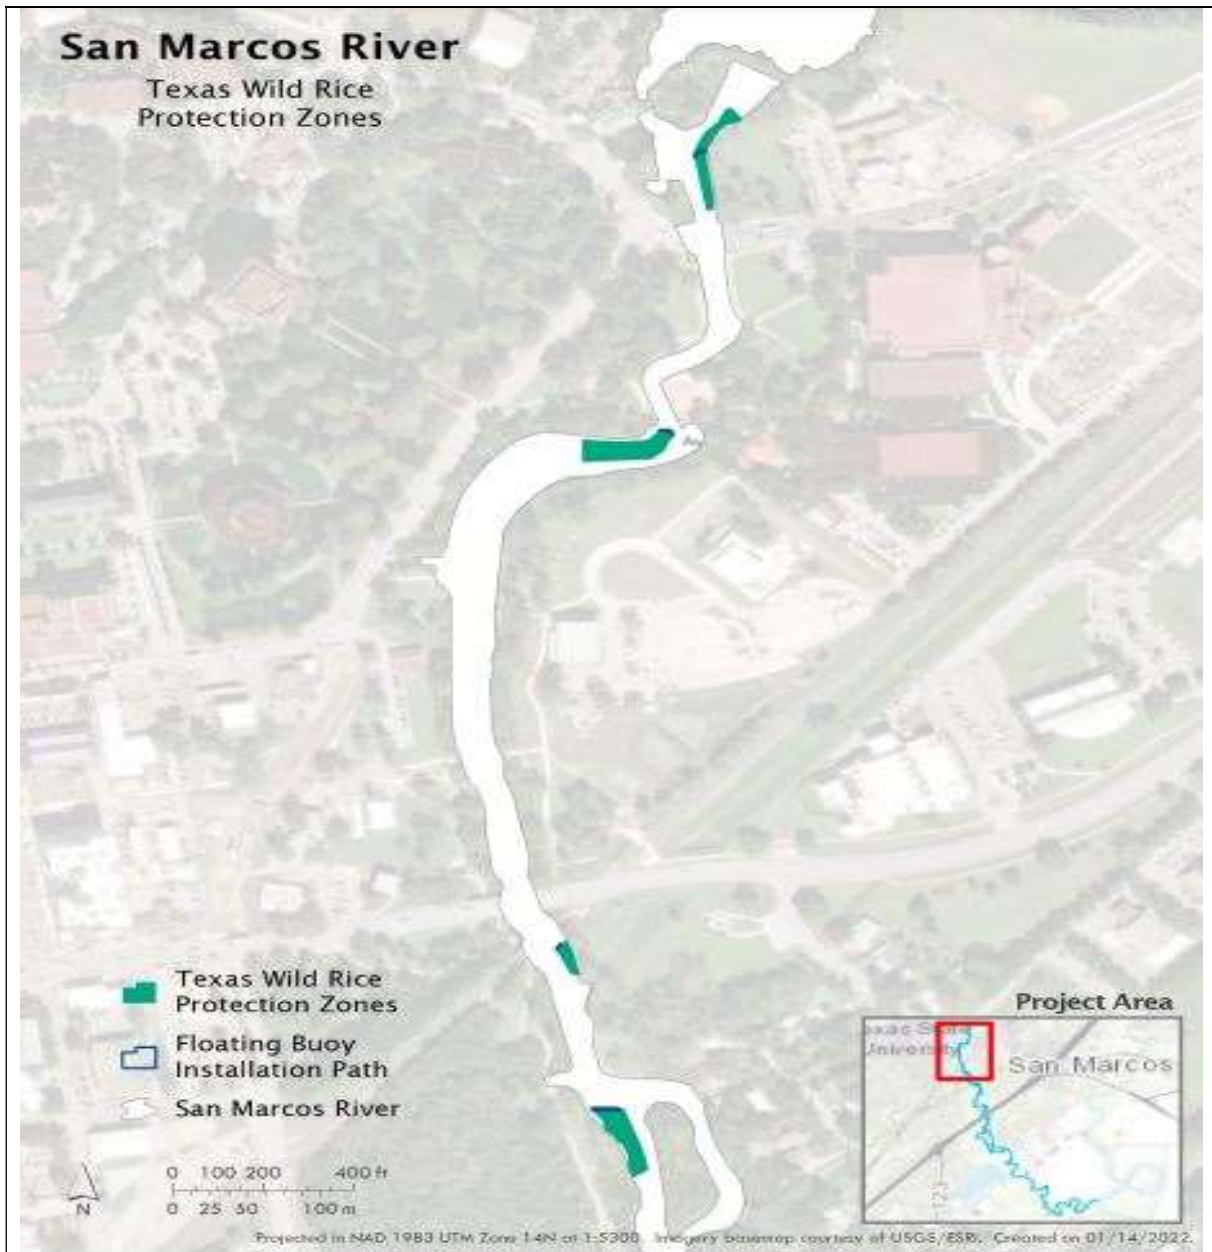
Figure 2. Map showing the location of TWR protection zones in the San Marcos River.

San Marcos River flow remained below 120 cfs for the duration of 2024. As such, TWR exclosures, buoys and signage established to protect TWR stands and sensitive habitat during low-flow periods remained in place throughout the entire year. **Figure 2** shows the location of the TWR protection zones and **Figure 3** shows examples of the installed protection zones. The Conservation Crew routinely monitored and maintained the exclosures throughout 2024. The exclosures will remain in place until river flow increases above 120cfs.

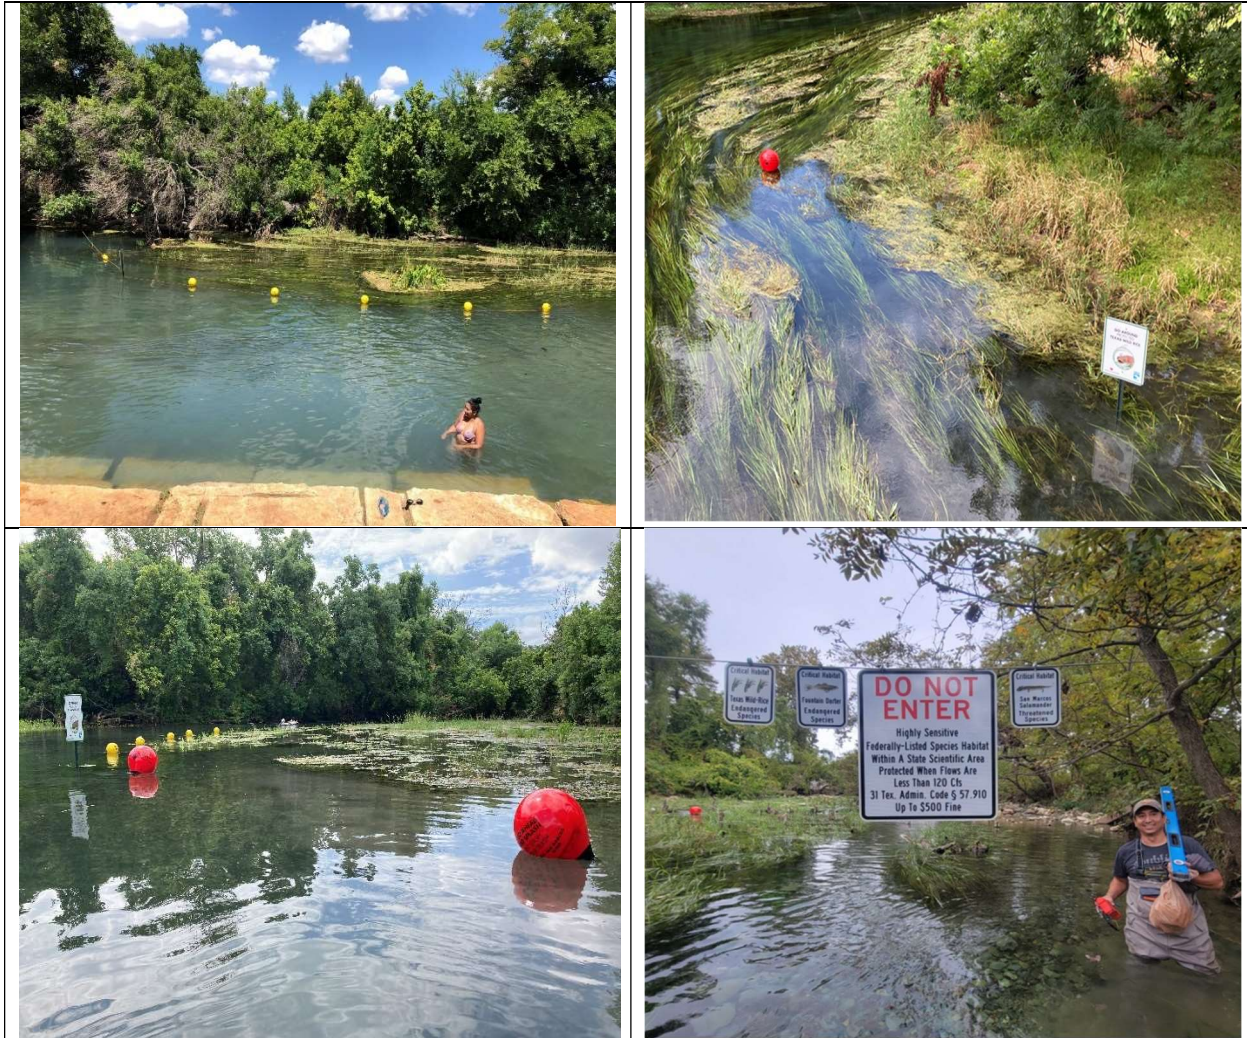
Figure 3. Photos showing the buoys, signage and exclosures that were installed to denote the TWR protection zones in the San Marcos River. The photo on the upper left is in the river immediately downstream of the Hopkins St bridge, photo on the right is immediately downstream of Sewell Park, photo on bottom left is at Bicentennial Park at the Purgatory Creek confluence and photo on bottom right is the signage in place at the Eastern Spillway area just below Spring Lake dam.

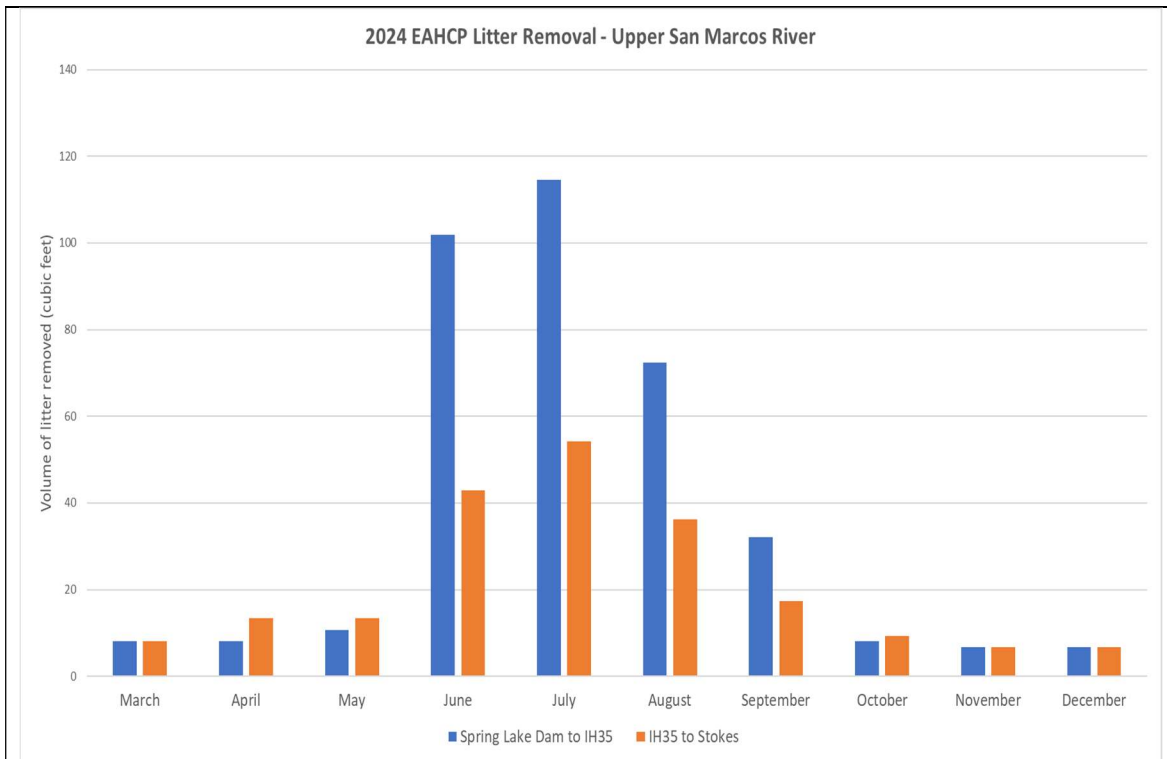
Figure 1. Volume of litter collected, per month, from the San Marcos River in 2024.

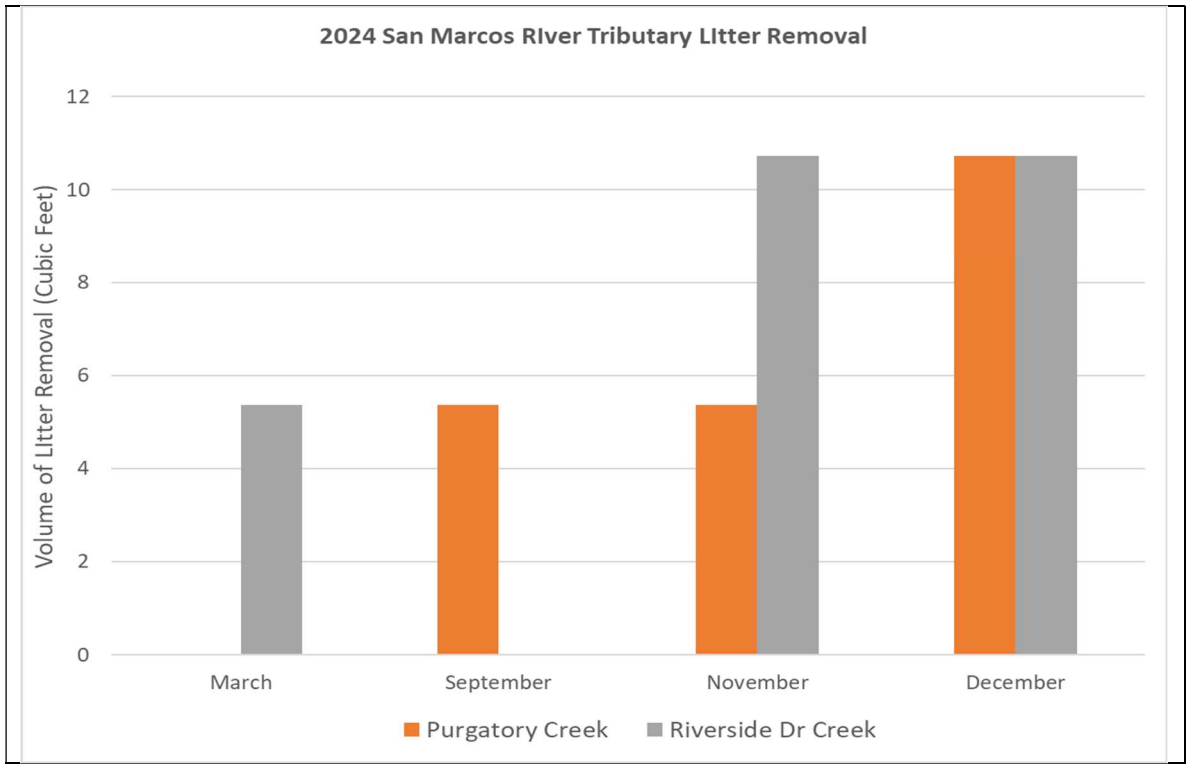
Figure 2. Volume of litter collected, per session, from San Marcos River tributaries in 2024.

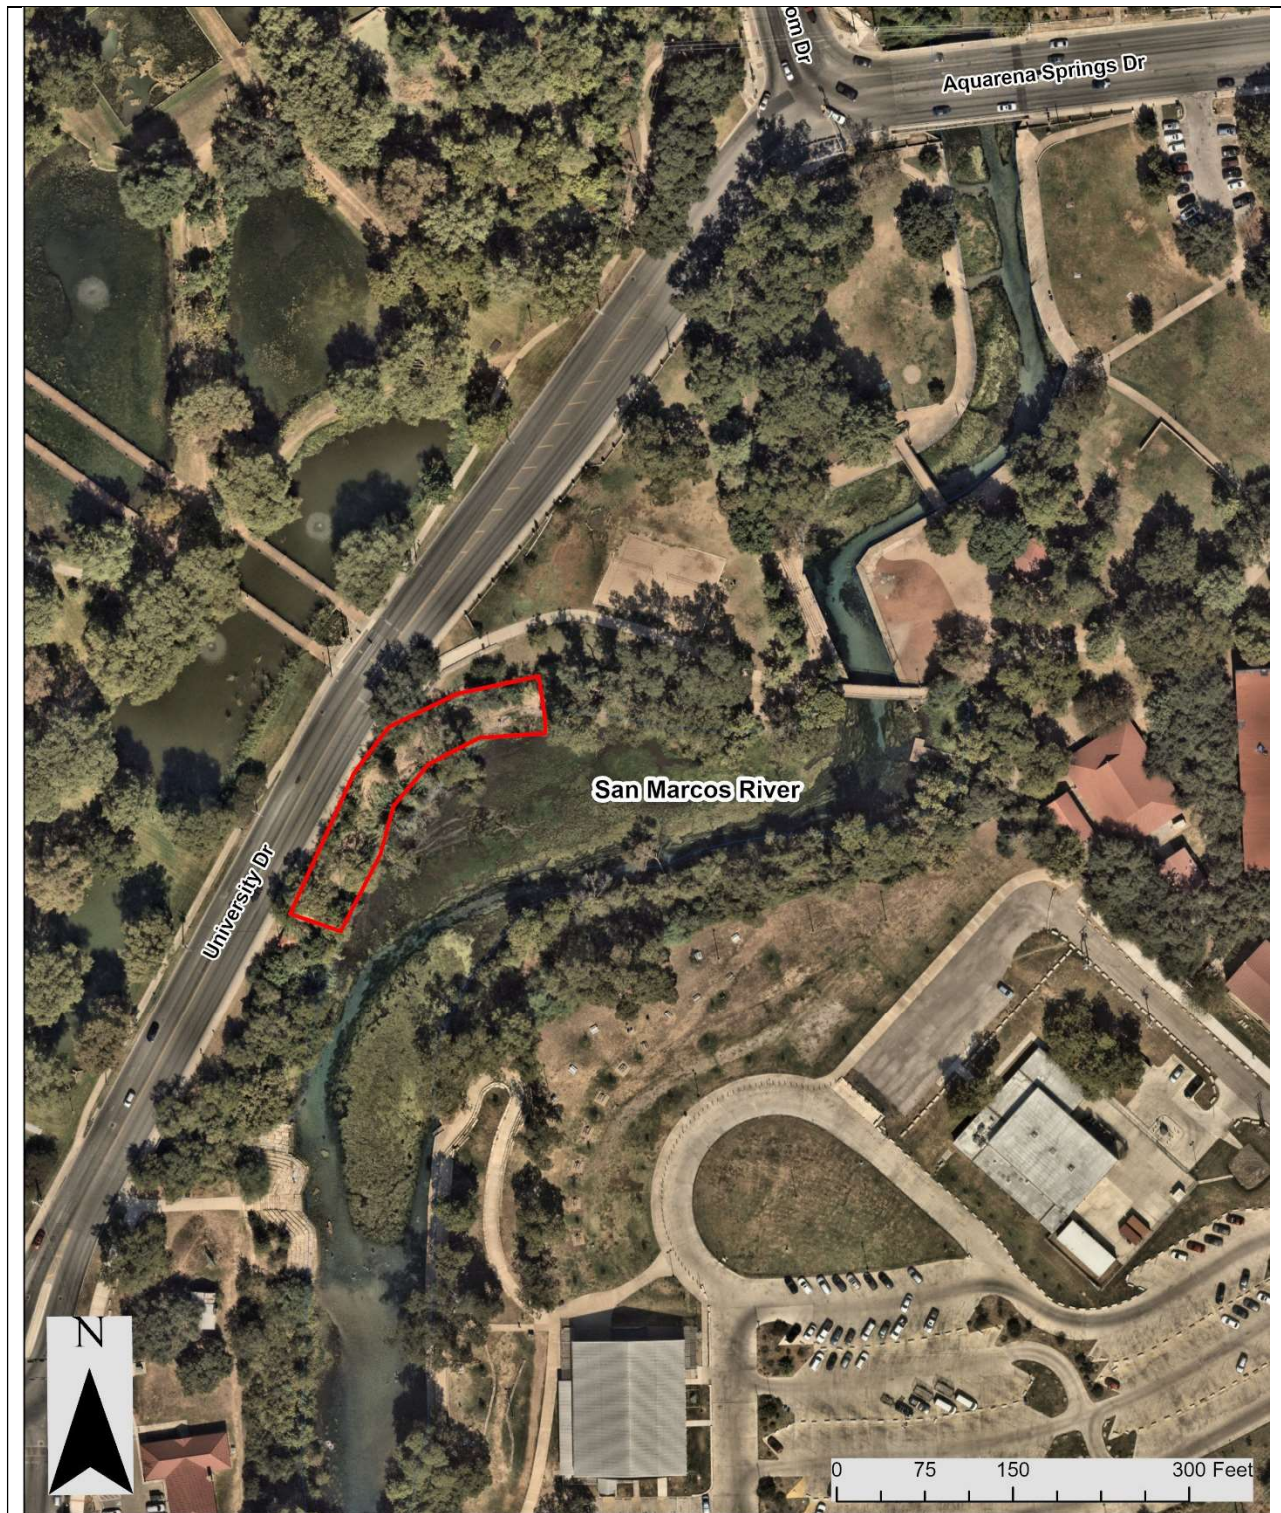
Figure 1. Location in TXSTs Sewell Park where intensive, initial non-native, invasive vegetation management occurred in 2024. The focus in the area was removal of non-native Arundo Cane

Approximately 1/3 of the Arundo stand was cut and treated in 2024 in addition to the 1/3 of the stand that was treated in 2023. Several follow-up maintenance herbicide treatments were performed through this area where re-emergent cane shoots were observed. The remaining portion of the stand will be managed in 2025.

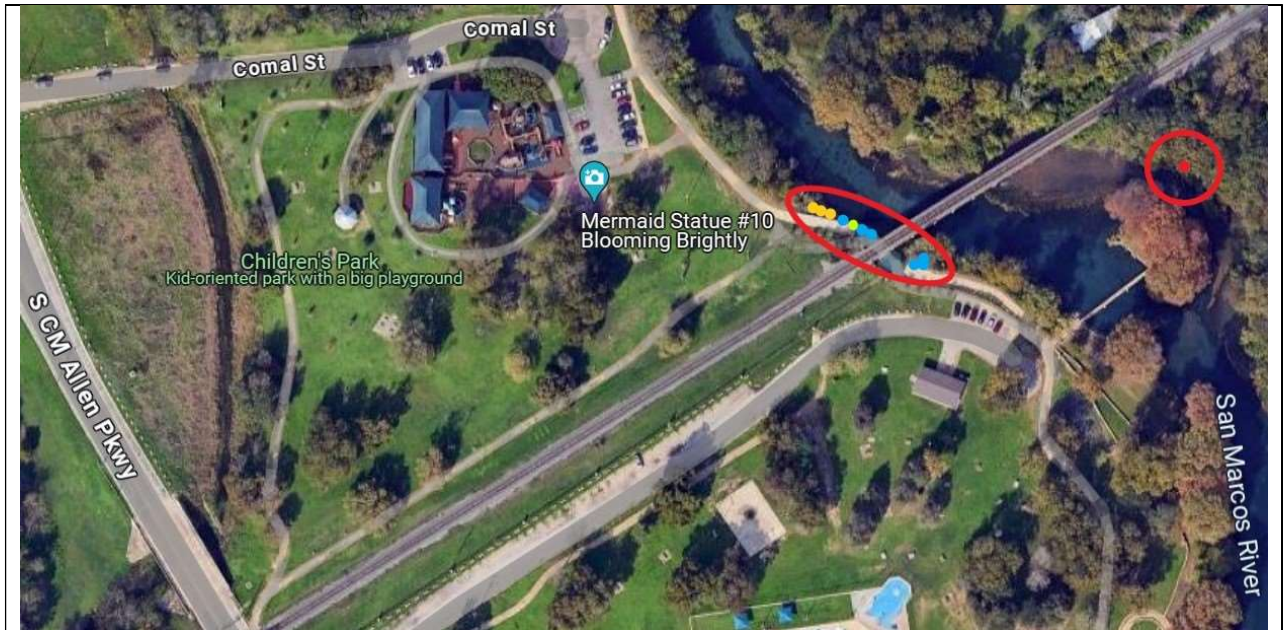
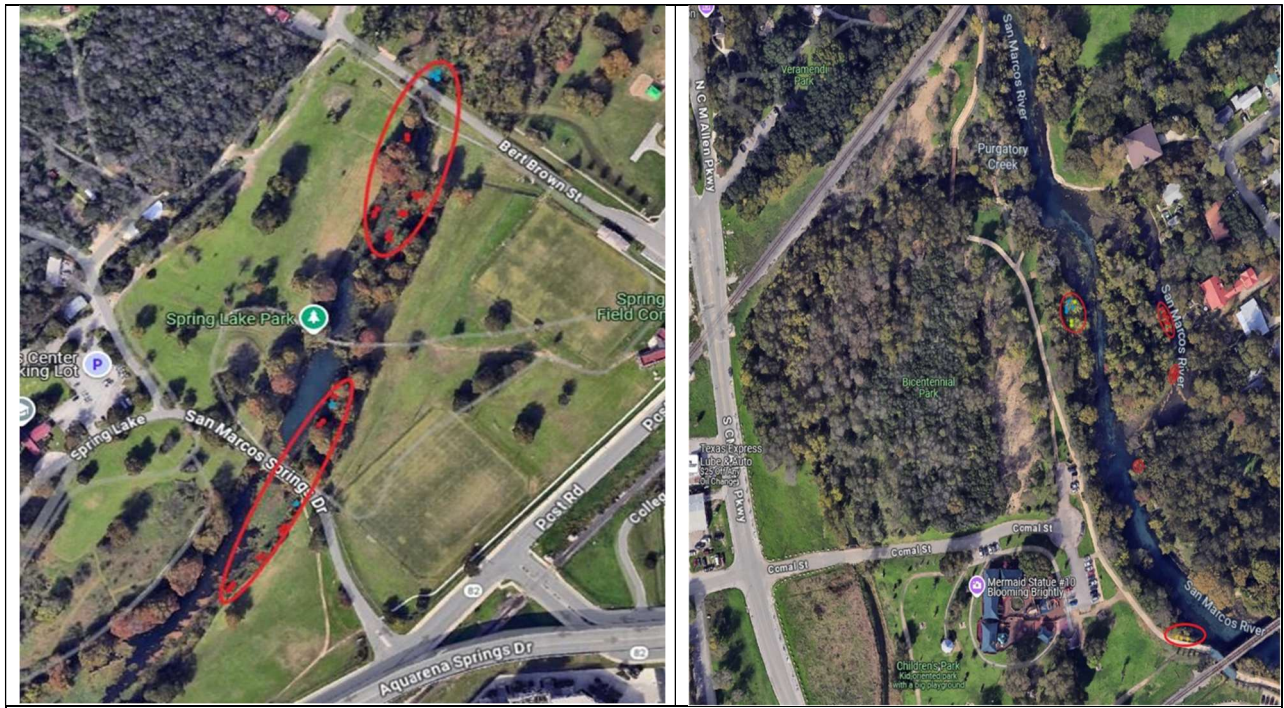
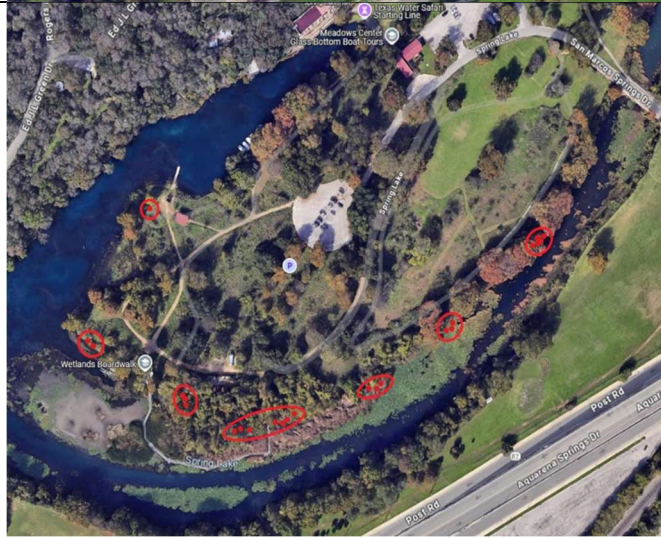
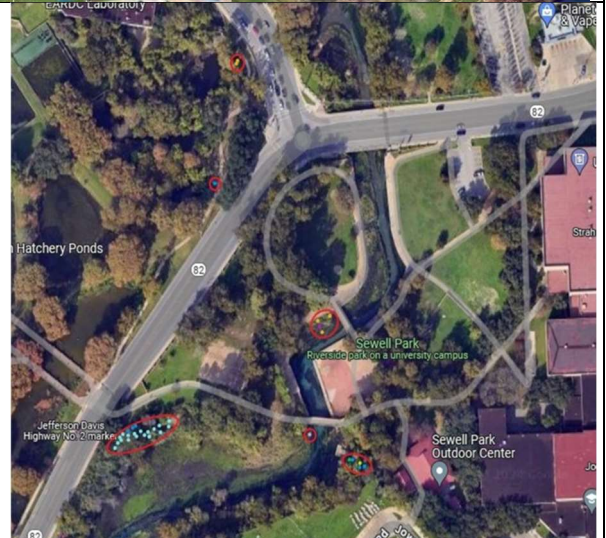
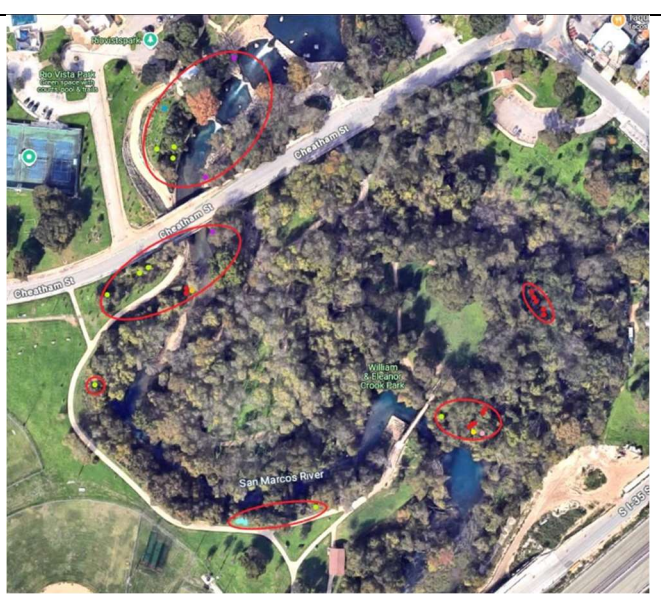
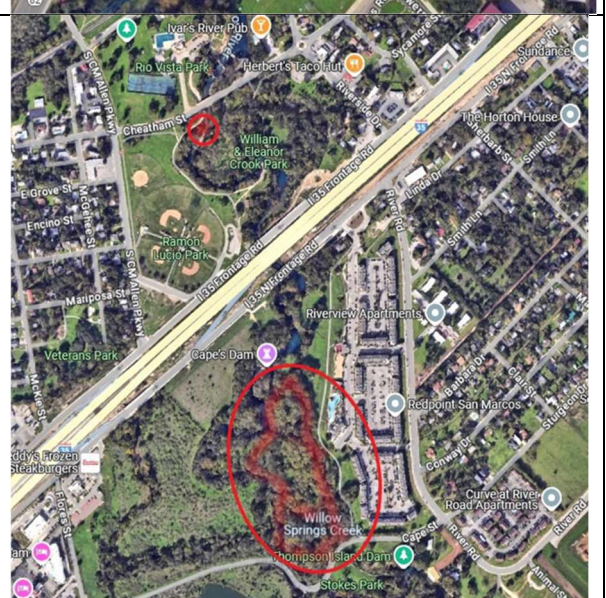
Figure 2. Aerial photos showing locations where non-native, invasive vegetation maintenance occurred in 2024.

Routine maintenance included monthly monitoring of the littoral zone along the San Marcos River from Sink Creek to just downstream of IH-35 and herbicide-treatment of any observed re-emergent non-native vegetation. Locations where intensive maintenance was required included the slough arm of Spring Lake (i.e. lower Sink Creek), Spring Lake Dam “Island” area, Crook Park, Ramon Lucio Park and the IH-35 area (**Figure 2**).

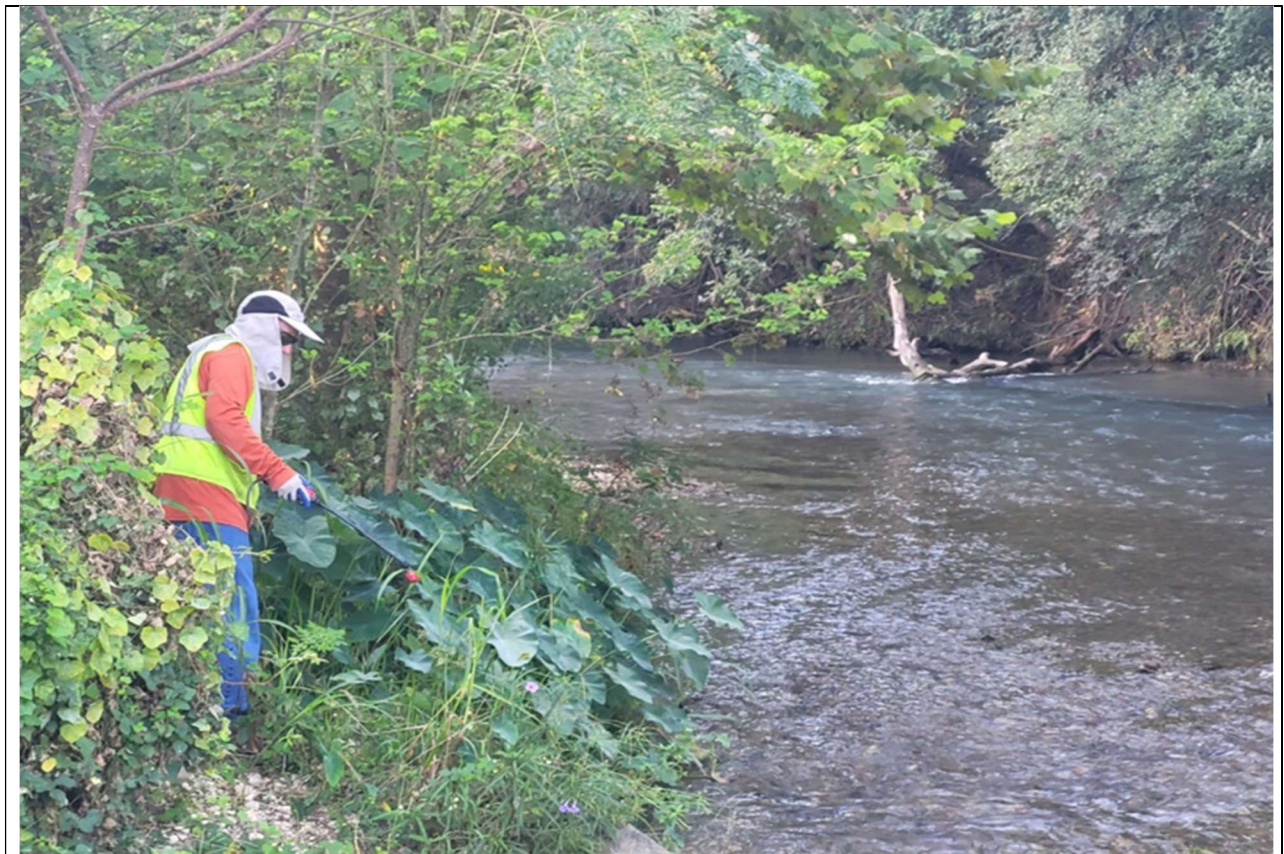
Photo 1. Targeted herbicide-spot treatment of elephant ears in Stokes Park
