Appendix I | **2024 COSM & Texas State University Reports**

Appendix I1 | **Aquatic Vegetation Restoration and Floating Vegetation Mat Management**

**Texas Wild-Rice Enhancement, Non-Native Aquatic Vegetation Removal and Floating Vegetation
Mat Mitigation in the Upper San Marcos River for Year 2024**

Prepared for:
City of San Marcos / Edwards Aquifer Habitat Conservation Plan

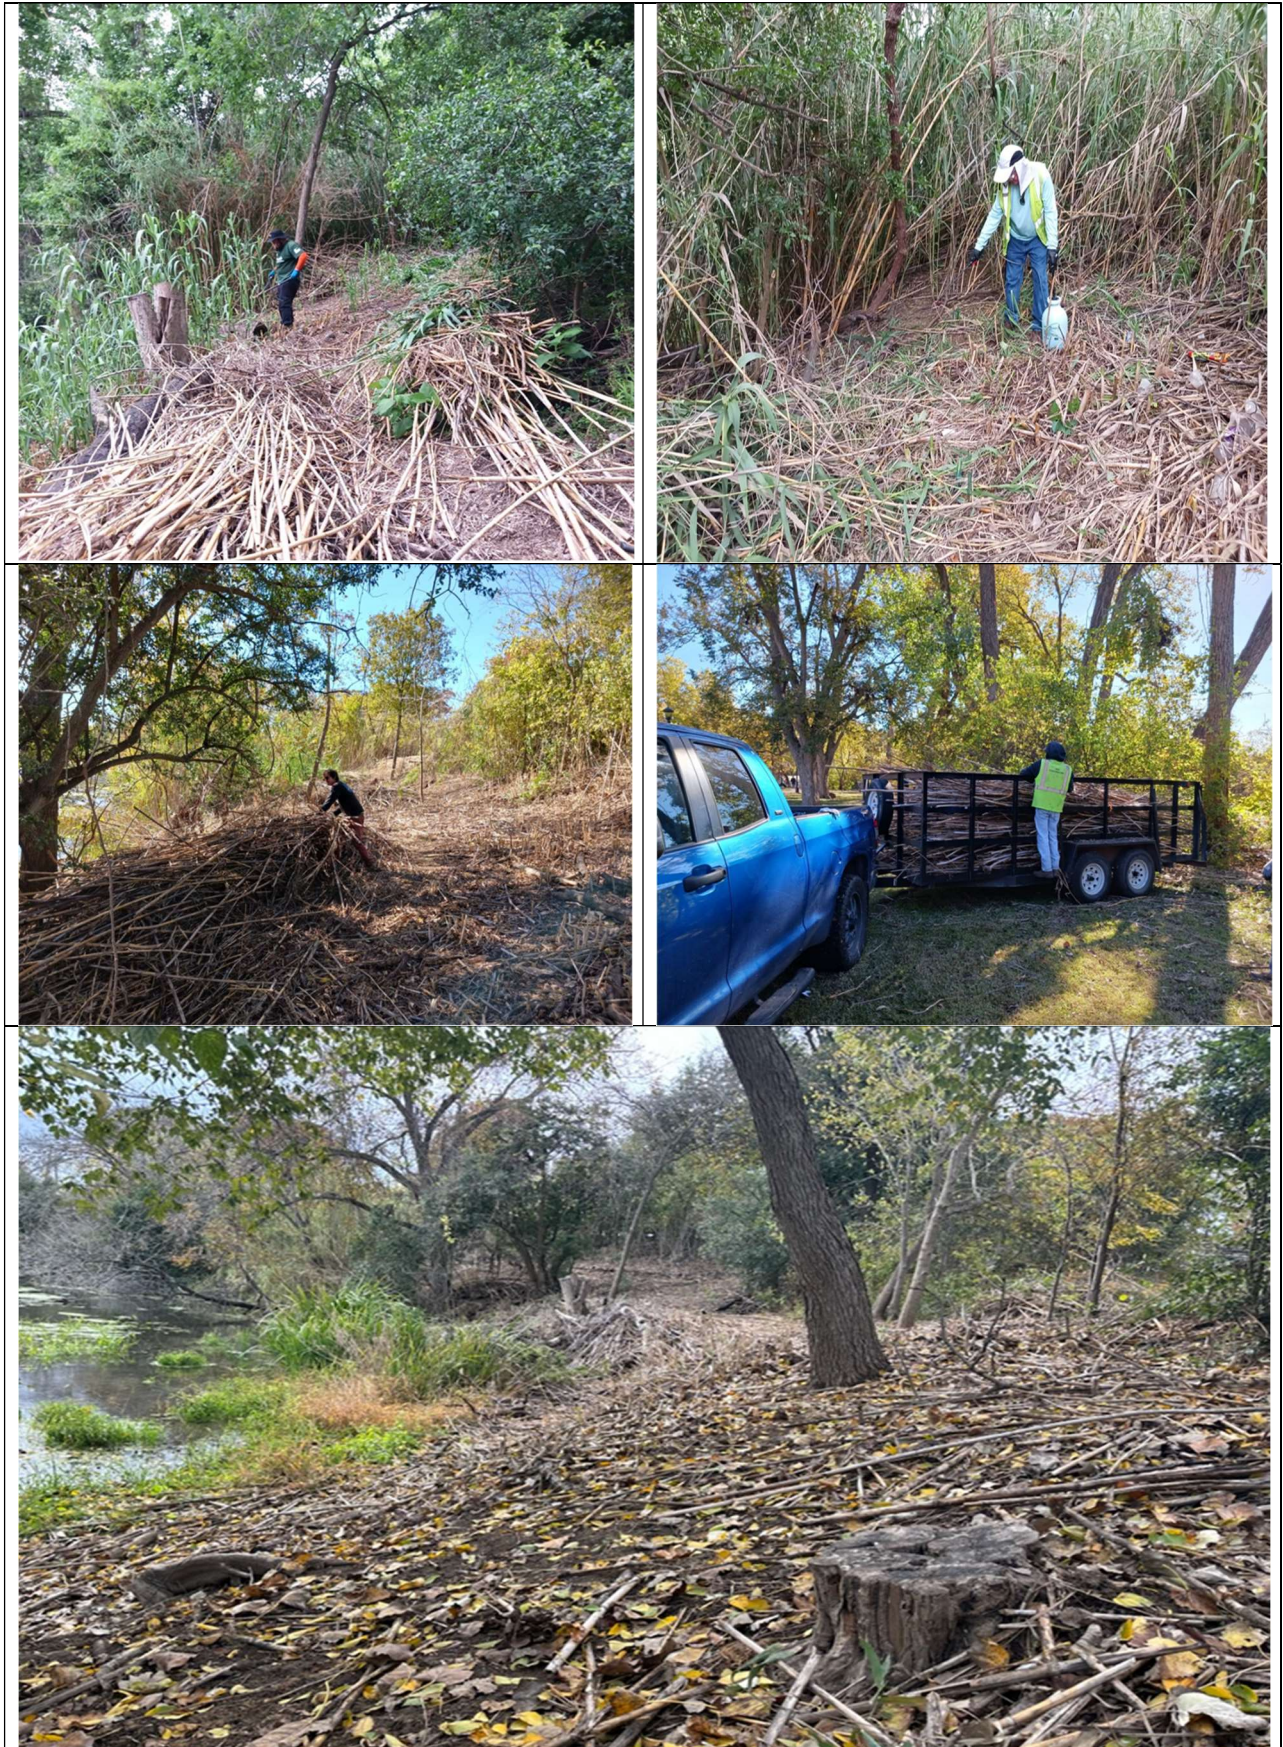
Photo 2. Cutting, spot herbicide-treatment, hauling and loading of Arundo Cane along the San Marcos River in Lower Sewell Park. The bottom photo shows an area in lower Sewell Park previously infested with dense Arundo Cane.

Chemicals (herbicides) were applied with a 1- or 2-gallon pump-up sprayer, set on a steady stream for a more precise target hit, to minimize leaching and non-target plant damage. The sides of stumps and root flares of woody plants were scarred up with a machete or other blade to expose more of the cambium layer and then treated with herbicide. Arundo cane treatment involved the cutting of individual canes and application of a small amount of herbicide on the remaining cut/ exposed cane.

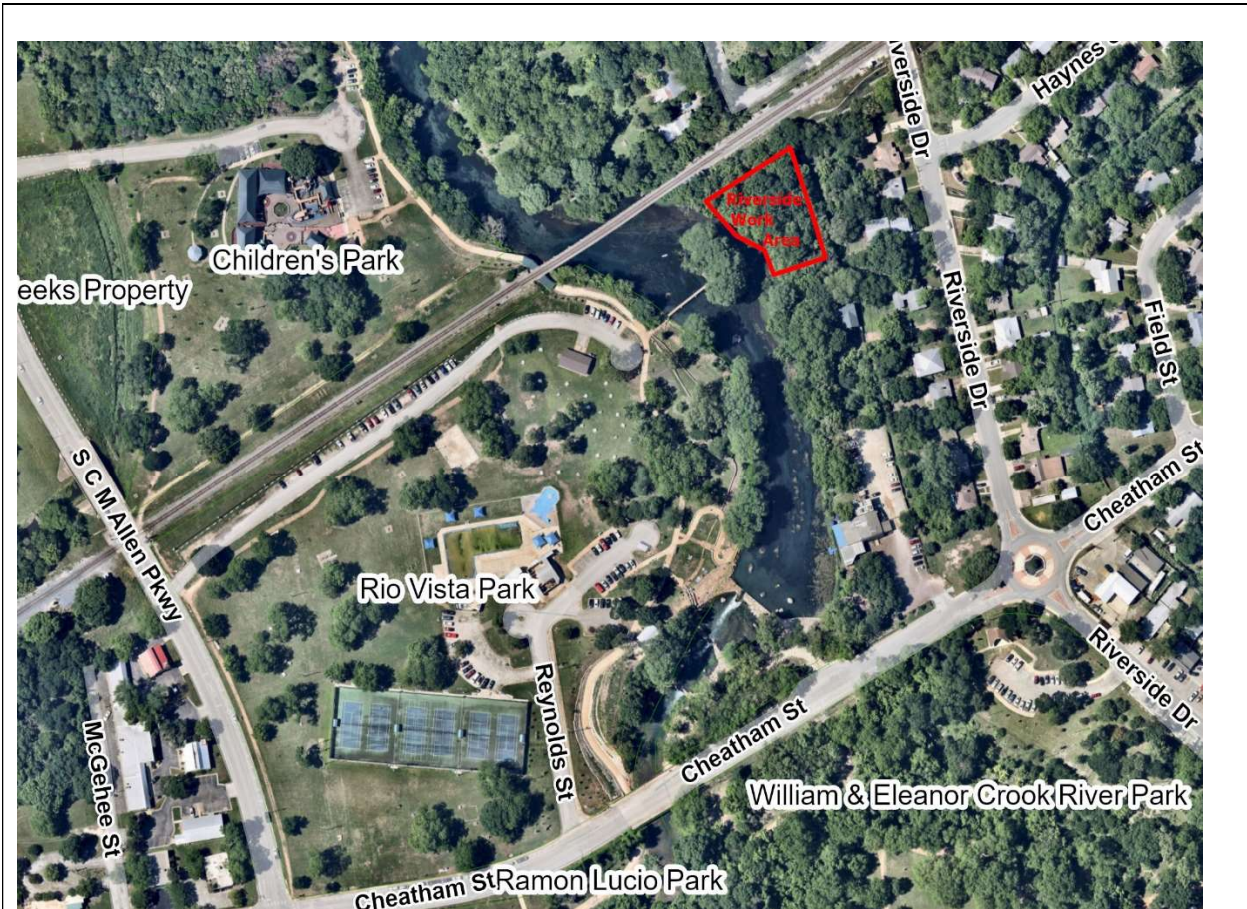
Figure 1. Location of intensive, non-native vegetation removal work area where work occurred in 2024 along the San Marcos River across the river from the “Cypress Island” of Rio Vista Park.

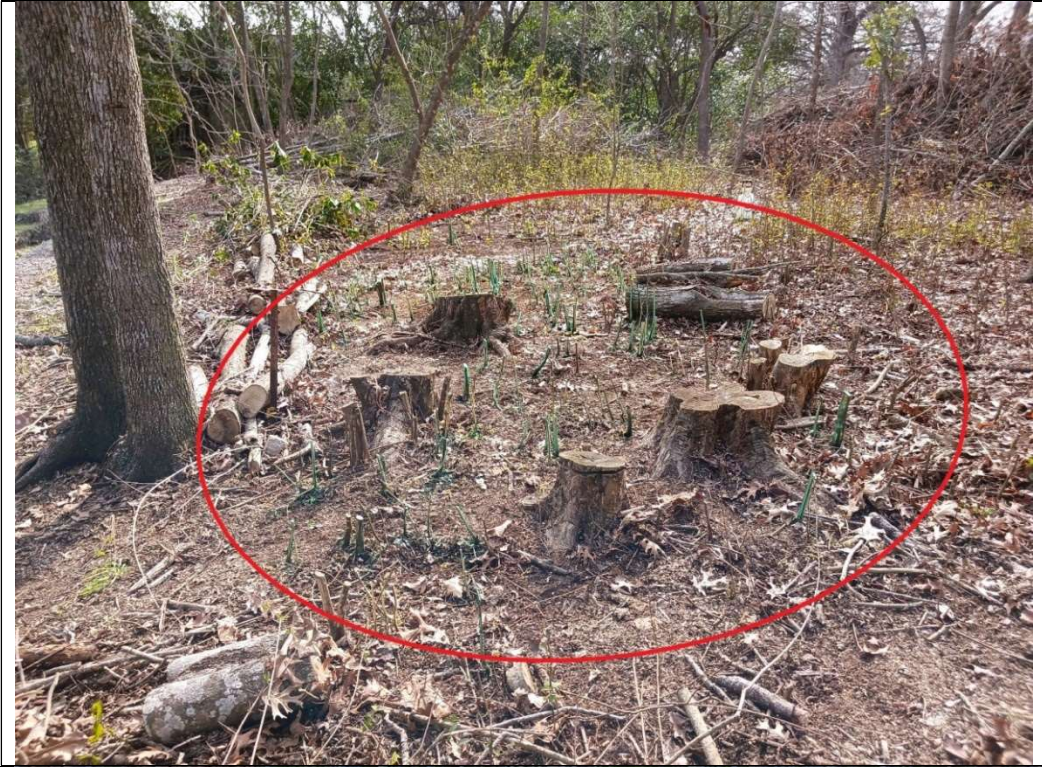
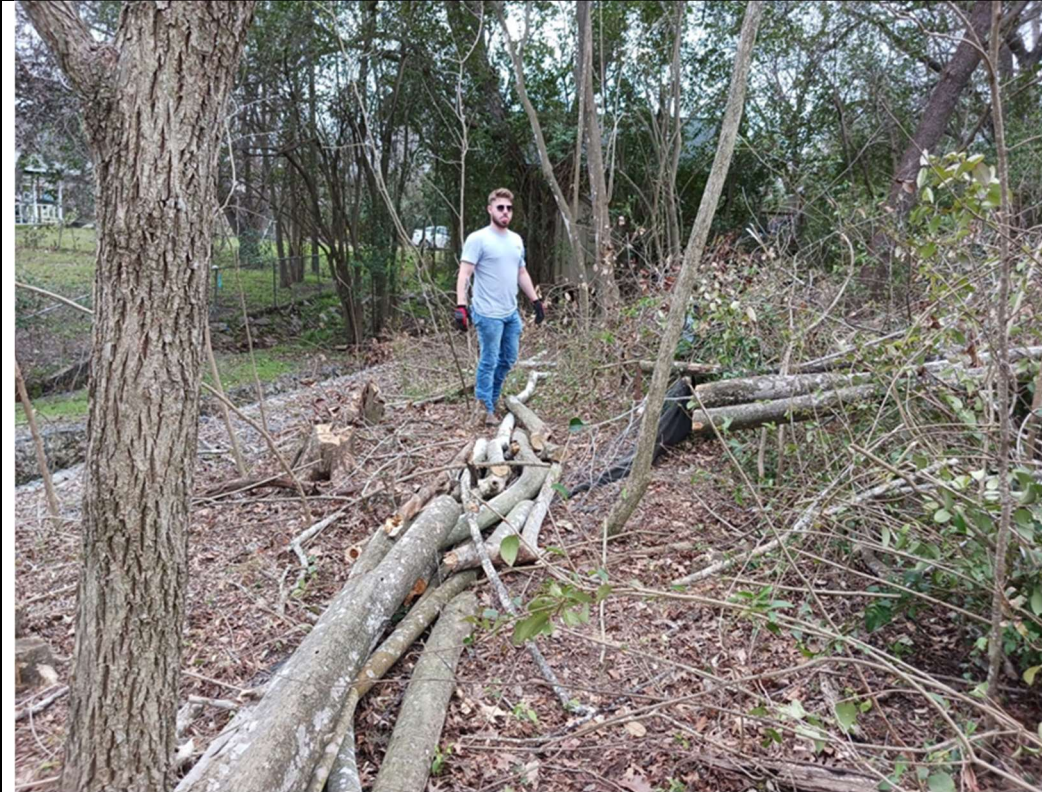
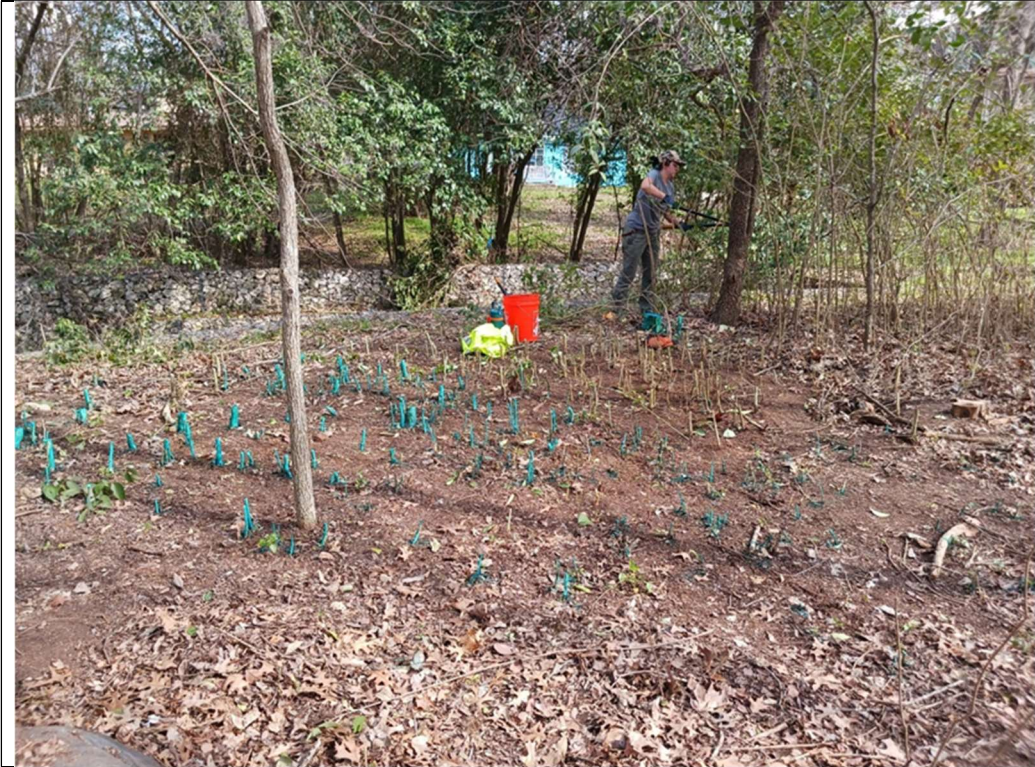
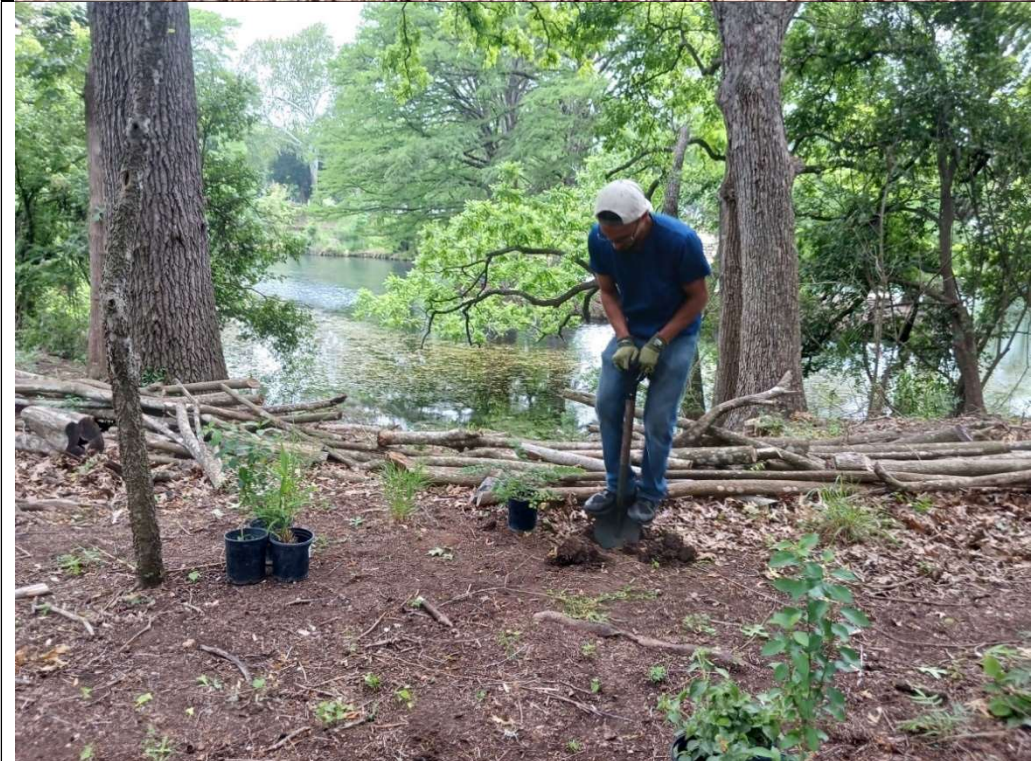
Figure 2. Photos of riparian restoration activity along the San Marcos River at the “Riverside” property across from the Cypress Island of Rio Vista Park. Photos depict cut and treated ligustrum trees, formation of sediment control berms and native planting.

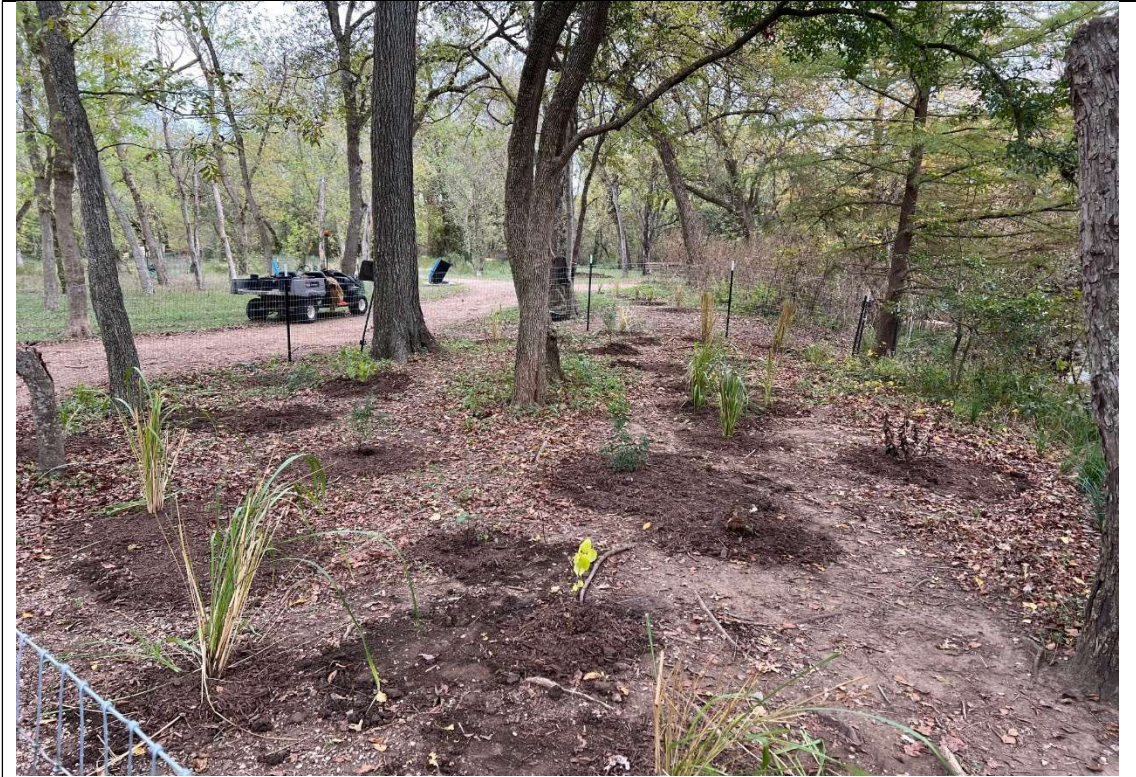
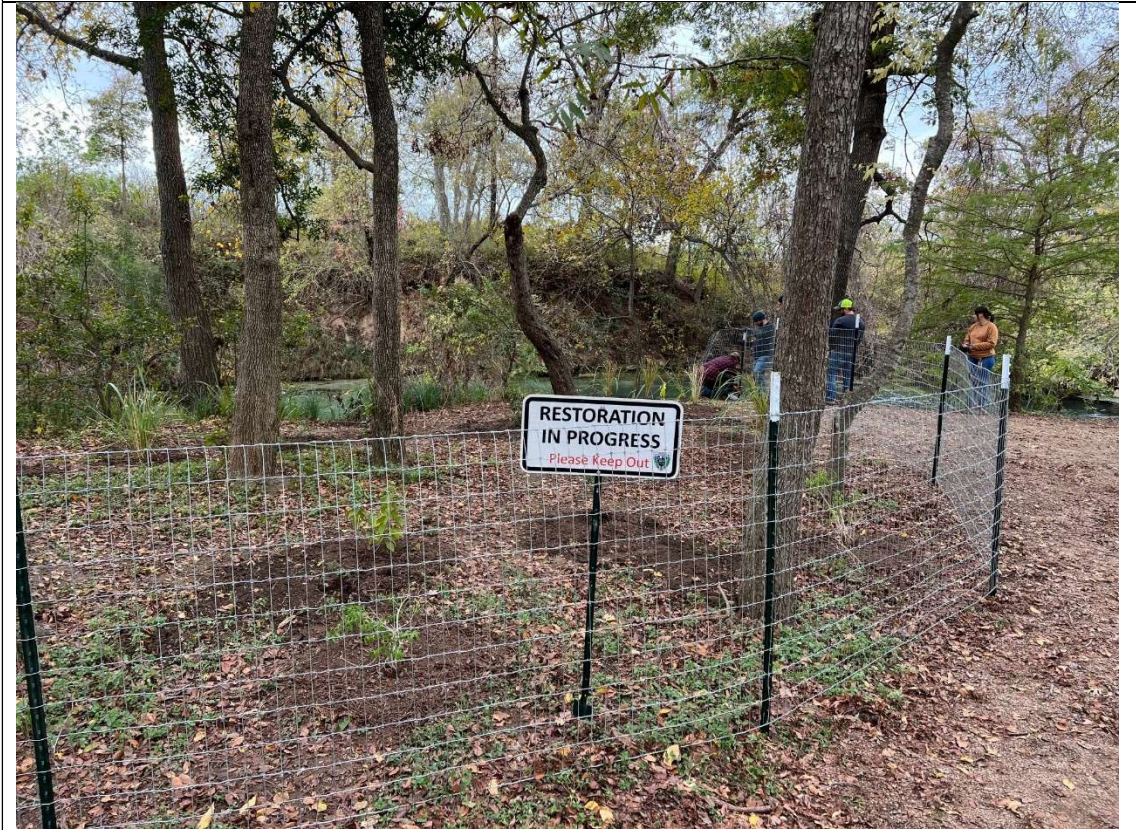
Figure 3. Native plantings and installed fencing to serve as a riparian protection zone, Crook Park/ Wildlife Annex.
