The EAA Abandoned Well Program Presentation to EAA Board of Directors

August 8, 2017
San Antonio, TX

Advocating for enhanced groundwater protection by:

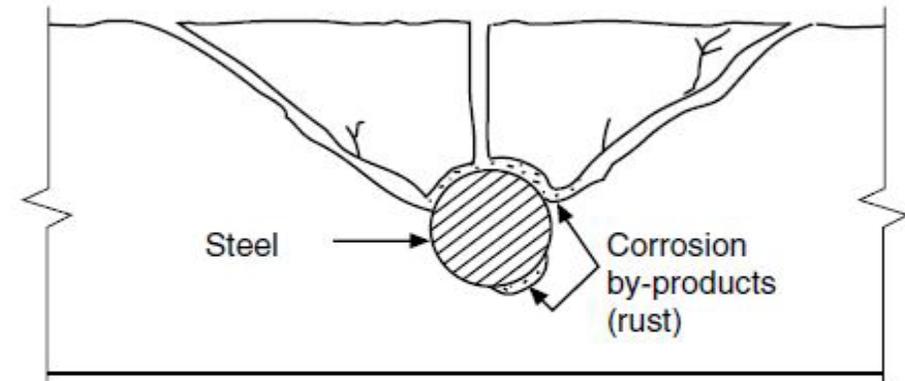
Fig. 2. The expansion of corroding steel creates tensile stresses in the concrete, which can cause cracking, delamination, and spalling.

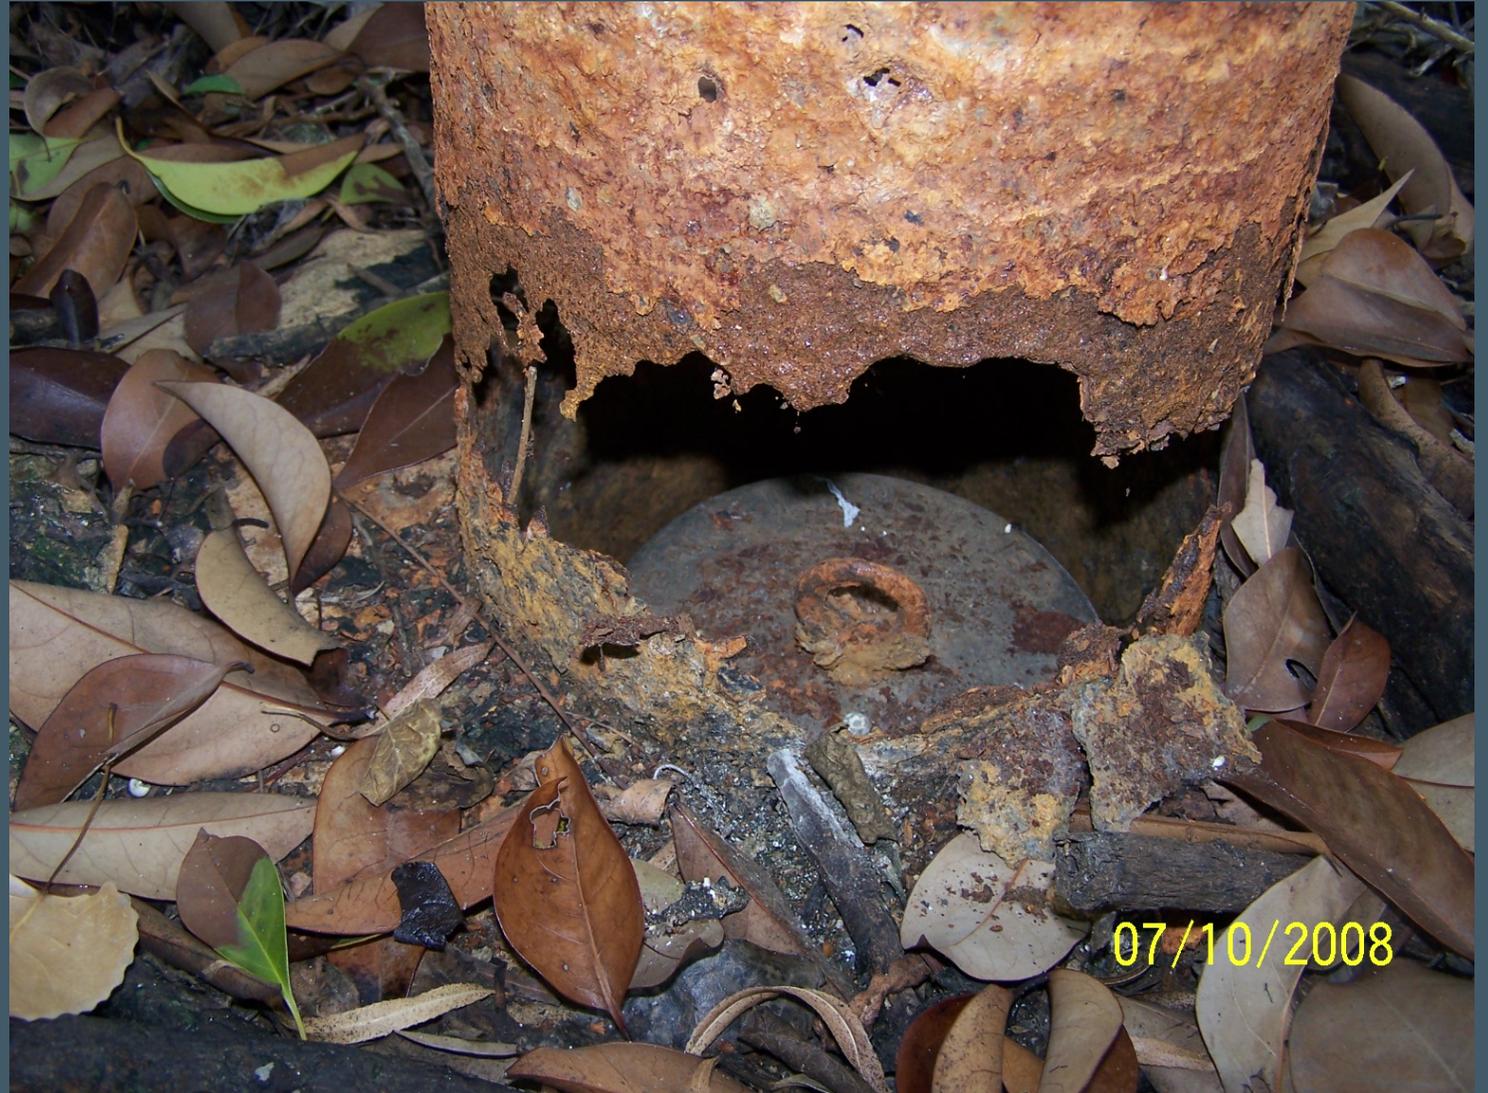
Deteriorated Casing: Split casing and holes in casing

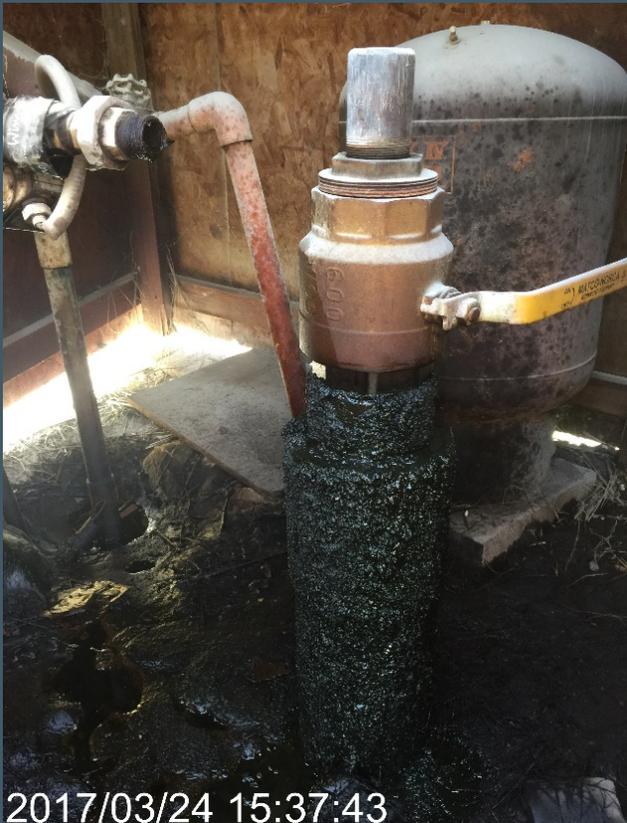
Deteriorated Wells: Water Quality Issue

Suspected oil source

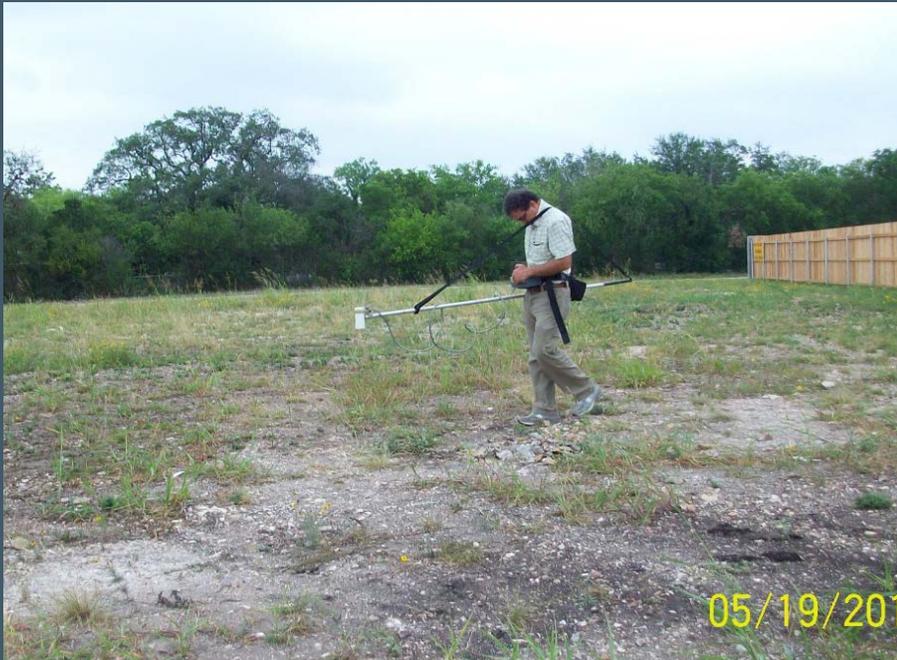
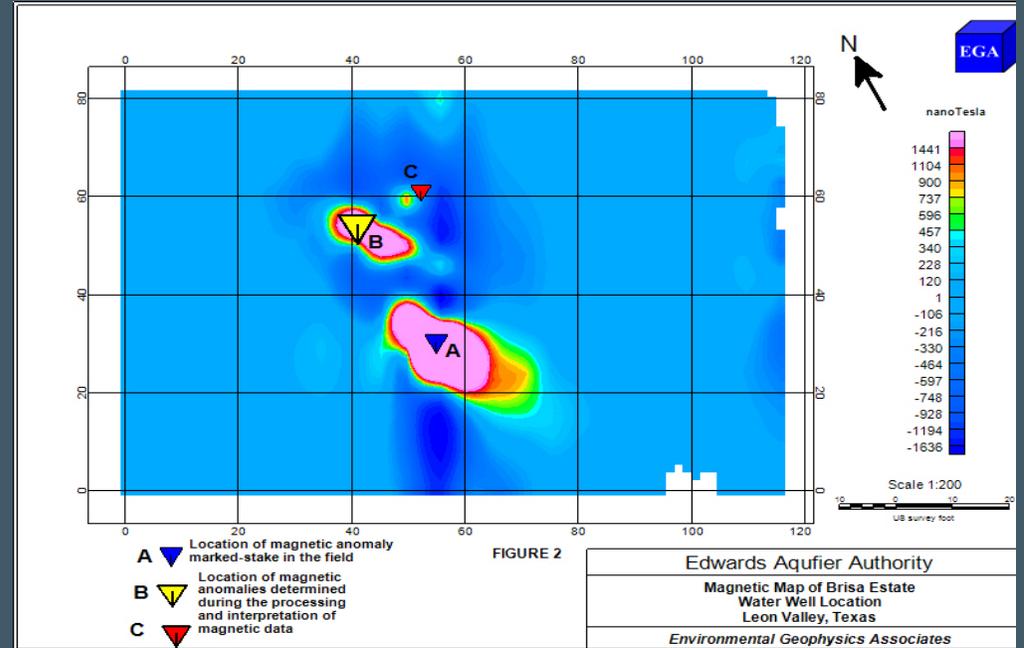
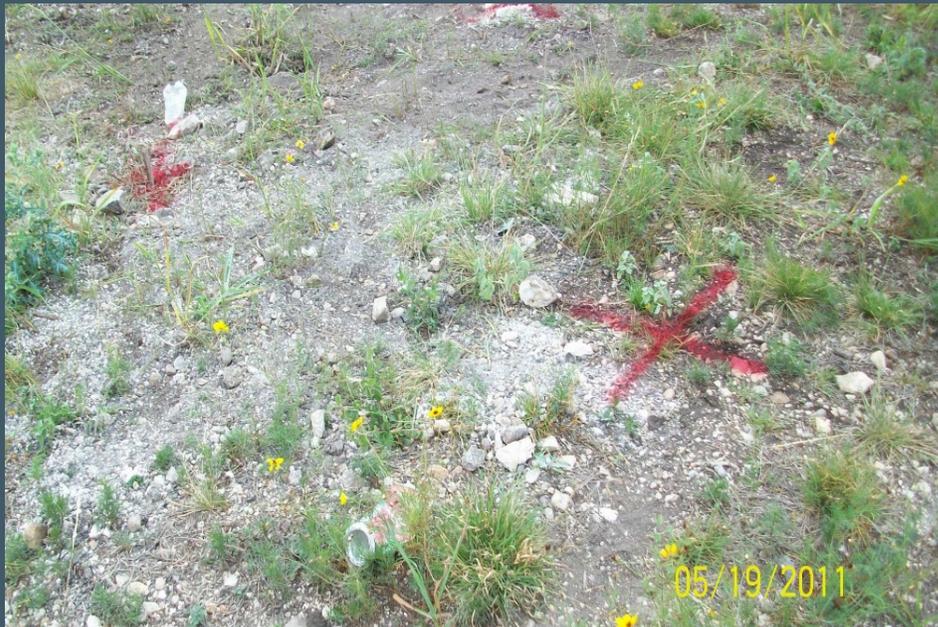
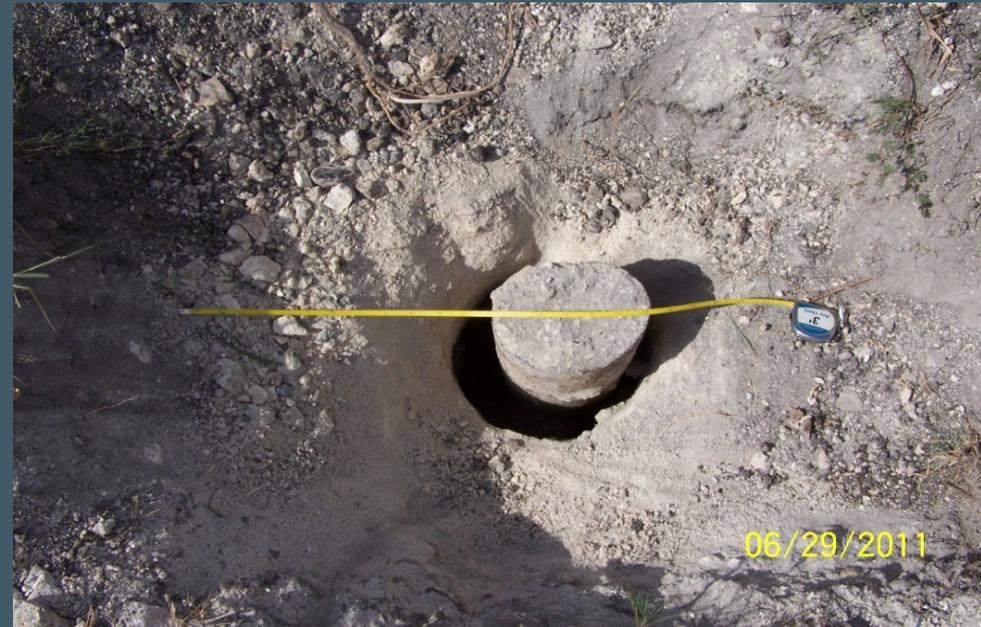
Leon Valley Well Site GPR and Magnetometer Survey Results

- Well reported June 2010
- Geophysics May 2011
- Excavated June 2011
- Plugged 2015

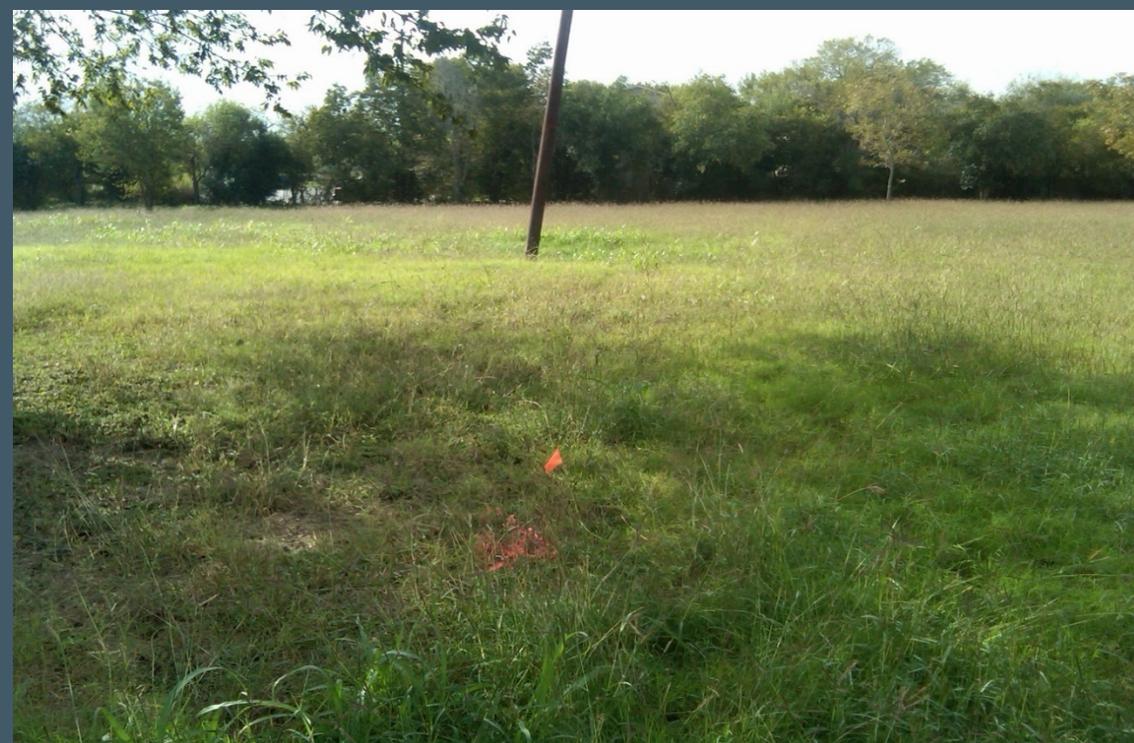
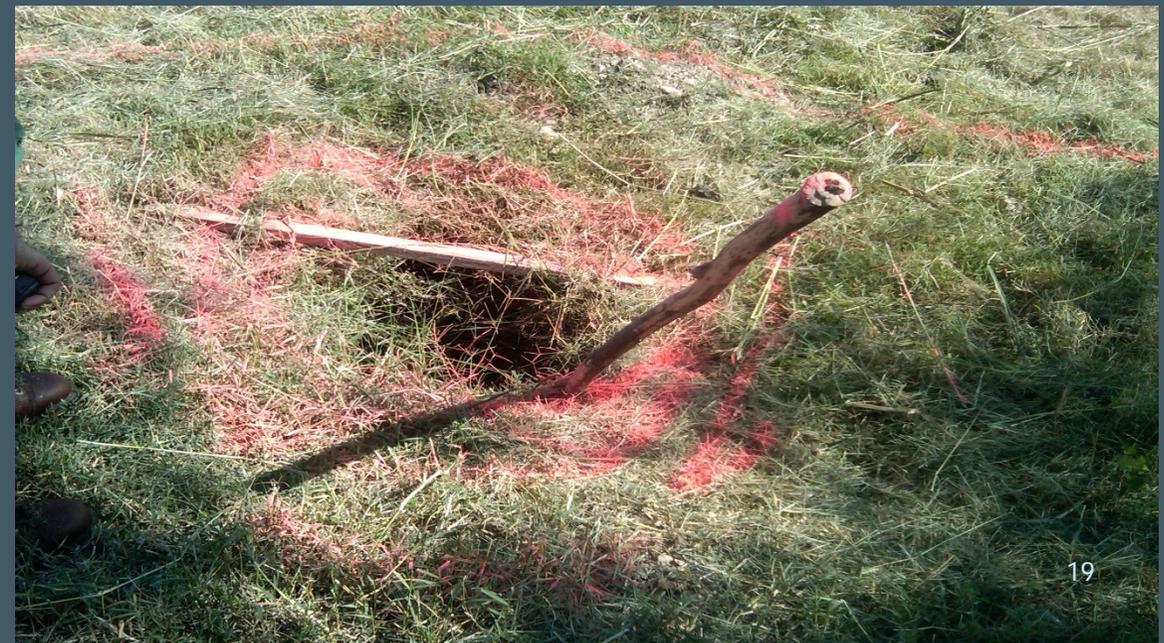
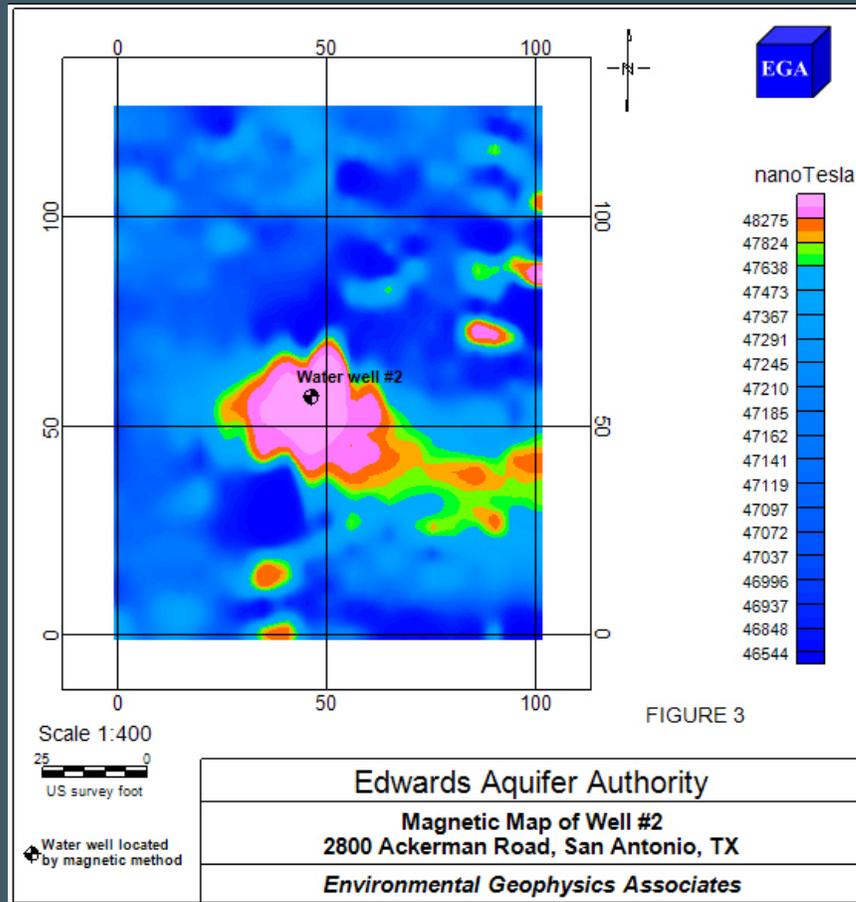
Ackermann Rd Well Site: Landis Wilson Water Supply System

- Reported seepage at site
- TWDB indicates two wells
- Owner excavating in search of well
- Magnetometer and GPR Survey

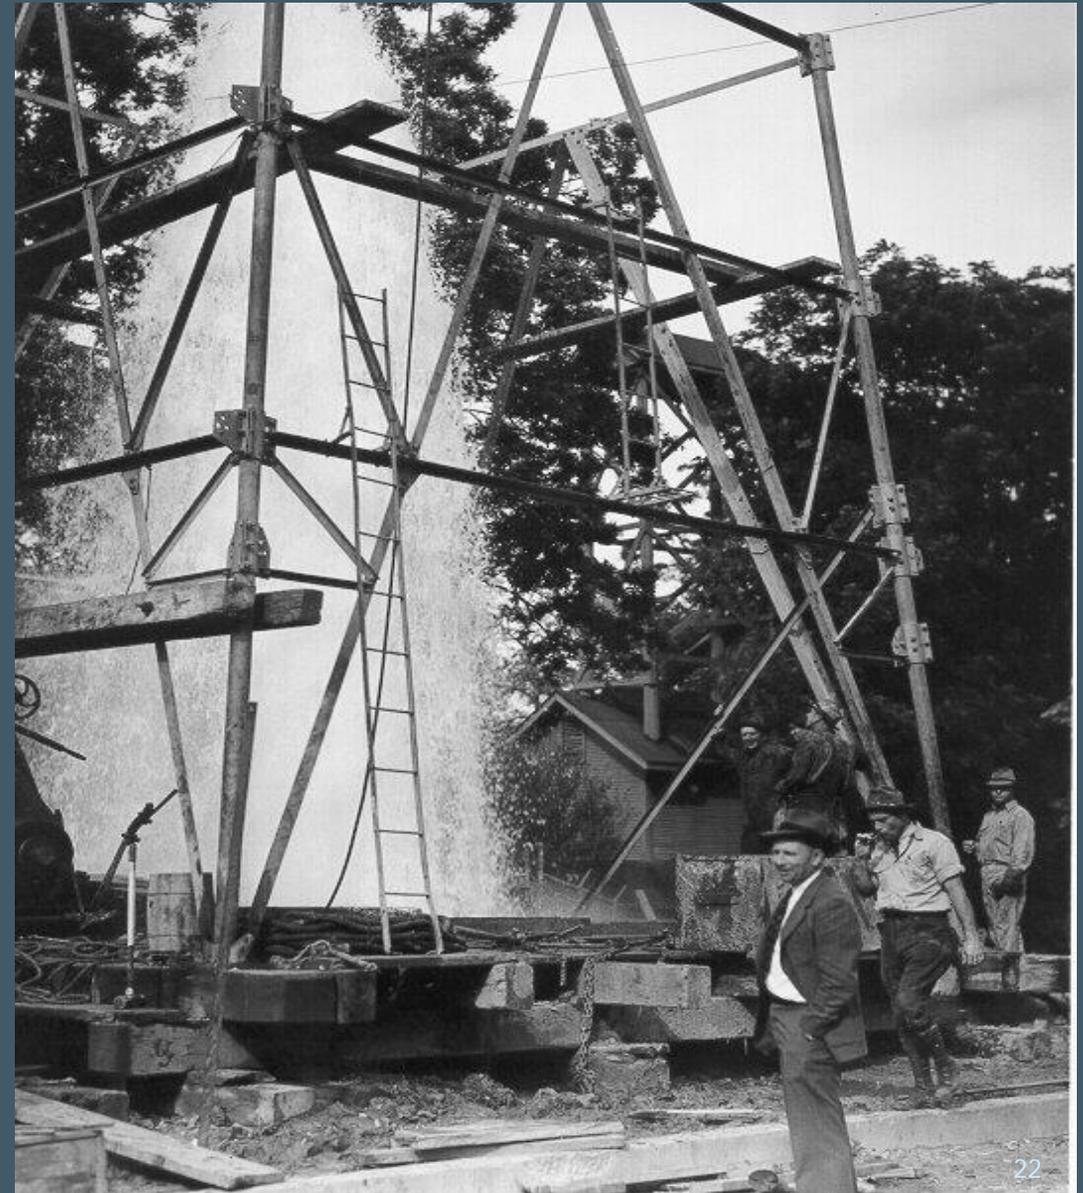
Station B artesian well with Braunig ca 1947

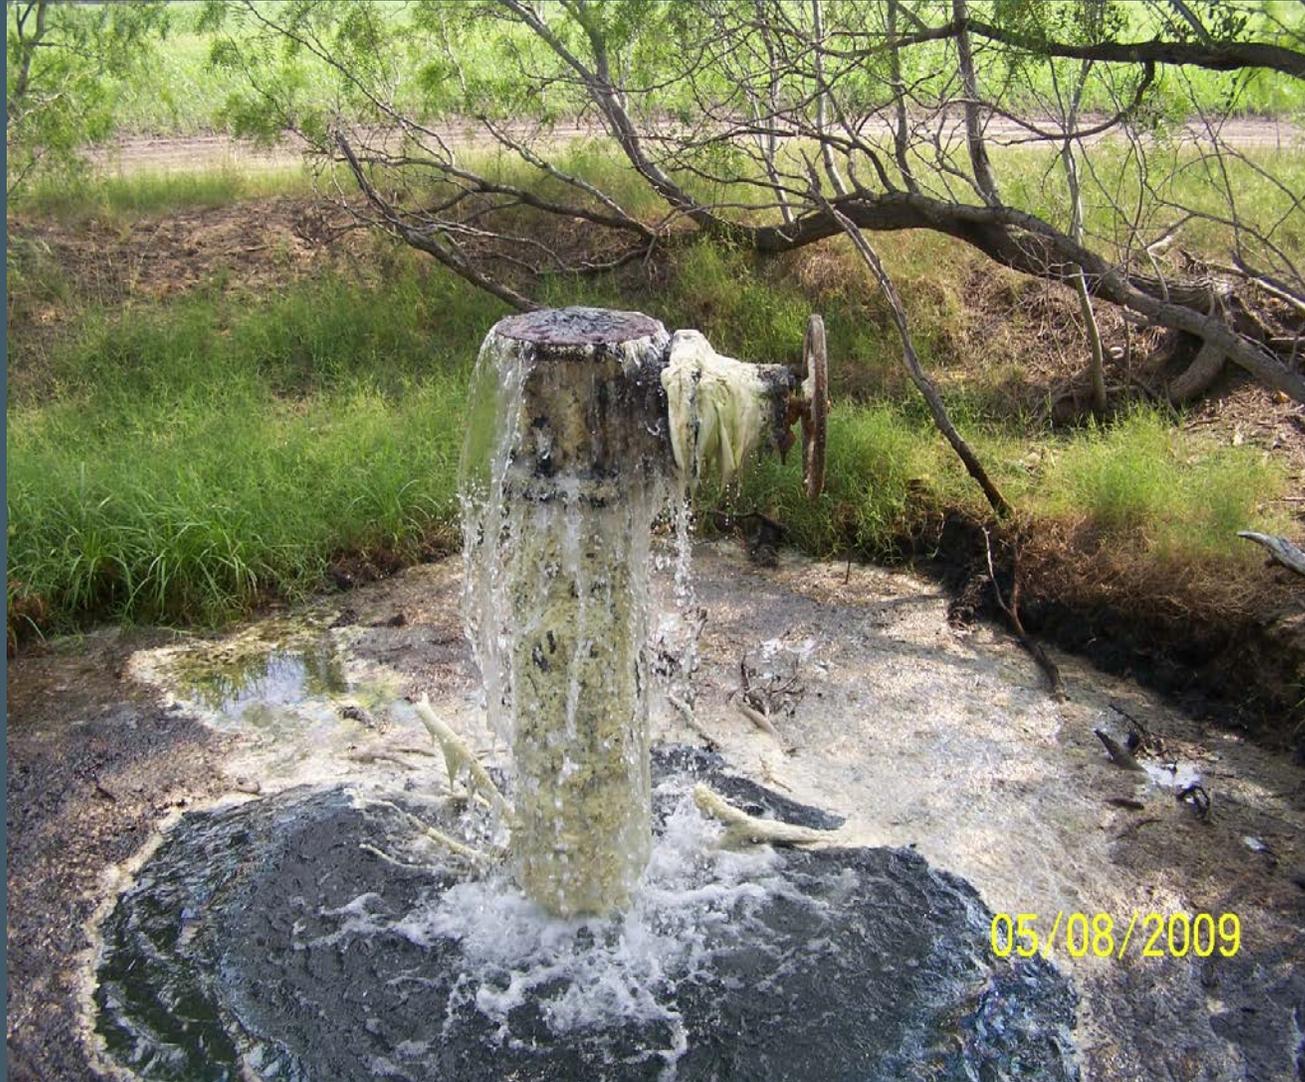
Flowing Artesian Well

Significant ecosystem has developed over many years from an abandoned flowing artesian well. Suggestion to plug well met significant resistance from community entities.

Costly to plug:

- Build platform around well
- Deep Well
- Stop artesian flow

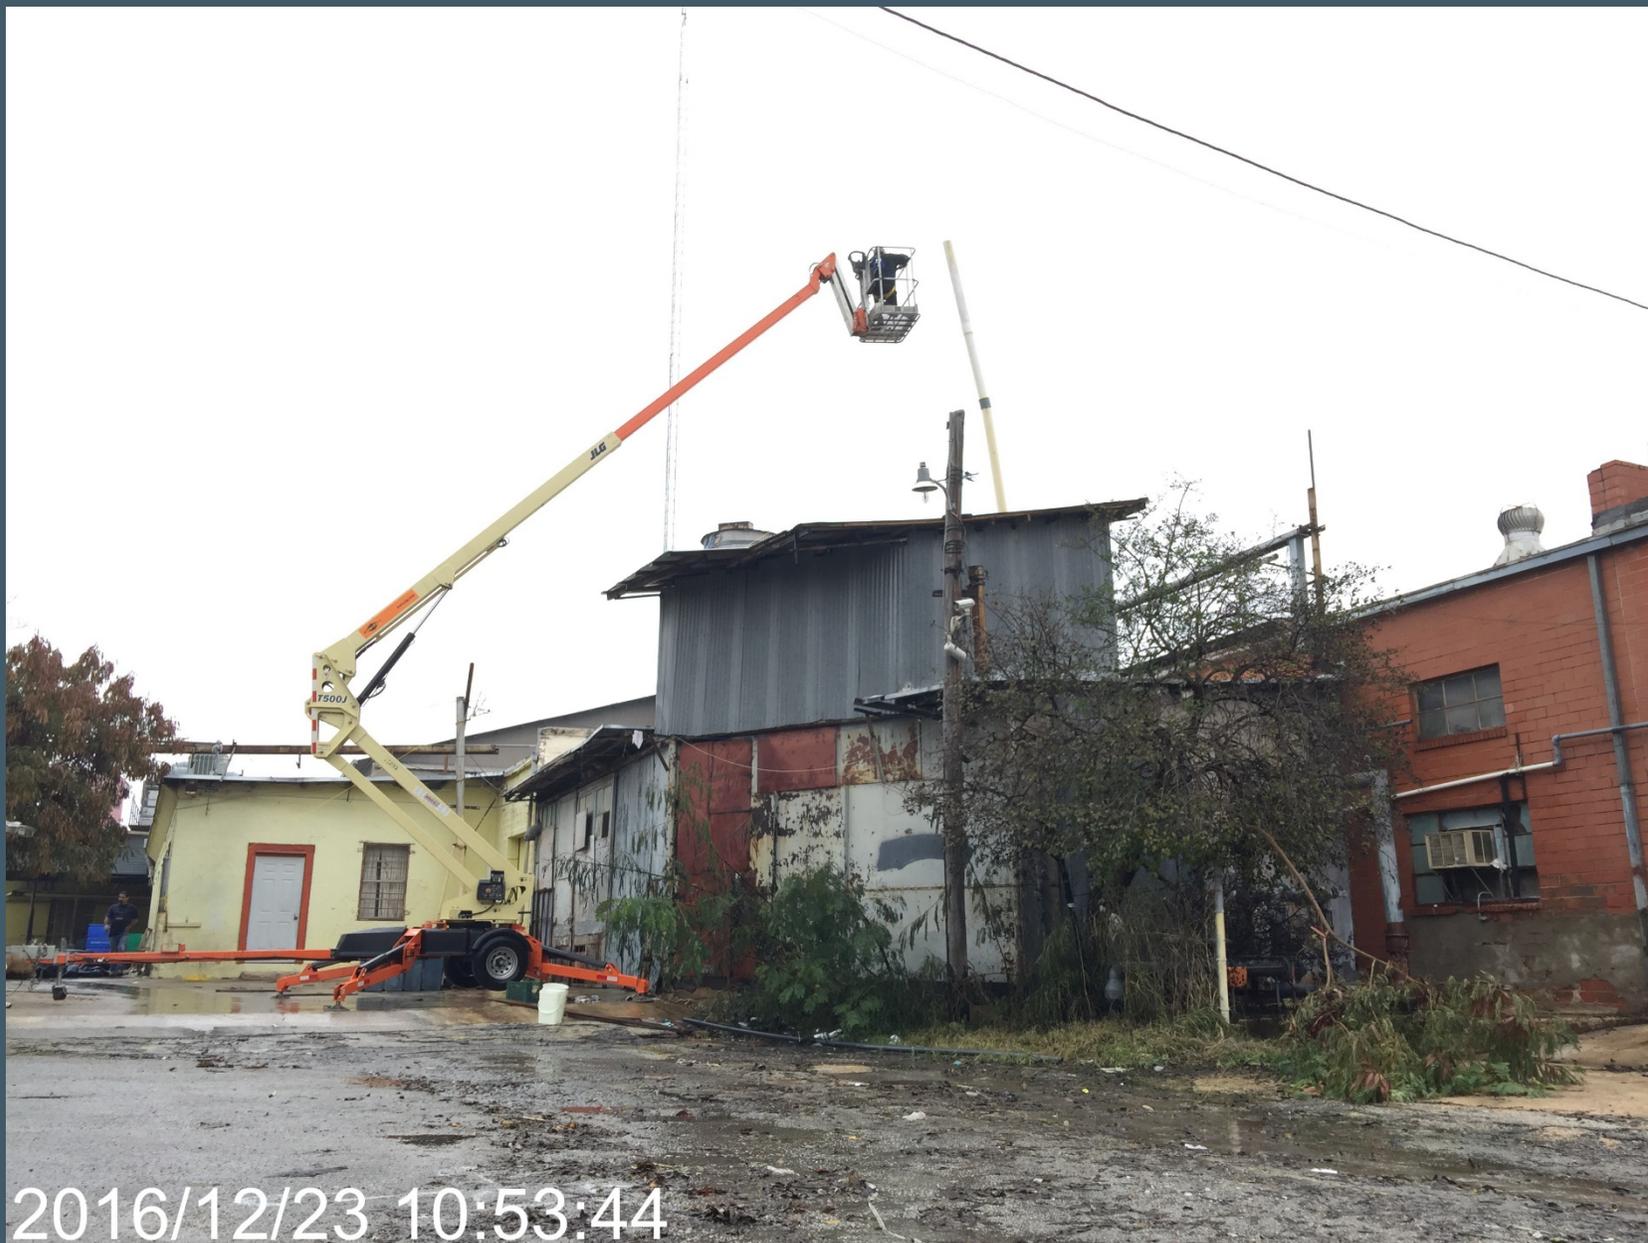
Case Study: Downtown San Antonio Well Site

Recent high aquifer levels to start flowing above standpipe height, requiring additional PVC section.
