# **Structural Controls on the Edwards Aquifer/Trinity Aquifer Interface in the Camp Bullis Quadrangle, Texas**

David A. Ferrill<sup>1</sup>, Darrell W. Sims<sup>1</sup>, Alan P. Morris<sup>2</sup>, Deborah J. Waiting<sup>1</sup>,  
Nathan Franklin<sup>1</sup>

Edwards Aquifer Authority

U.S. Army Corps of Engineers

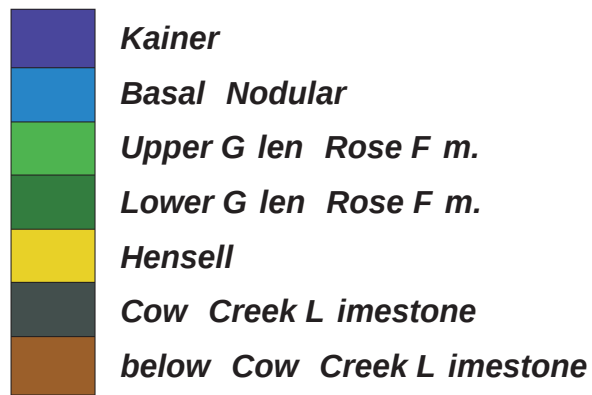
### Cross section view of model

**Figure 3-28.** Cross section view of model. Section is oriented NW-SE and extends corner to corner across the model area (see Fig. 3-1), with left end starting at NW model corner. Vertical Exaggeration = 5:1. Horizontal units are meters distance from left end.

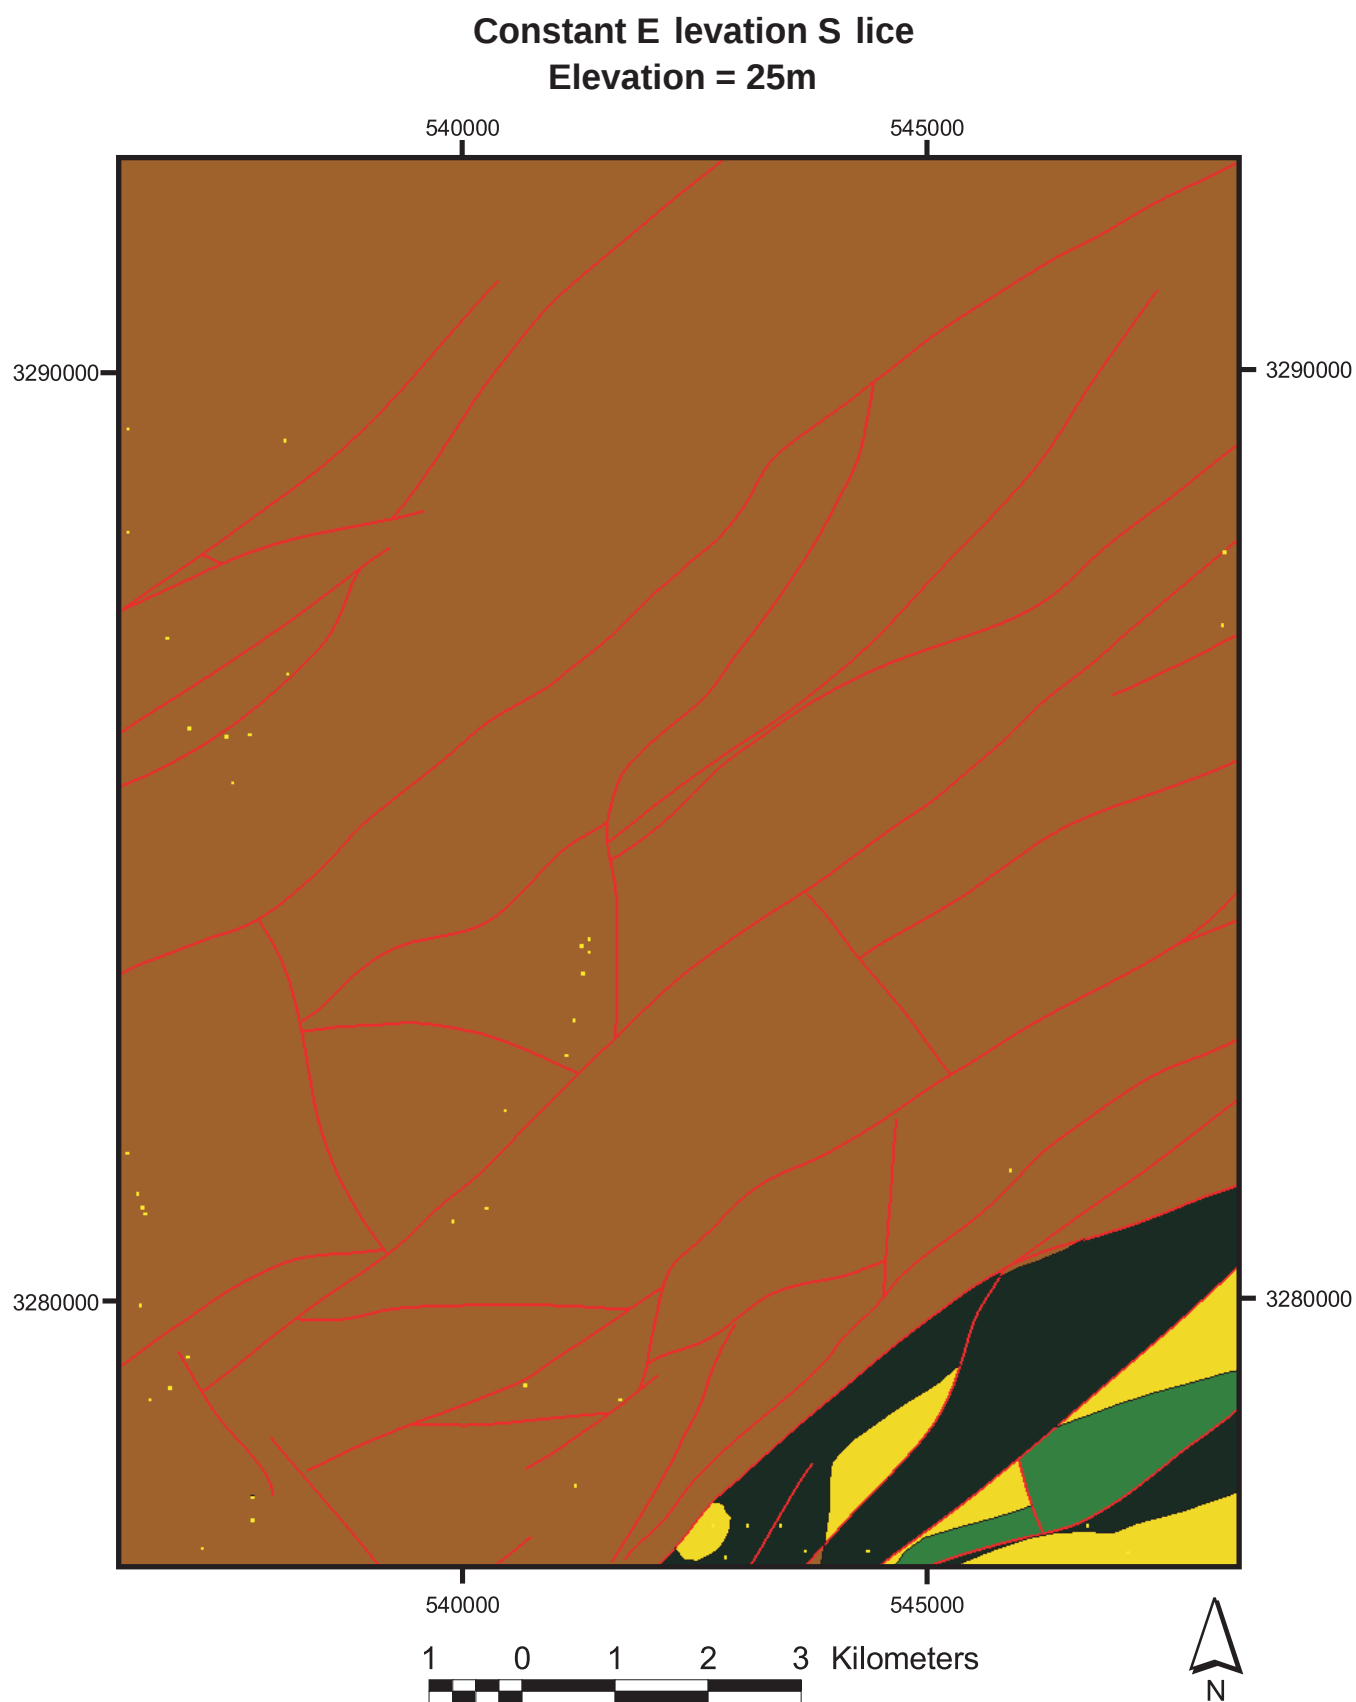
**Figure 3-32.** Map view of constant elevation (horizontal) slice through model. Elevation = 25 m. Units are UTM meters, NAD27. Red lines show fault traces, and yellow points show well locations. See Figure 3-1 for complete color key.

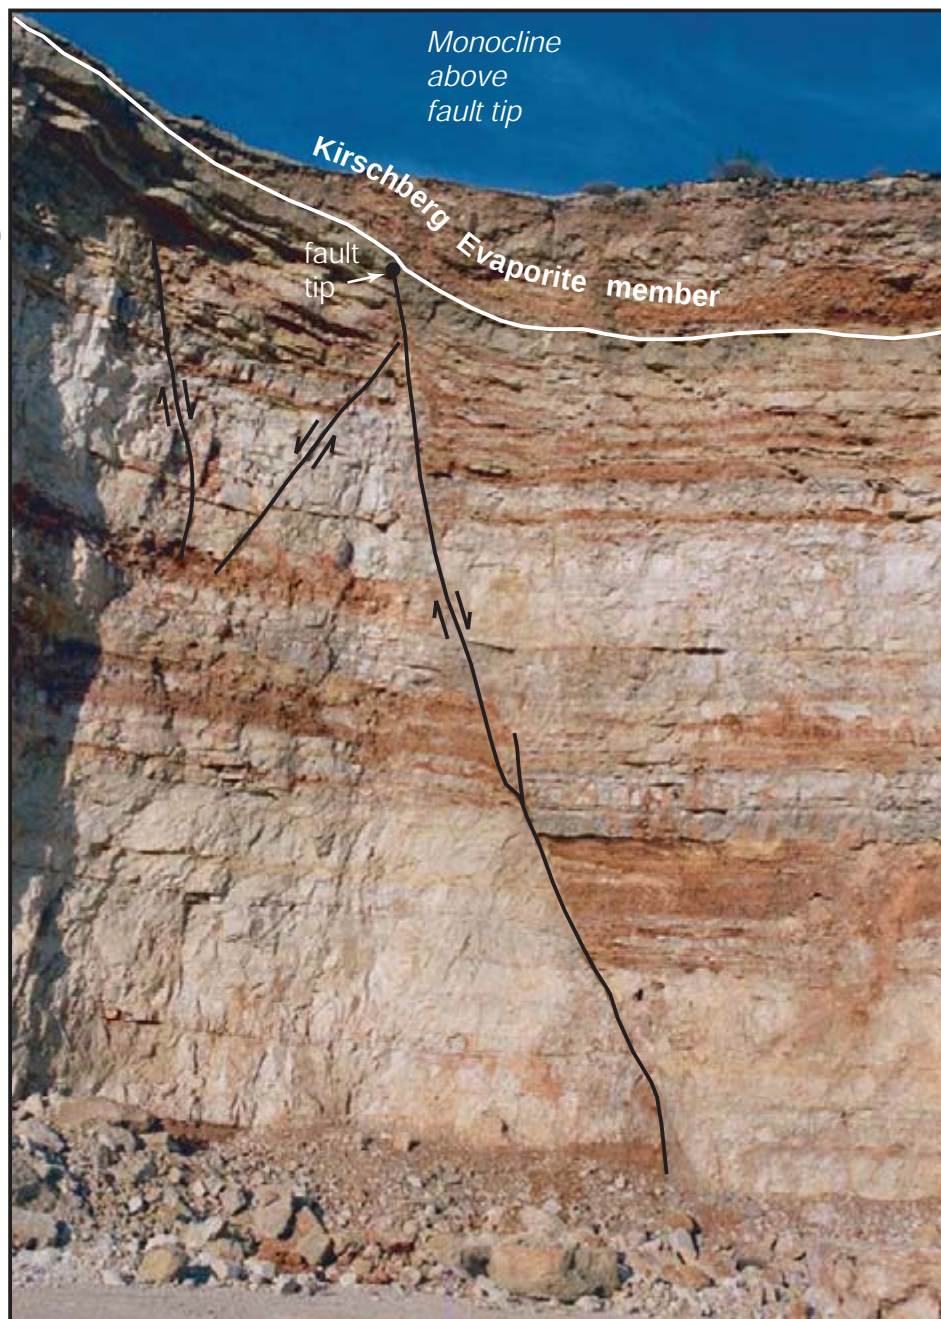
**Figure 5-2.** Fault in the dolomitic member of the Kainer Formation tips (terminates) upward into the Kirschberg Evaporite member. Displacement in the dolomitic member is replaced by monoclinal folding in the overlying Kirschberg Evaporite member. Photo from the Beckmann Quarry, San Antonio, Texas. View is to the ENE, along the direction of strike of the fault.

Over a distance of several hundred meters along one quarry wall in the northeast part of Beckmann Quarry in northwest San Antonio, Texas, six faults with maximum displacement of <6 m (20 ft) extend upward from the quarry floor through the dolomitic member of the Kainer Formation. All six faults terminate at or within the more clay-rich and thinly bedded Kirschberg evaporitic member of the Kainer Formation. Of the faults visible in the exposure, the fault with the largest displacement has a maximum observed displacement of 6 meters (20 ft) along its exposed profile length of 25 m (82 ft) (Figure 5-2). This fault has fairly uniform displacement of 4-6 m (13 - 20 ft) over 15 m (49 ft) of length. At its upward end, displacement drops from 4 m (13 ft) to 0 m over a vertical distance of 5 m (16 ft) (Figure 5-2). Above the fault tip, throw is accomplished by folding, forming a monocline in the Kirschberg evaporitic member above the fault tip. The other five faults that span the dolomitic member in the quarry wall have less displacement, with displacement ranging from decimeters to meters, and all of the faults tip upward in the same stratigraphic interval. Based on their consistent dip extent, but variable maximum displacements, these faults probably propagated through the dolomitic member relatively rapidly with respect to displacement accumulation and continued to accumulate displacement without commensurate upward propagation. The Kirschberg Evaporite member therefore arrests upward fault propagation by deforming in a ductile manner.

Although generally within the Edwards Group, mechanical contrasts are not sufficient to generate monoclines much larger than the one illustrated in Figure 5-2. The overlying Del Rio Clay is much weaker than the Edwards limestones. Consequently, fault propagation monoclines might be expected to develop at the interface between the Edwards Group and the Del Rio Clay. In the San Antonio area this stratigraphic interval is not well-exposed, however, the Sierra Del Carmen range of West Texas provides excellent, well exposed examples of the geometry and deformation processes likely to have occurred in and above the Edwards Aquifer during deformation (Ferrill et al., 2003a). The Sierra Del Carmen range lies along the eastern margin of Big Bend National Park and the contiguous western margin of Black Gap Wildlife Management Area. Range morphology is controlled by the resistant (ridge forming) Cretaceous Santa Elena Limestone (an Edwards Group equivalent), which has largely been exhumed by erosion of the overlying Del Rio Formation (Maxwell et al., 1967; Maxwell, 1968; Moustafa, 1988; Maler, 1990). In Big Brushy Canyon, the massive Santa Elena Limestone is displaced by at least 30 m (98 ft) on a NNW-SSE trending, down-to-the-east normal fault. The Del Rio Formation (clay-rich calcareous strata) which overlies the Santa Elena Limestone, is not completely cut by the fault, but is dramatically thinned over the fault tip (Ferrill et al., 2003a). Overlying the Del Rio Formation is the Buda Limestone, which contains limestone beds 1 to 2 m (3 to 7 ft) thick. The Buda Limestone beds are not faulted, but form a monoclinial fold over the fault. Buda Limestone layers are cut by bed-perpendicular extension fractures that have extended beds by several percent. The Buda and Edwards limestones, however, are not in physical contact with one another, nor is there a physical rupture through the Del Rio Formation that would allow communication between the two potential aquifers. The Del Rio Formation has been folded and
