## **TRACING GROUNDWATER FLOWPATHS IN THE VICINITY OF SAN MARCOS SPRINGS, TEXAS**

Steve Johnson<sup>1</sup>, Geary Schindel<sup>1</sup>, George Veni<sup>2</sup>, Nico Hauwert<sup>3</sup>, Brian Hunt<sup>4</sup>, Brian Smith<sup>4</sup>, and Marcus Gary<sup>1</sup>

**August 2012**

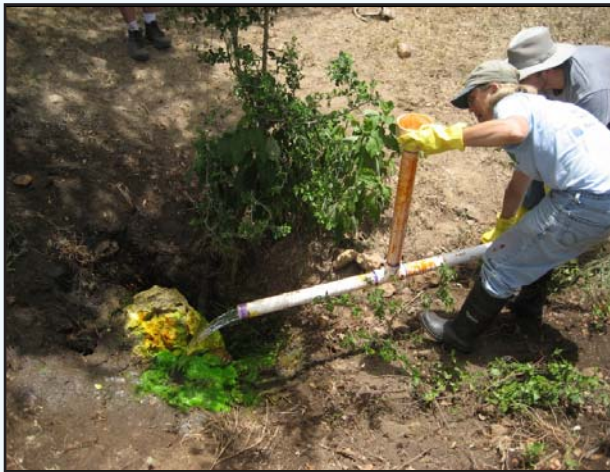
**Figure 29. Julie Jenkins (BSEACD) and Justin Camp (COA) Injecting Uranine into Bull Pasture Sink**

**Bull Pasture Sink.** A small amount of Uranine dye (0.11 kg; 0.24 lb) was injected into Bull Pasture Sinkhole on May 20, 2008, and was flushed with approximately 10,000 gal (38,000 L) of Blanco River water. Two nearby wells (Wells 62 and 70) had low-level positive detections in a water sample and receptor, respectively. No visible dye was detected or reported after this initial injection. A follow-up quantity of 13.6 kg (30 lb) of Uranine was injected on June 10, 2008, and was similarly flushed with approximately 10,000 gal (38,000 L) of Blanco River water (Figure 29).

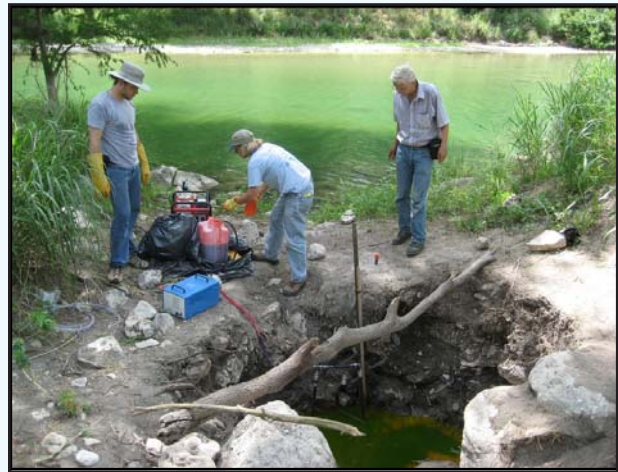
**Figure 30. From left, Bill Russell (TCMA), Julie Jenkins (BSEACD), and Justin Camp (COA) Injecting Eosin into Halifax Sink**

**Halifax Creek Sink.** A small amount of Eosin (0.2 kg; 0.45 lb) was injected with a peristaltic pump through piezometers hammered into the excavation at Halifax Creek on May 20 and 21, 2008, and was flushed with Blanco River water (Figure 30). Up to a week after the initial injection, low levels of Eosin were detected on a charcoal receptor in one public water supply well (Well 75), located approximately 3 mi (5.3 km) north-northeast of the injection point. Because no visible dye was detected or reported in nearby wells after this initial injection, larger quantities of dye (6 kg; 13 lb) were subsequently injected on June 10, 2008, and September 12, 2008 (Table 12).
