## Appendix K | **2024 Permit Oversight**

# Appendix K1 | **2024 Comal Cultural Resources Coordination**

Re: Antiquities Code of Texas Cultural Resource Coordination Letter for the City of New Braunfels and Edwards Aquifer Authority's Proposed Habitat Conservation Plan for 2024 at the Comal River, New Braunfels, Comal County, Texas.

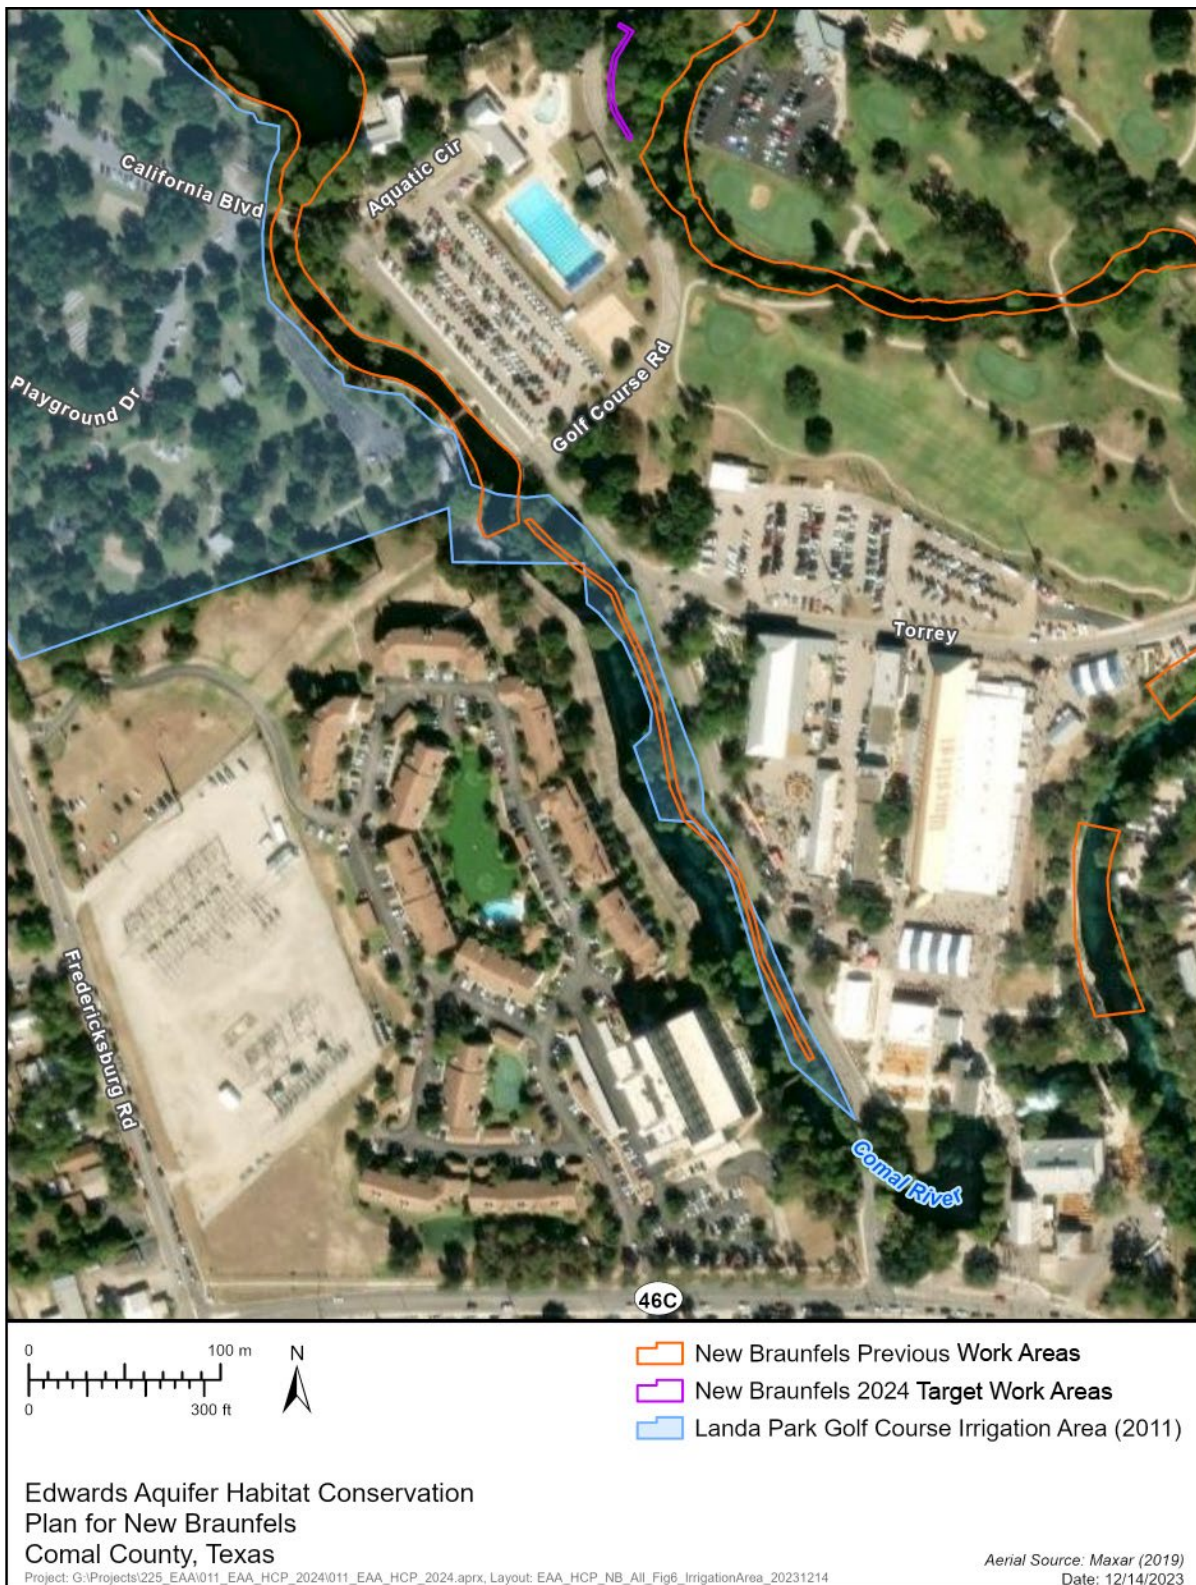
**Figure 6.** Map depicting the project area in relation to Landa Park Golf Course Irrigation Areas.

Ecological Communications Corporation's (EComm's) 2010 intensive archeological survey of Landa Park and the Landa Park Golf Course is particularly relevant to the EAA's planned Riparian Planting Activities (**Figure 6; Attachment 1: Item 7; Antiquities Permit 5642, Nickels 2011**). During that survey, archeologists monitored extensive trenching for irrigation lines along the shorelines of Landa Park. Archeologists recovered three chipped stone artifacts on the surface on the east bank of the Mill Race. No concentrated, intact cultural deposits were observed. Crews extended the boundaries for site

areas may impact adjacent archeological resources (Items 1, 2, 5 and 7). Most of these areas have been surveyed many times over the past decades. Recent exhaustive surface inspection and intensive irrigation trench monitoring (see Nickels 2011 and **Figure 6**) directly within the proposed riparian planting footprints were either devoid of artifacts altogether or they contained minimal artifacts in shallow and/or disturbed contexts. Though these planting components are within or next to recorded SALs, these previous survey findings suggest the planting activities are not likely to adversely affect SAL-eligible deposits.

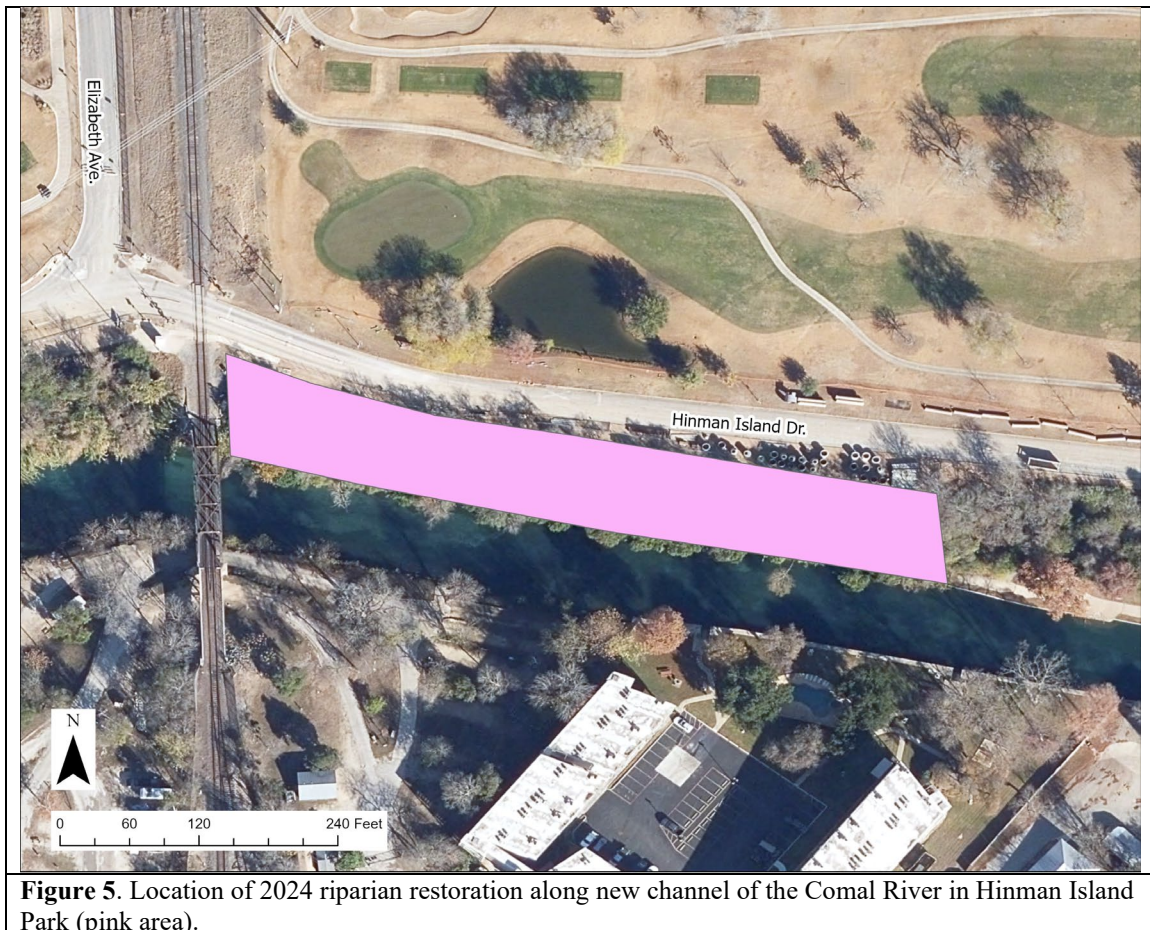
**Figure 5.** Location of 2024 riparian restoration along new channel of the Comal River in Hinman Island Park (pink area).

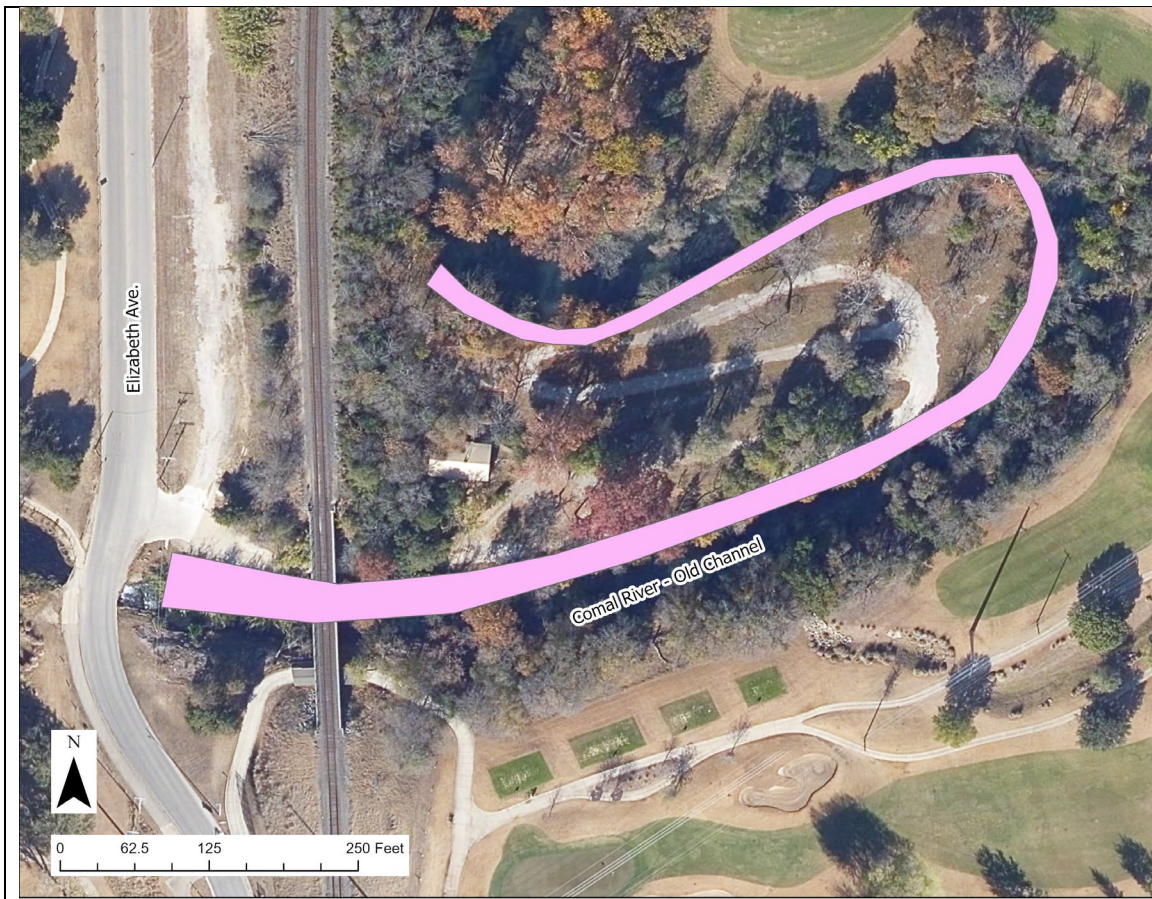
**Figure 7.** Location of 2024 riparian restoration along the banks of the Old Channel of the Comal River located on Schlitterbahn property.

Remove non-native riparian vegetation from the banks the new channel of the Comal River and along a portion of Landa Lake and plant native vegetation where non-natives are removed. The target work areas for 2024 are along the bank along the new channel in Hinman Island Park (**Figure 5**), along Landa Lake adjacent to Spring Island on property owned by the Comal County Water Recreation District #1 (**Figure 6**), and along the bank of the Old Channel on property owned by Schlitterbahn (**Figure 7**).

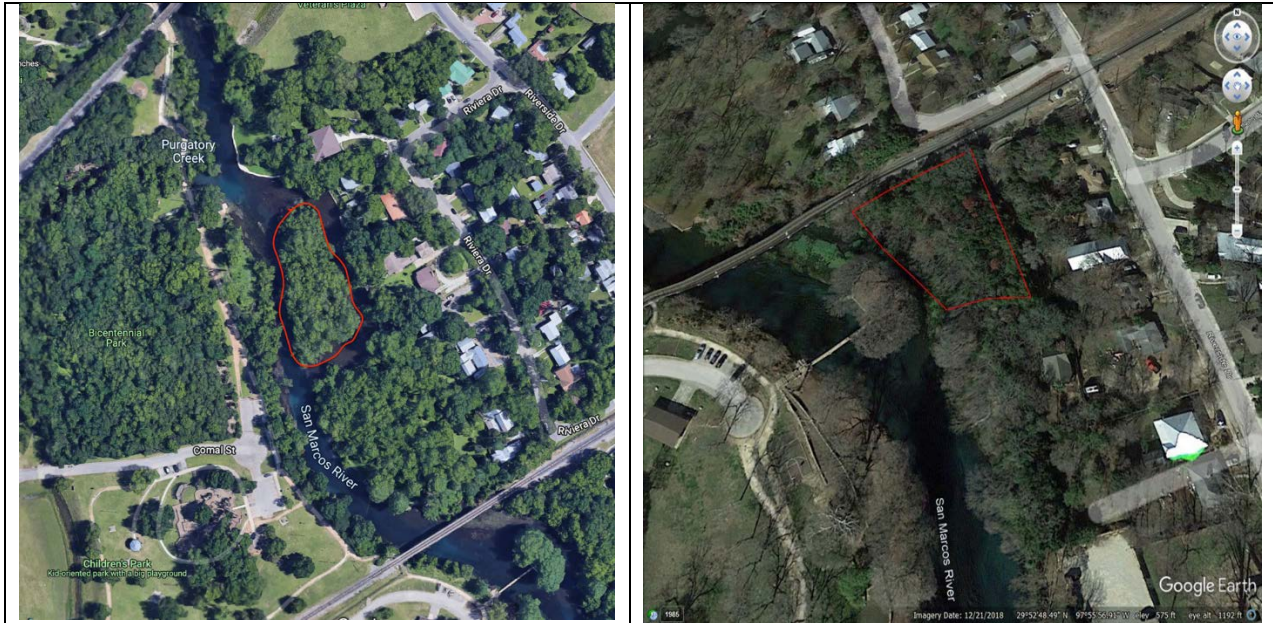
**Figure 2.** 2024 riparian restoration focus areas include Snake Island located across from Bicentennial Park (left) and City property across from Cypress Island in Rio Vista Park (right).

Continue efforts to remove remaining non-native vegetation from Snake Island, within City property located on river-left across from the Cypress Island in Rio Vista Park (**Figure 2**). Plant native vegetation, as needed, in areas where non-native vegetation has been adequately controlled.

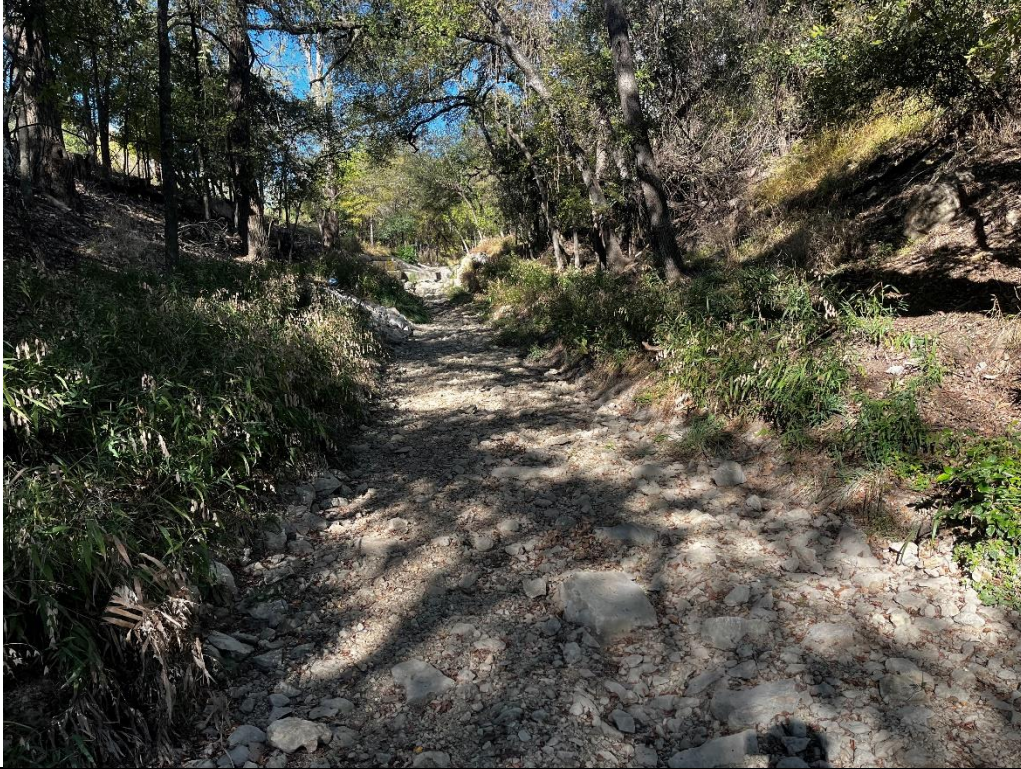
**Photo 1. Downstream extent (Station 1) directly upstream of the intersection of N. LBJ, facing upstream. Photo taken on 11/21/2024.**

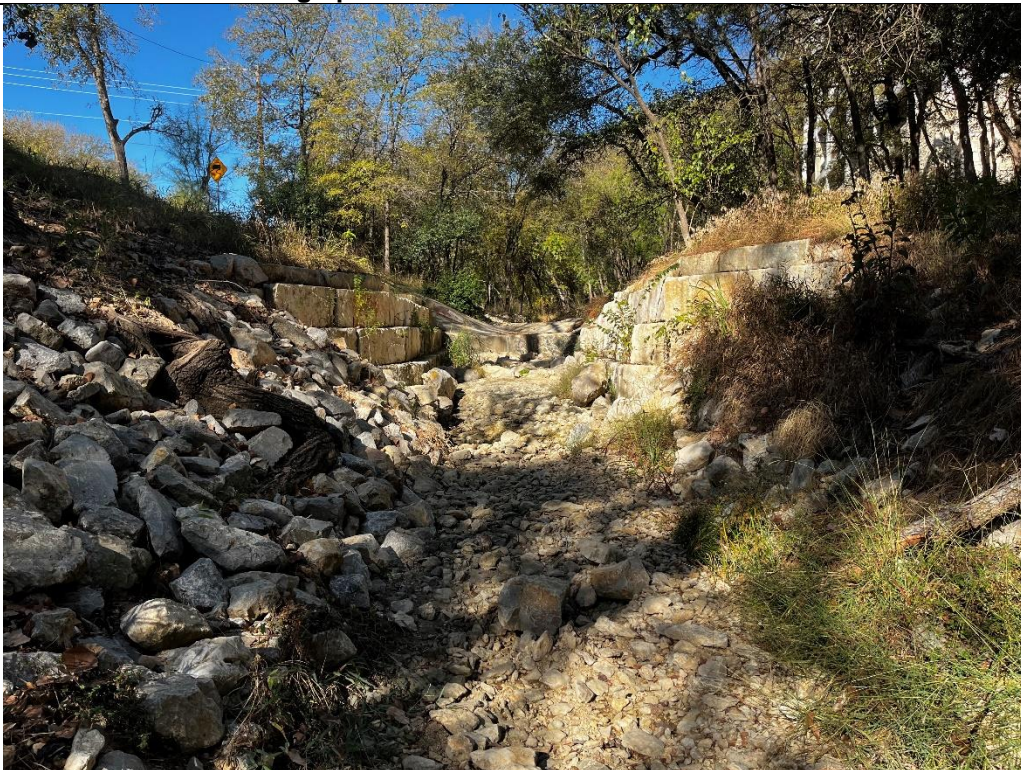
**Photo 2. Station 2, directly downstream of gully control #1 and #2, facing upstream. Photo taken 11/21/2024.**

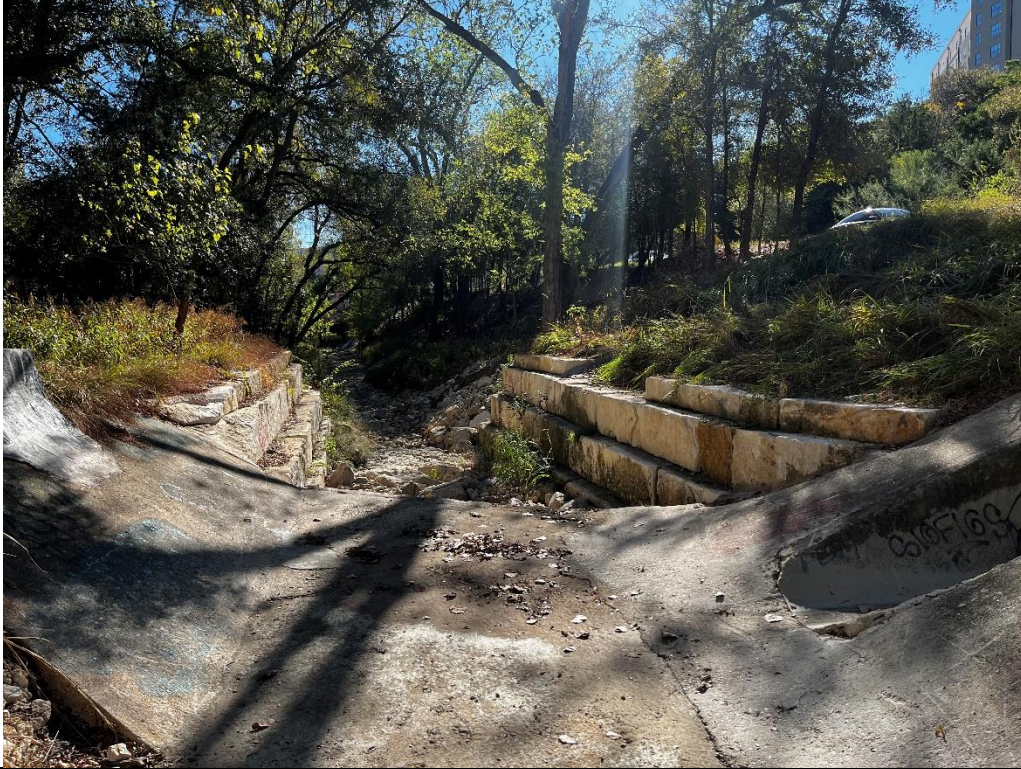
**Photo 3. Station 3, directly downstream of gully control #1 and #2, facing downstream. Photo taken 11/21/2024.**

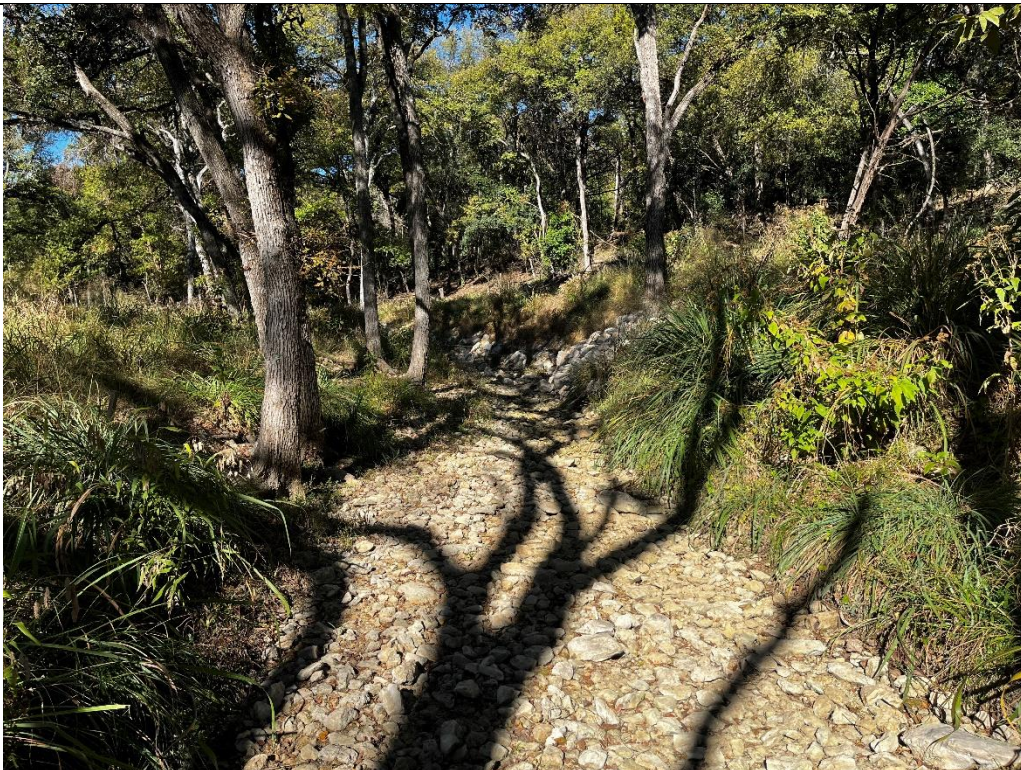
**Photo 4. Station 4, between bank stabilization # 2 and #3, facing, facing upstream. Photo taken 11/21/2024.**

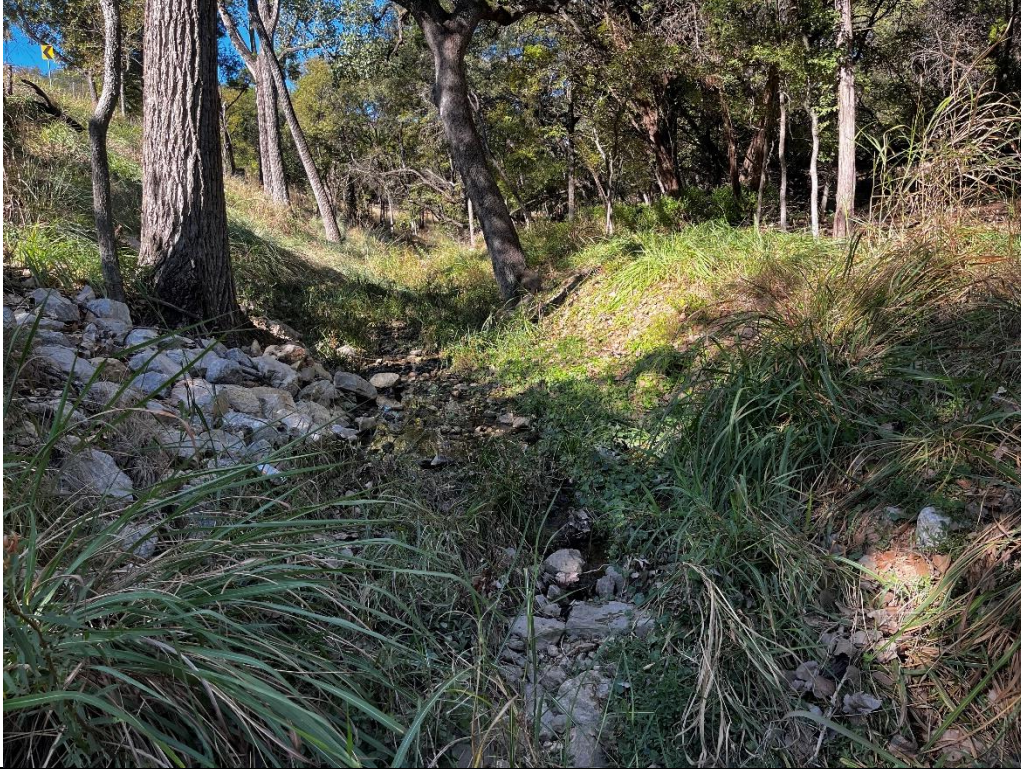
**Photo 5. Station 5, between grade control structure #3 and bank stabilization #5, facing upstream. Photo taken 11/21/2024.**

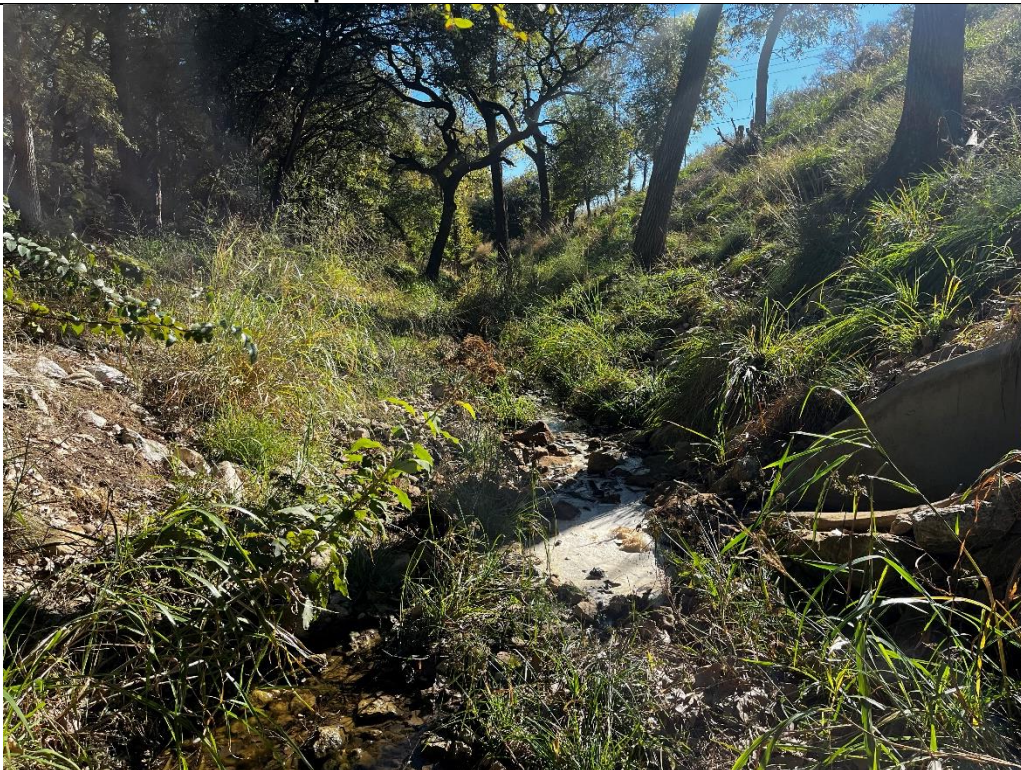
**Photo 6. Station 6, between grade control structure #4 and bank stabilization #5, facing downstream. Photo taken 11/21/2024.**

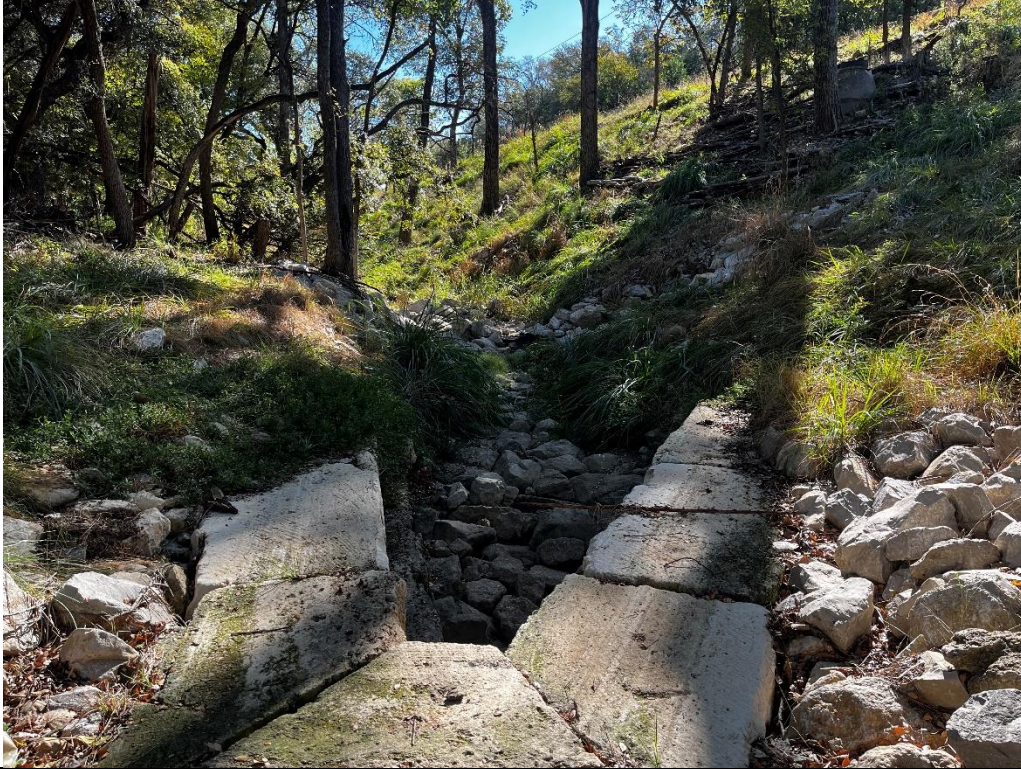
**Photo 7. Station 7, facing downstream from grade control structure #5. Photo taken 11/21/2024.**

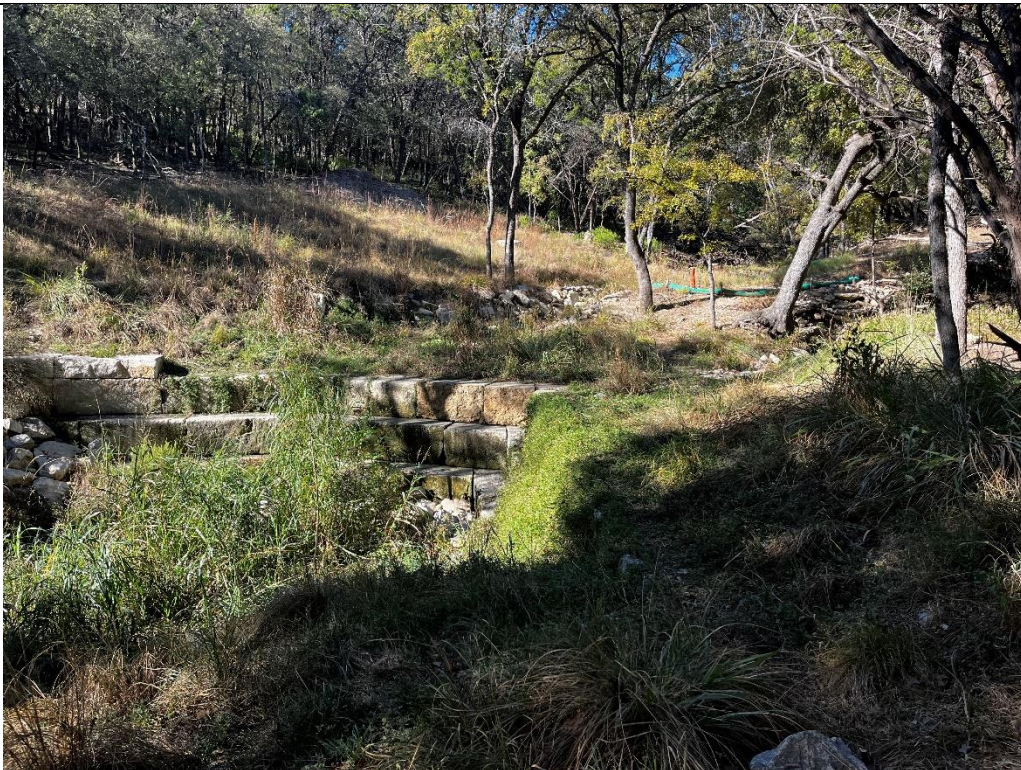
**Photo 8. Station 8, between grade control structure #5 and #6, facing upstream towards Sessom Creek and Windmill tributary confluence. Photo taken 11/21/2024.**

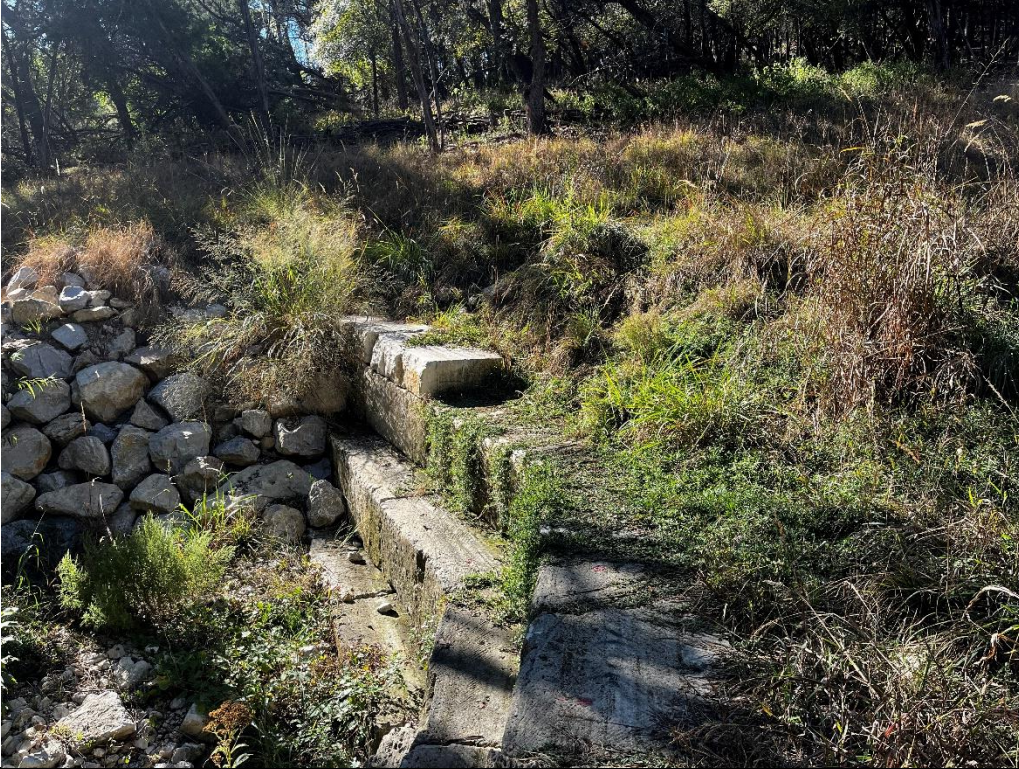
**Photo 9. Grade control structure #6, vegetation established in-channel and along banks.  
Photo taken on 11/21/2024.**

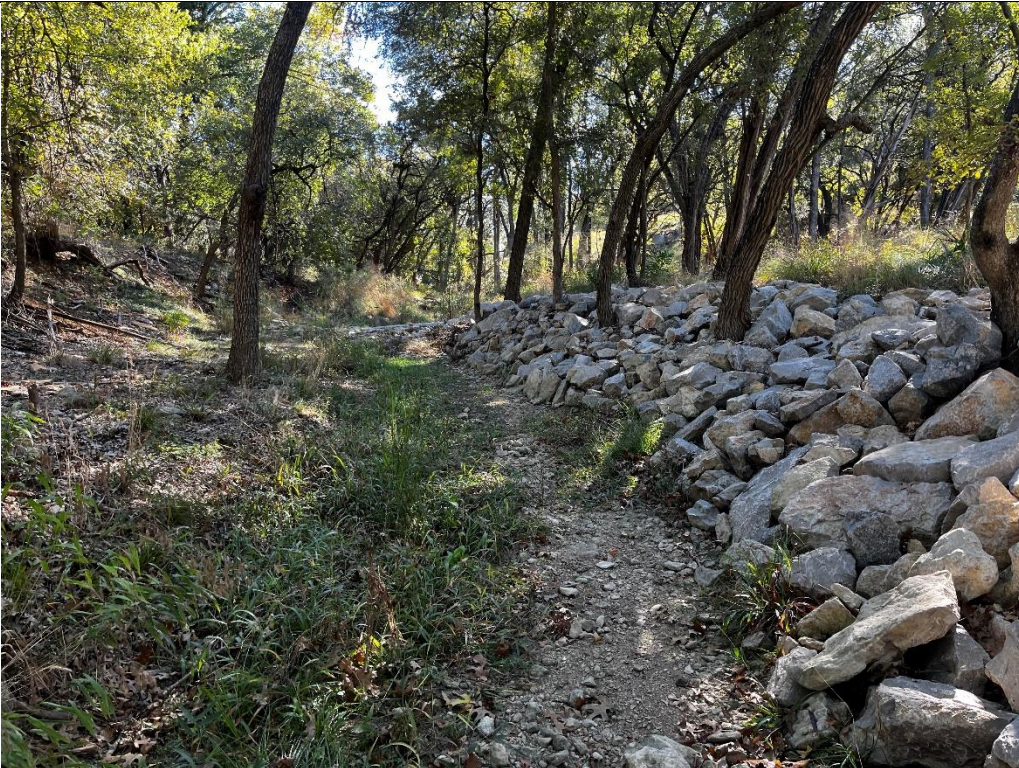
**Photo 10. Stabilized infrastructure between grade control structure # 5 and #6, facing  
downstream. Photo taken on 11/21/2024.**

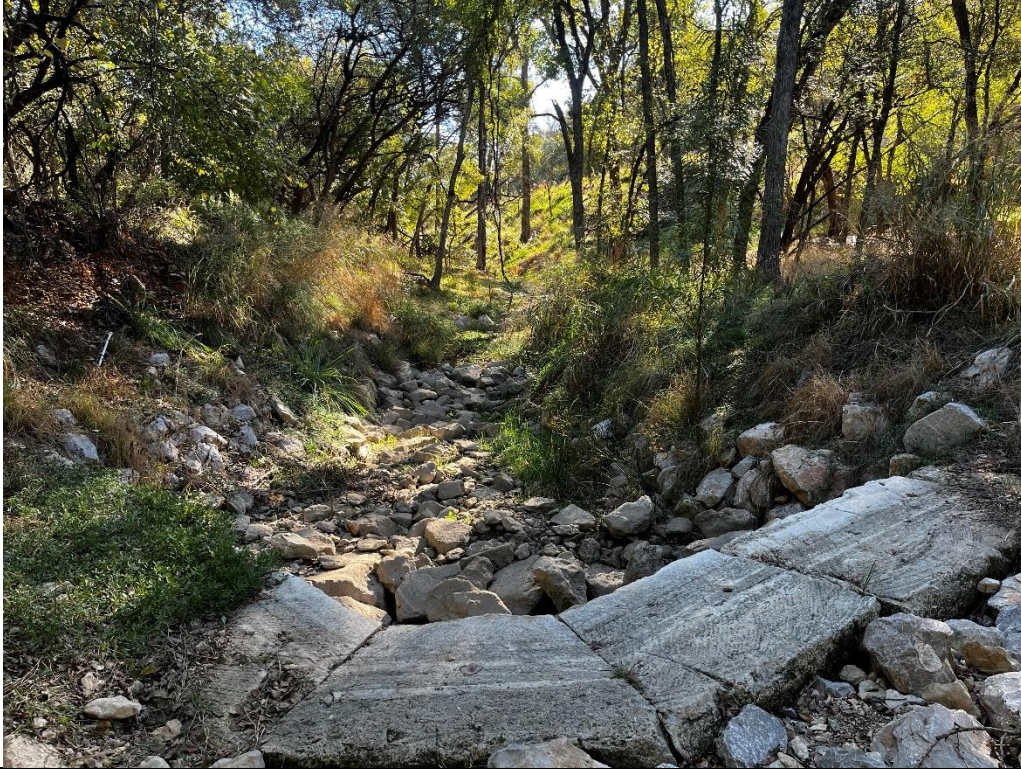
**Photo 11. Established riparian vegetation, from grade control structure #5, facing downstream. Photo taken on 11/21/2024.**

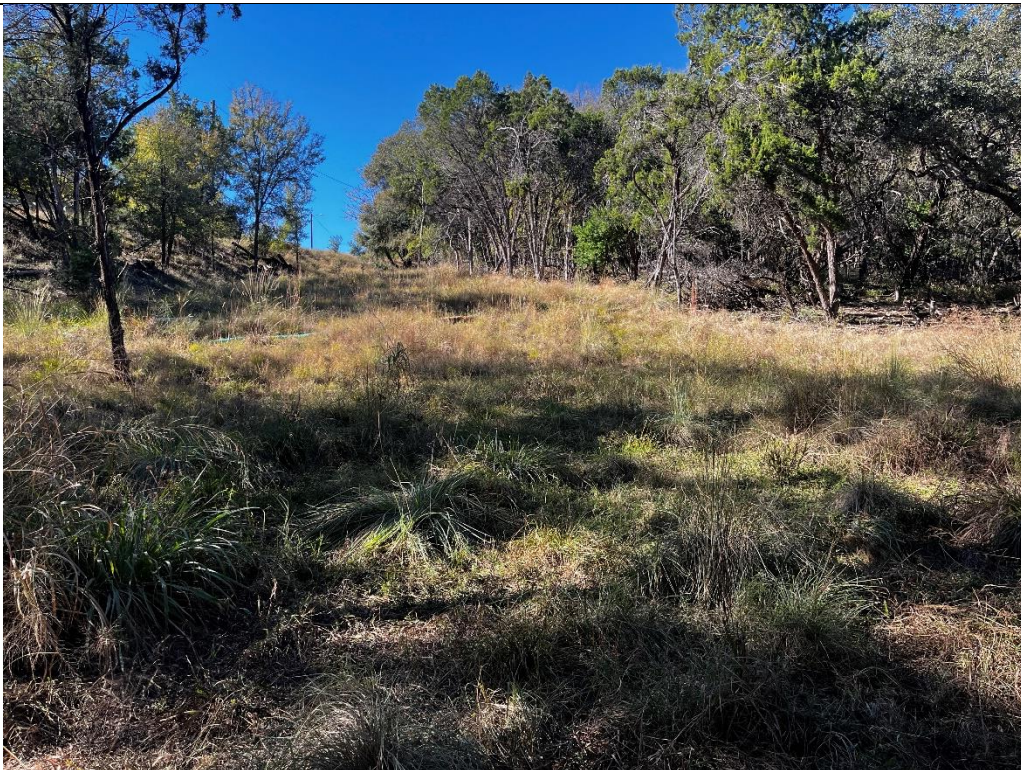
**Photo 12. Restored staging area with established vegetation. Photo taken on 11/21/2024.**

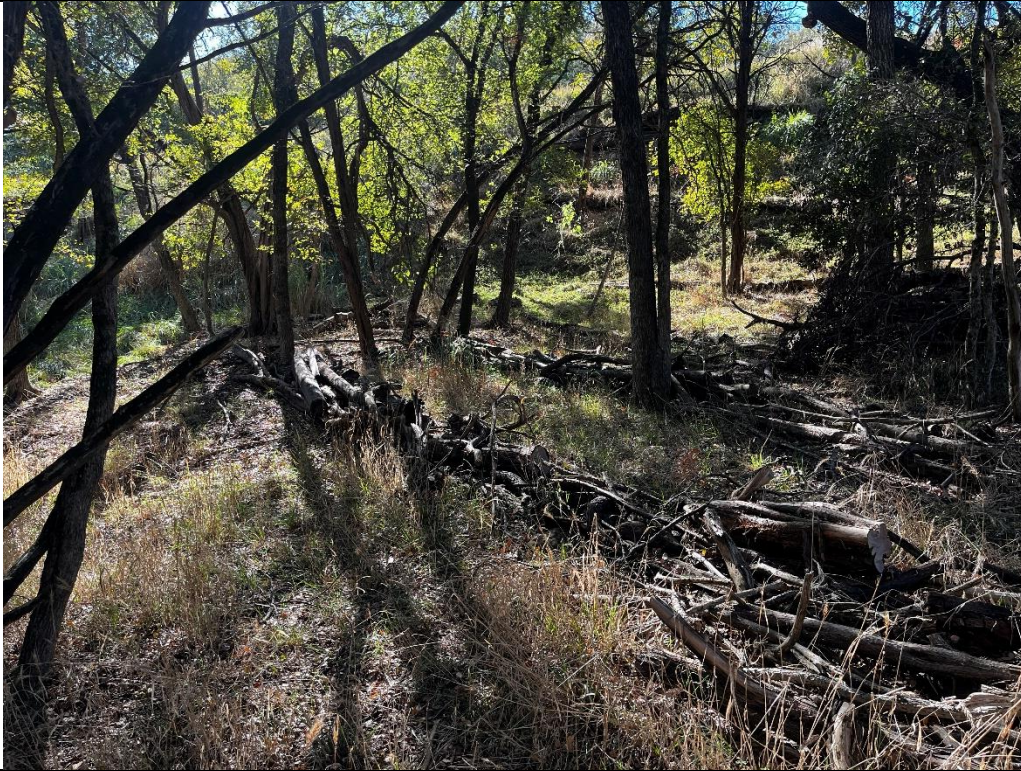
**Photo 13. Established riparian vegetation with log breaks in place. Photo taken on 11/21/2024.**

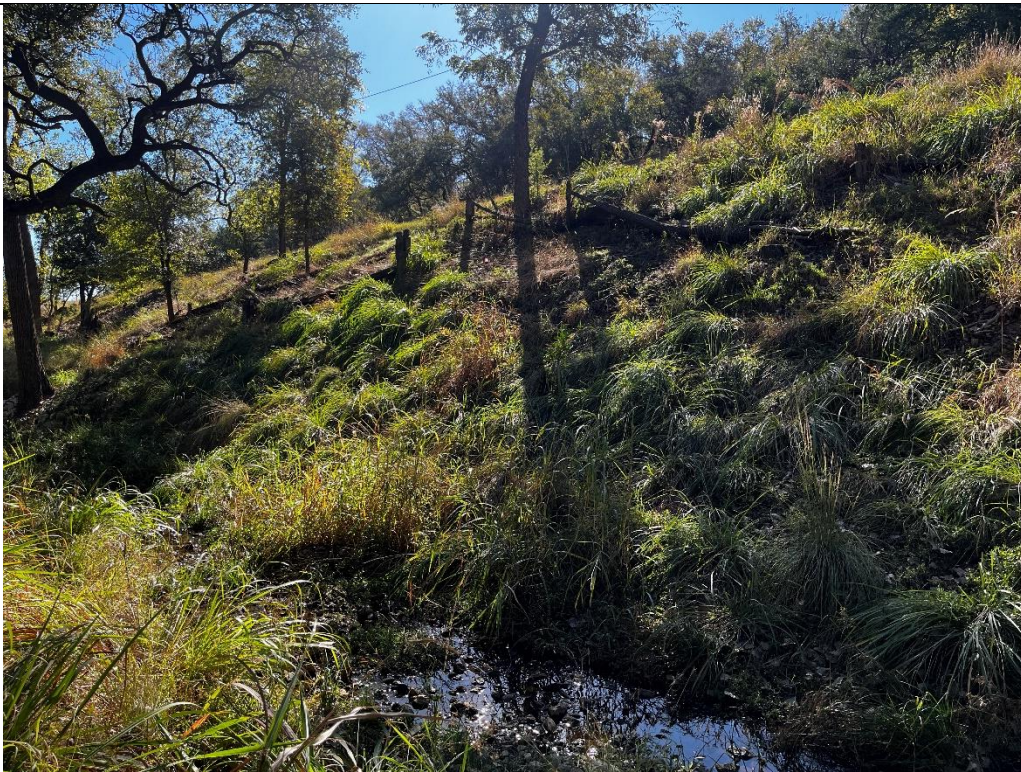
**Photo 14. Established vegetation along steep bank between Sessom Creek and Sessom Drive. Photo taken on 11/21/2024.**

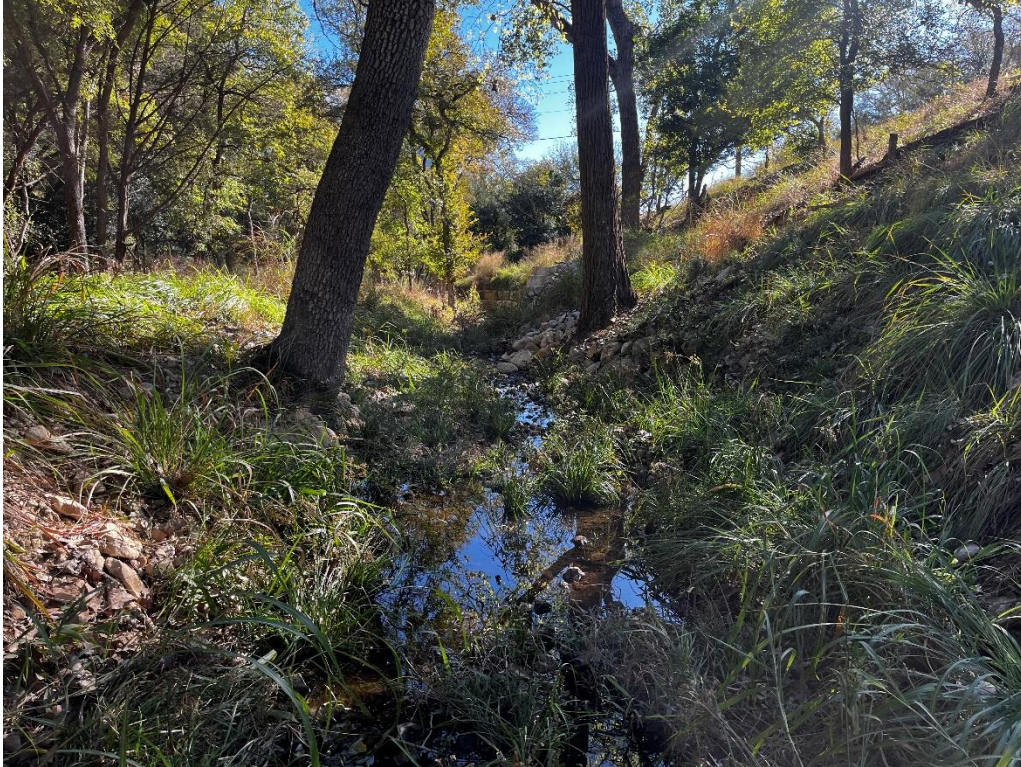
**Photo 15. Established riparian and in-channel vegetation. Photo taken on 11/21/2024.**

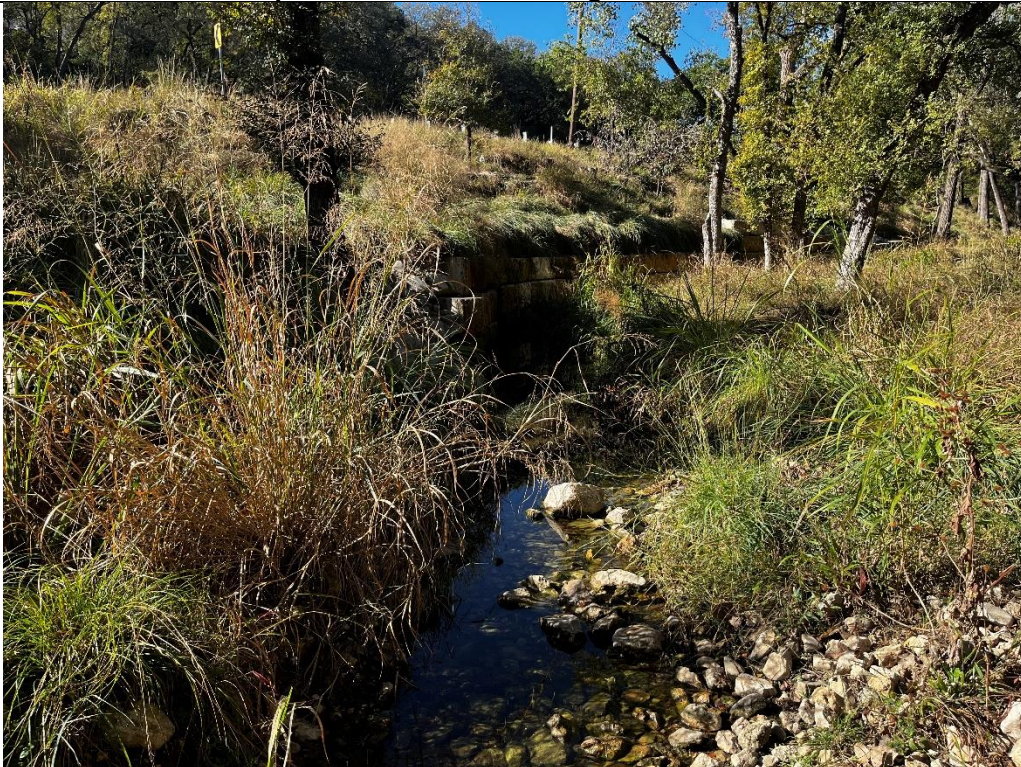
**Photo 16. Established vegetation and stabilized infrastructure (bank stabilization #4). Photo taken on 11/21/2024.**

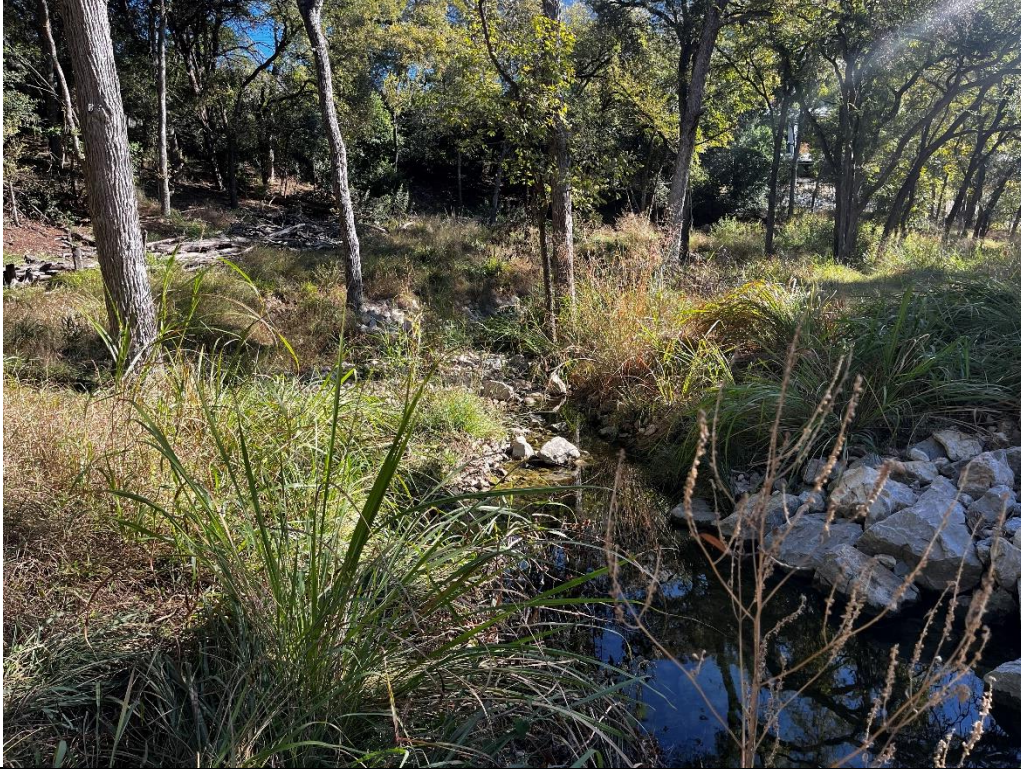
**Photo 17. Established riparian and in-channel vegetation, between bank stabilization #4 and grade control structure #3, facing downstream. Photo taken on 11/21/2024.**

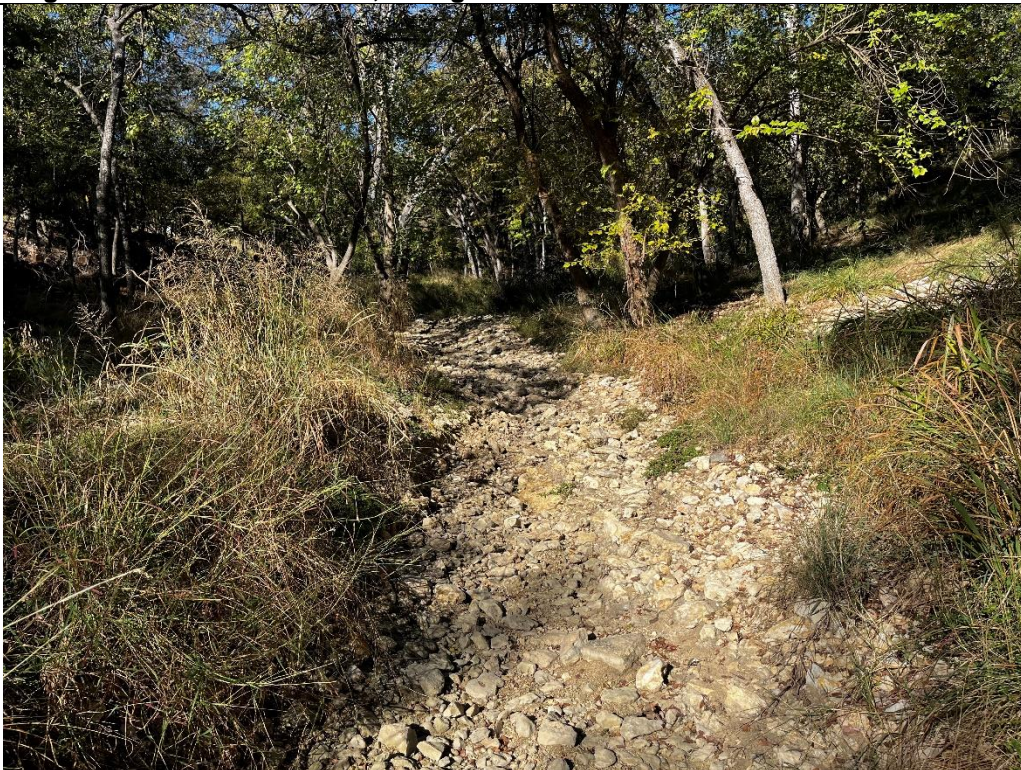
**Photo 18. Established riparian vegetation between gully control #1 and #2, facing upstream. Photo taken on 11/21/2024.**
